# Trend Monitoring Summary: 2004-2009

## Unnamed Tributary to the Coosa R. (Etowah Co.) at North Gadsden Park (34.0396/-85.9726)

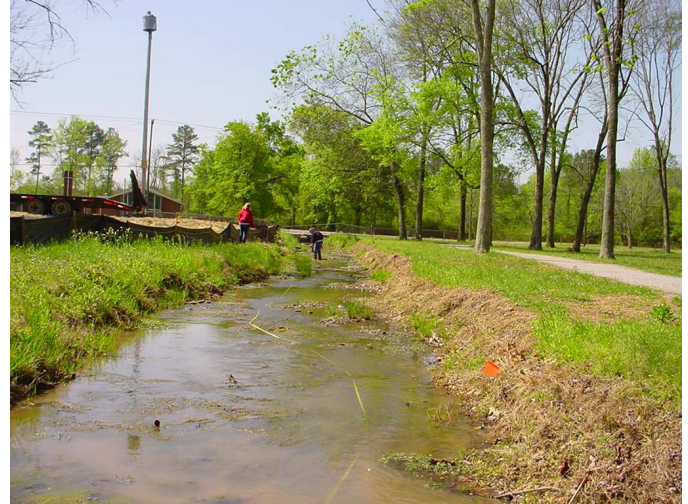
In June 2004, the reach was observed to be overly wide and shallow due to repeated dredging. It lacked the rootbank and riparian vegetation areas that provide habitat for aquatic communities (Figure 1; Table 1). Bedrock, which limits habitat for macroinvertebrates and fish, dominated the bottom substrate (Table 1). Overall habitat quality for macroinvertebrate communities was rated as *fair* (Table 2).

**Figure 1.** Unnamed tributary to the Coosa River in North Gadsden Park. This photo, looking downstream, was taken in 2004, prior to project construction.

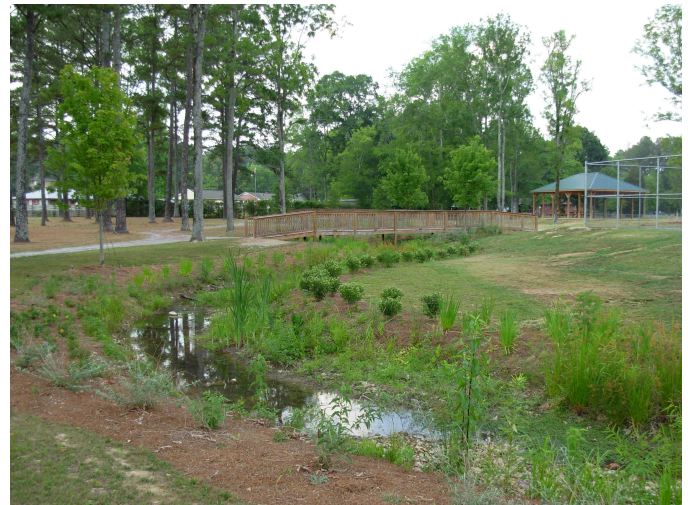
As part of the stream restoration completed in 2005, the stream channel was narrowed to improve flow and increase stream depth. Vegetation was also planted on the banks to provide additional habitat and bank stability. Stable substrates, which provide habitat for insect colonization, also comprised a greater proportion of the stream bottom. (Table 1; Figure 2). These changes resulted in improved instream habitat quality, a higher frequency of riffle habitat, and greater bank and vegetative stability. Overall habitat quality improved from *fair* in 2004 to *good* in 2009 (Table 2).

**Figure 2.** Unnamed tributary to the Coosa River in North Gadsden Park. This photo, facing upstream, was taken in 2006, one year after project completion.

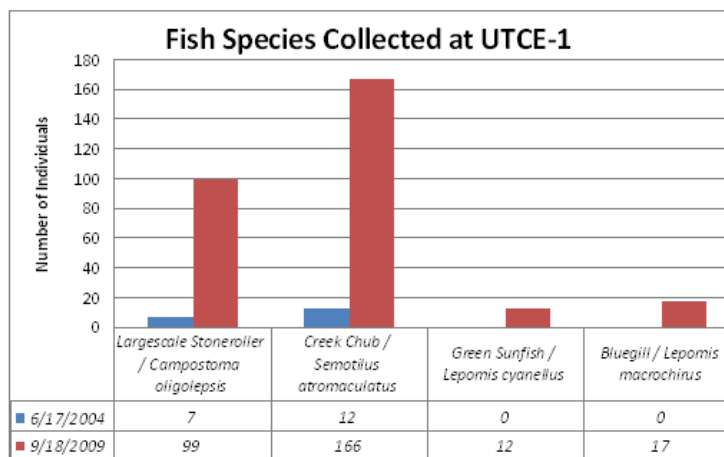
The ADEM conducted fish IBI sampling events before and after the stream restoration (Figure 3). These sampling events were completed using a time-based method where all available habitat within the reach is sampled using a backpack electrofisher for a period of 30 minutes. In 2004, prior to the stream restoration, only two species were collected in low numbers. The ADEM returned in 2009 to conduct a five year post-restoration comparison study. Using the same method as before, the total number of species collected doubled, and total number of individuals increased dramatically. The species collected included sunfish species not previously seen in the reach. The catch per hour rate increased from 38 in 2004 to 441 in 2009. After five years, the reach is showing signs of increased diversity and richness.

**Figure 3.** Comparison of fish species collected at Unnamed tributary to the Coosa River in North Gadsden Park during pre-restoration event in 2004 and post-restoration event in 2009.
