EVALUATION OF A RUBBER-MODIFIED MIXTURE DESIGNED USING A BALANCED DESIGN IN COFFEE COUNTY, ALABAMA

Year 3 Evaluation Report

Evaluation of a Rubber-Modified Mixture Designed Using a Balanced Design in Coffee County, Alabama

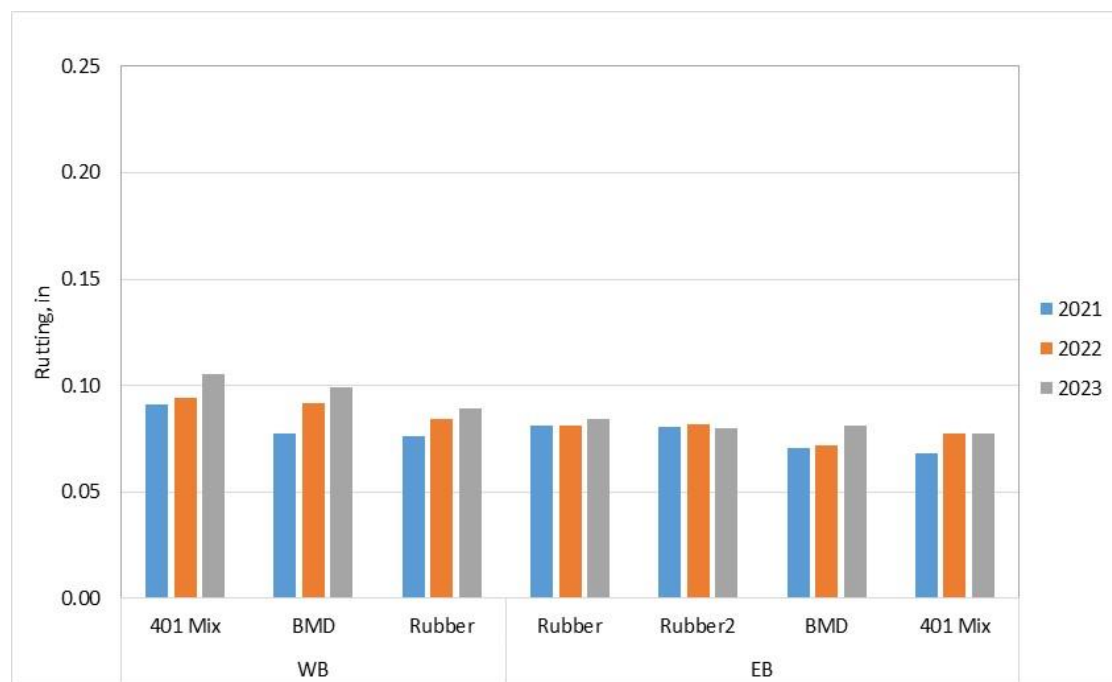
Figure 3 Rutting Results

The average performance data for IRI, rutting, and texture measured after 1, 2, and 3 years of performance are shown in Figures 3-5. As presented in Figure 3, the rutting performance of all the sections after 3 years did not change significantly with rutting not exceeding 0.11 in. IRI of the sections was similar with the BMD-WB mix showing the highest value after 3 years of performance at 100 in/mi. The macrotexture increased for year 3, with the highest value reported for the control Superpave mix (401 mix).

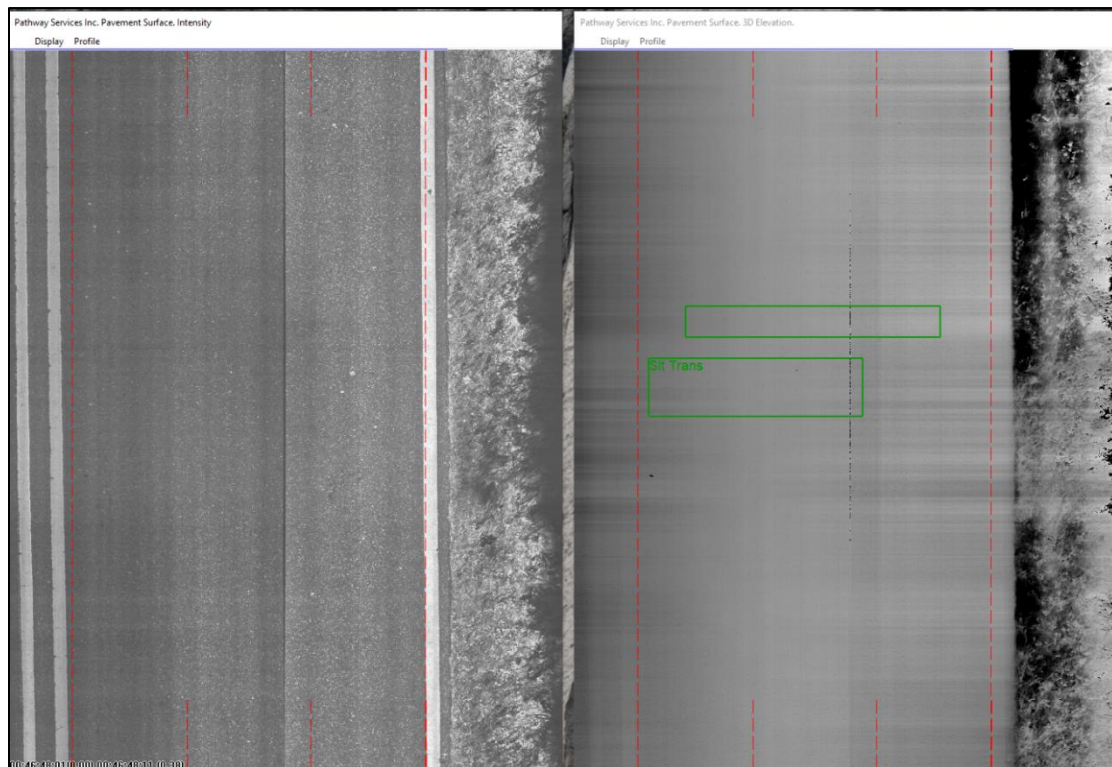
Figure 6 Example of Cracking Identified by Pathway System

Cracking was detected and classified using Pathway Service’s software AutoCrack and AutoClass which classifies cracking by type. At the time of the 3-year visit, there was still very little cracking observed. The cracking identified by the AutoClass software was manually inspected for quality, and any obvious errors made by the software were then corrected. Tables 1 and 2 show summaries of the few cracks that were identified by the Pathway system at the time of the 2022 and 2023 visits respectively. There was more cracking detected in 2022 compared to 2023. This is not uncommon since the cracks are so small, that sometimes the collection vehicle will not detect them.

The width of these cracks is minimal and could have been caused by a wide variety of factors. Since it makes up such a small percentage of the lane area, these cracks are probably not indicative of mix performance. Overall, the test sections appear to be performing well.
