EVALUATION OF A RUBBER MODIFIED MIXTURE DESIGNED USING A BALANCED DESIGN IN COFFEE COUNTY, ALABAMA

Year 2 Evaluation Report Submitted to COFFEE COUNTY, AL

Evaluation of A Rubber Modified Mixture Designed Using A Balanced Design in Coffee County, Alabama Year 2 Evaluation Report

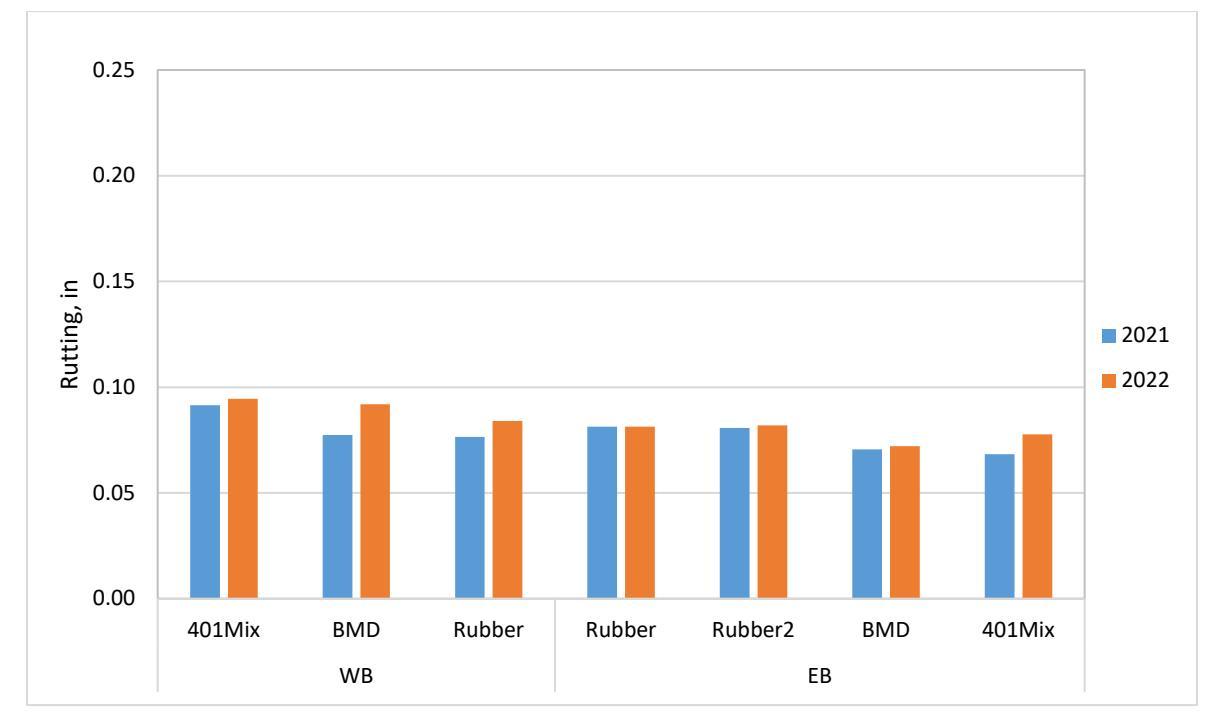
Figure 3 Rutting Results

The average performance data for IRI, rutting, and texture measured after 1 and 2 years of performance are shown in Figures 3-5. As presented in figure 3, the rutting performance of all the sections after 2 years did not change significantly with rutting not exceeding 0.09 in. IRI of the sections was similar with the BMD-EB mix showing the highest value after 2 years of performance at 99 in/mi. The macrotexture increased slightly, with the highest value reported for the control Superpave mix (401 mix).

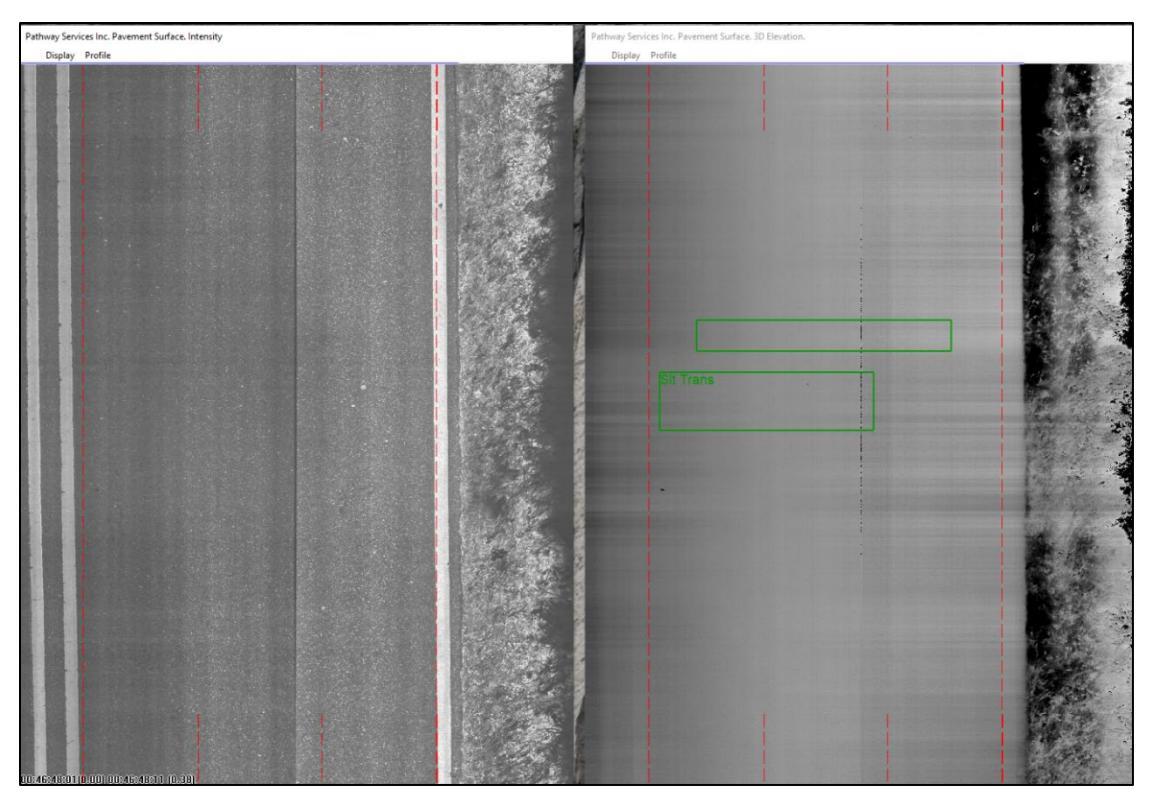
Cracking was detected and classified using Pathway Service's software AutoCrack and AutoClass which classifies cracking by type. At the time of the 2-year visit, there was very little cracking observed. The cracking identified by the AutoClass software was manually inspected for quality, and any obvious errors made by the software were then corrected. Table 1 shows a summary of the few cracks that were identified by the Pathway system. The width of these cracks is minimal and could have been caused by a wide variety of factors. Since it makes up such a small percentage of the lane area, these cracks are probably not indicative of mix performance. Overall the test sections appear to be performing well.

Figure 6 Example of Cracking Identified by Pathway System

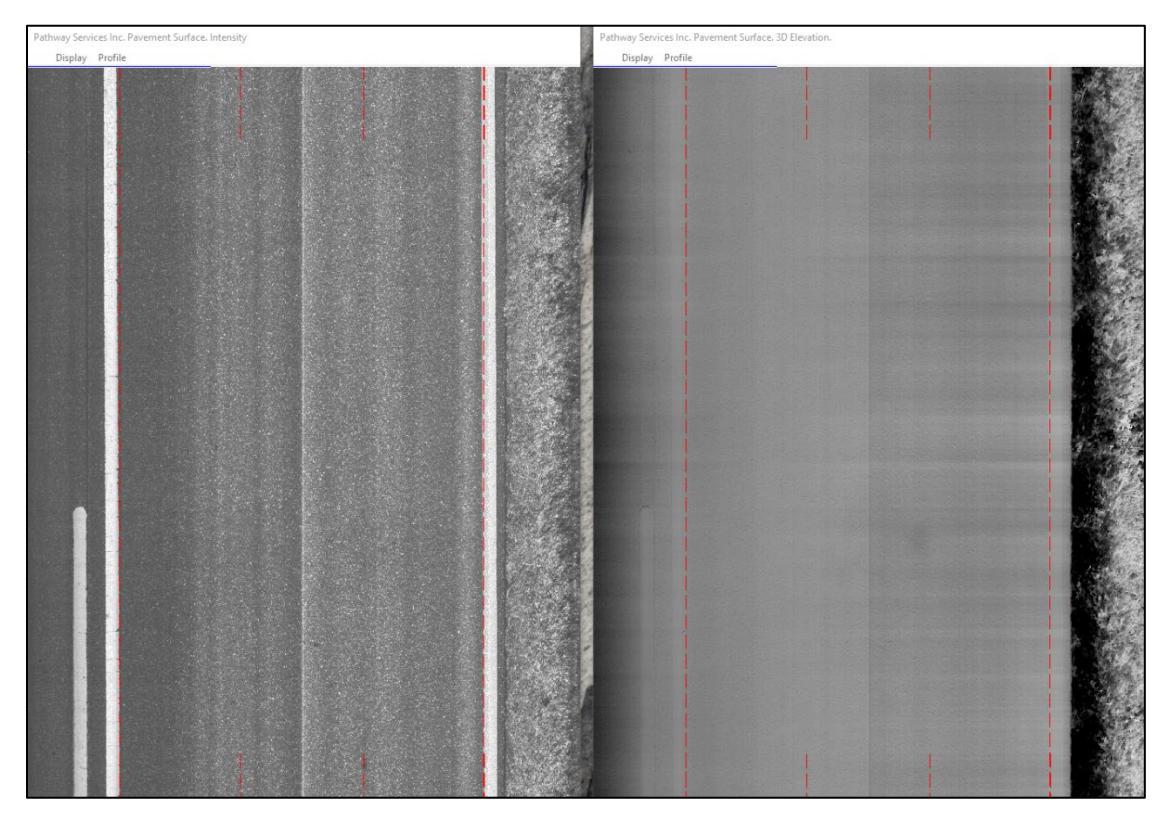
Figure 7 WB 401-Mix Section @ 25' scale

At the time of the year two evaluation, no significant differences were observed in the performance of the rubber and control sections. The next field inspection will take place in October 2023.
