GROUNDWATER REMEDIATION OF A LARGE FUEL HYDROCARBON PLUME IN MOUNDVILLE, ALABAMA

Bob Goodson, AL PG#1303

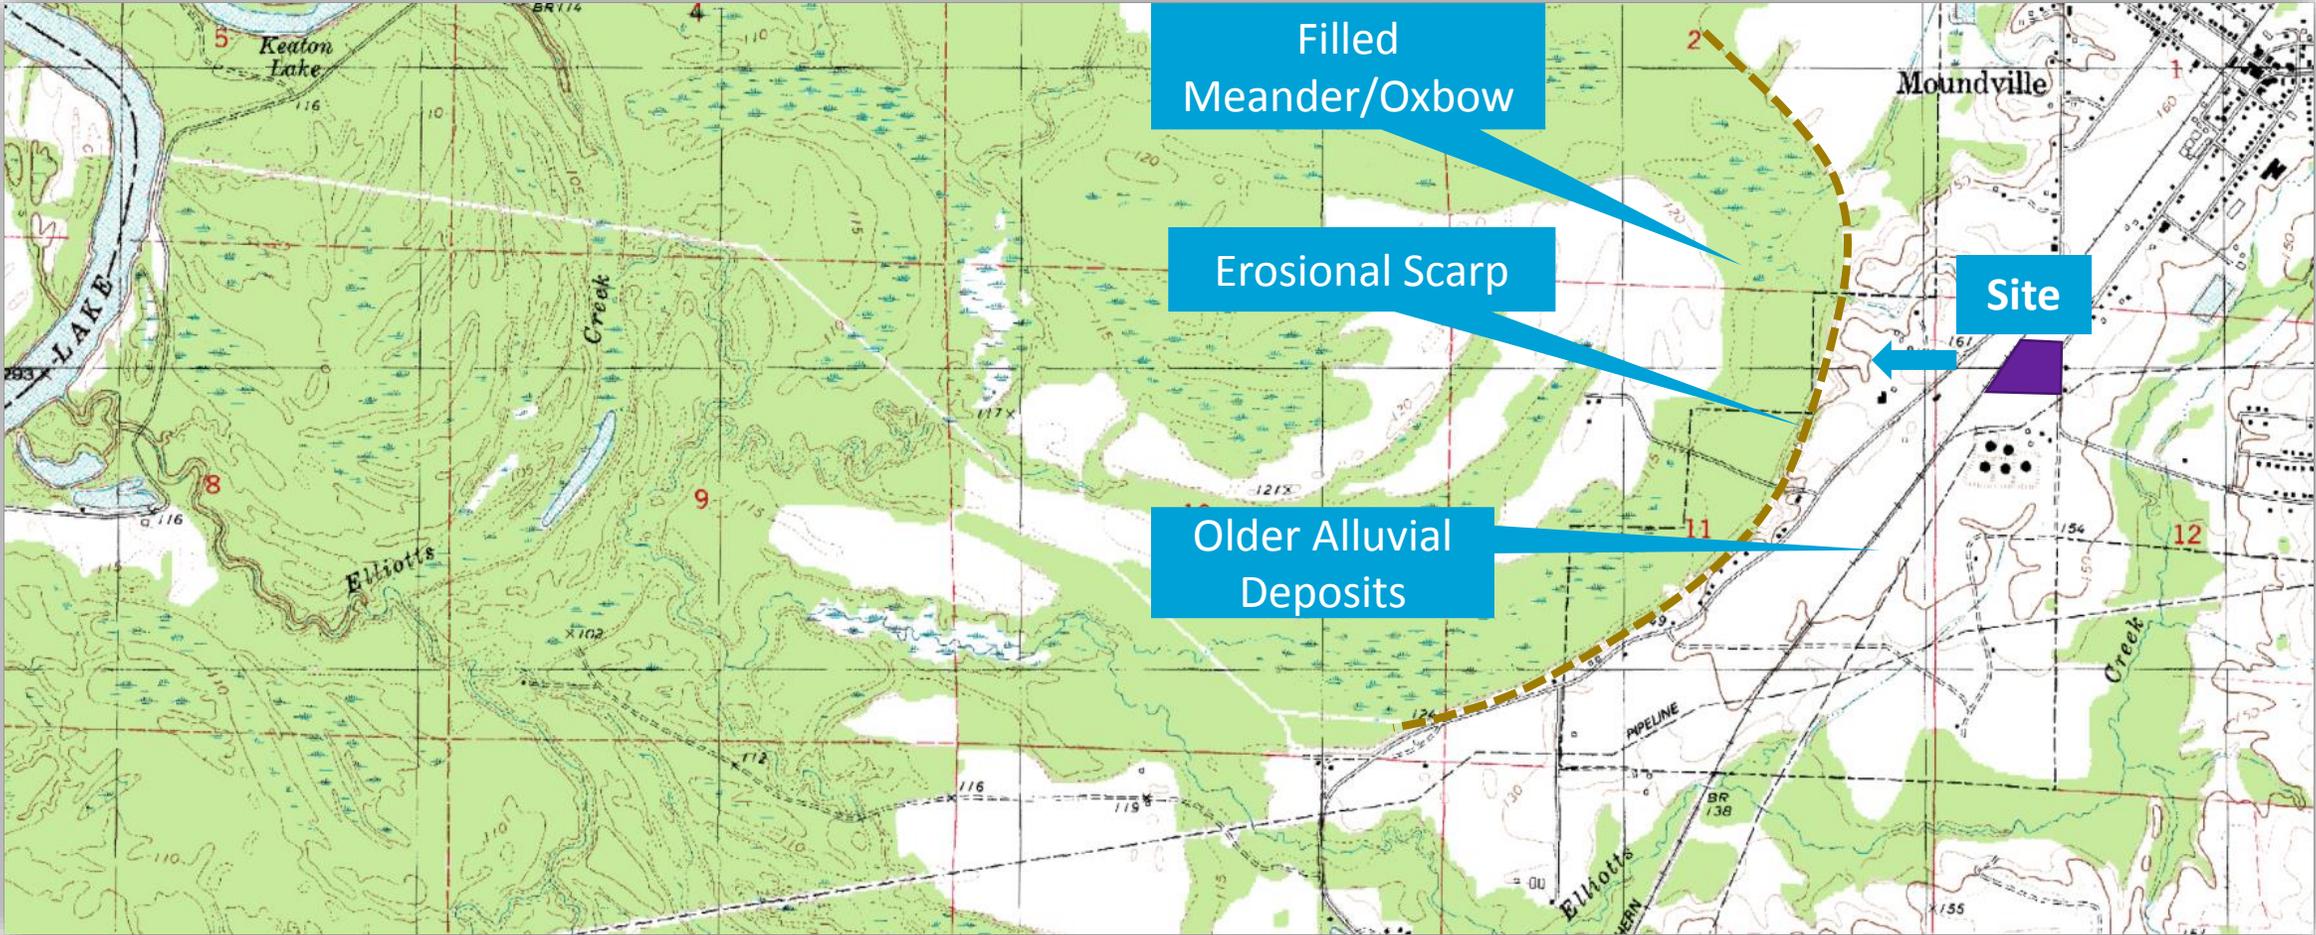
Geomorphology – Key to the Conceptual Site Model

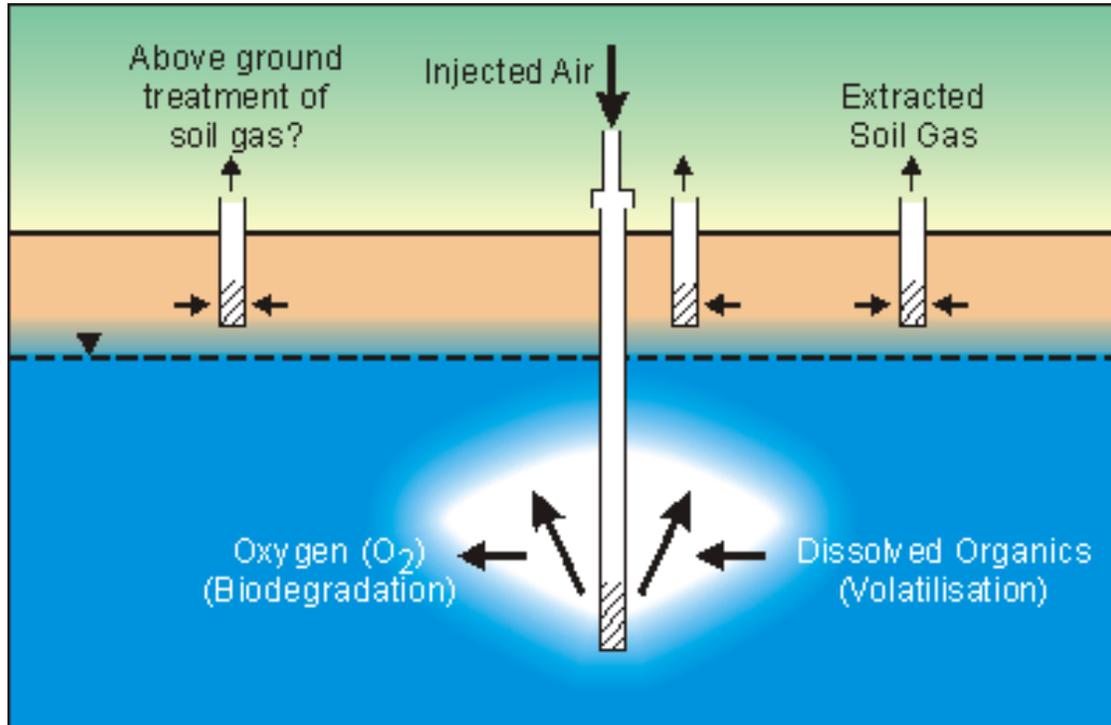
Groundwater: Air Sparging

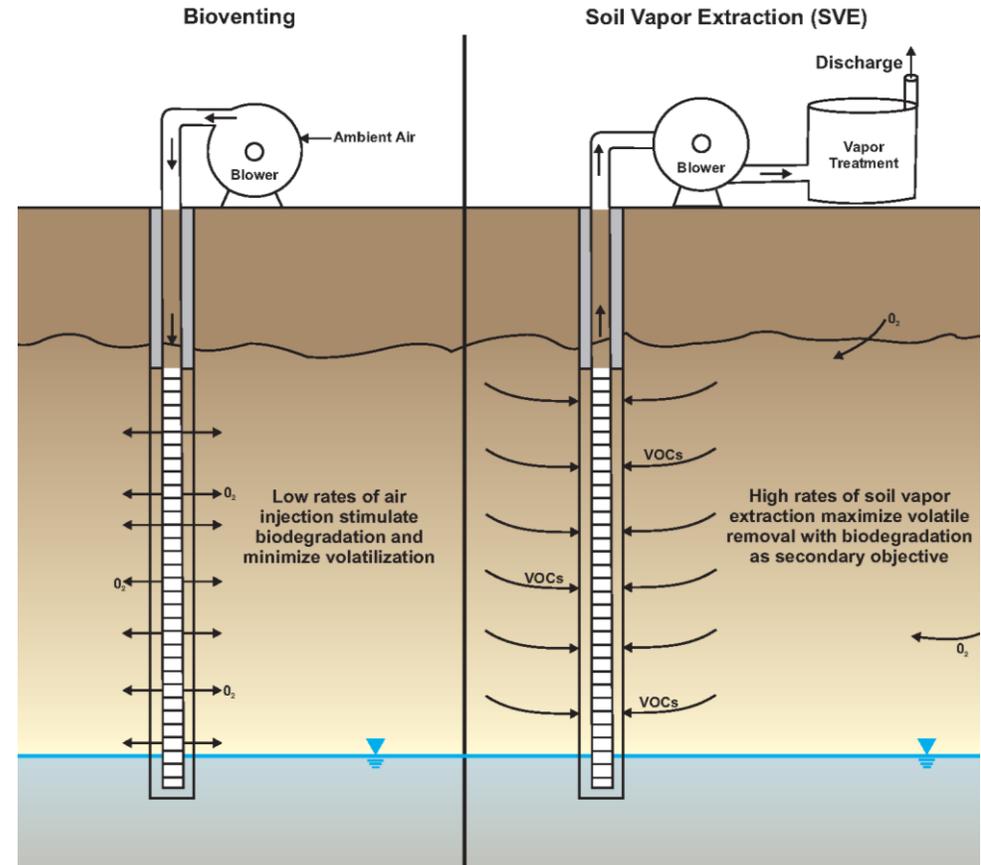
Soil: SVE and Bioventing

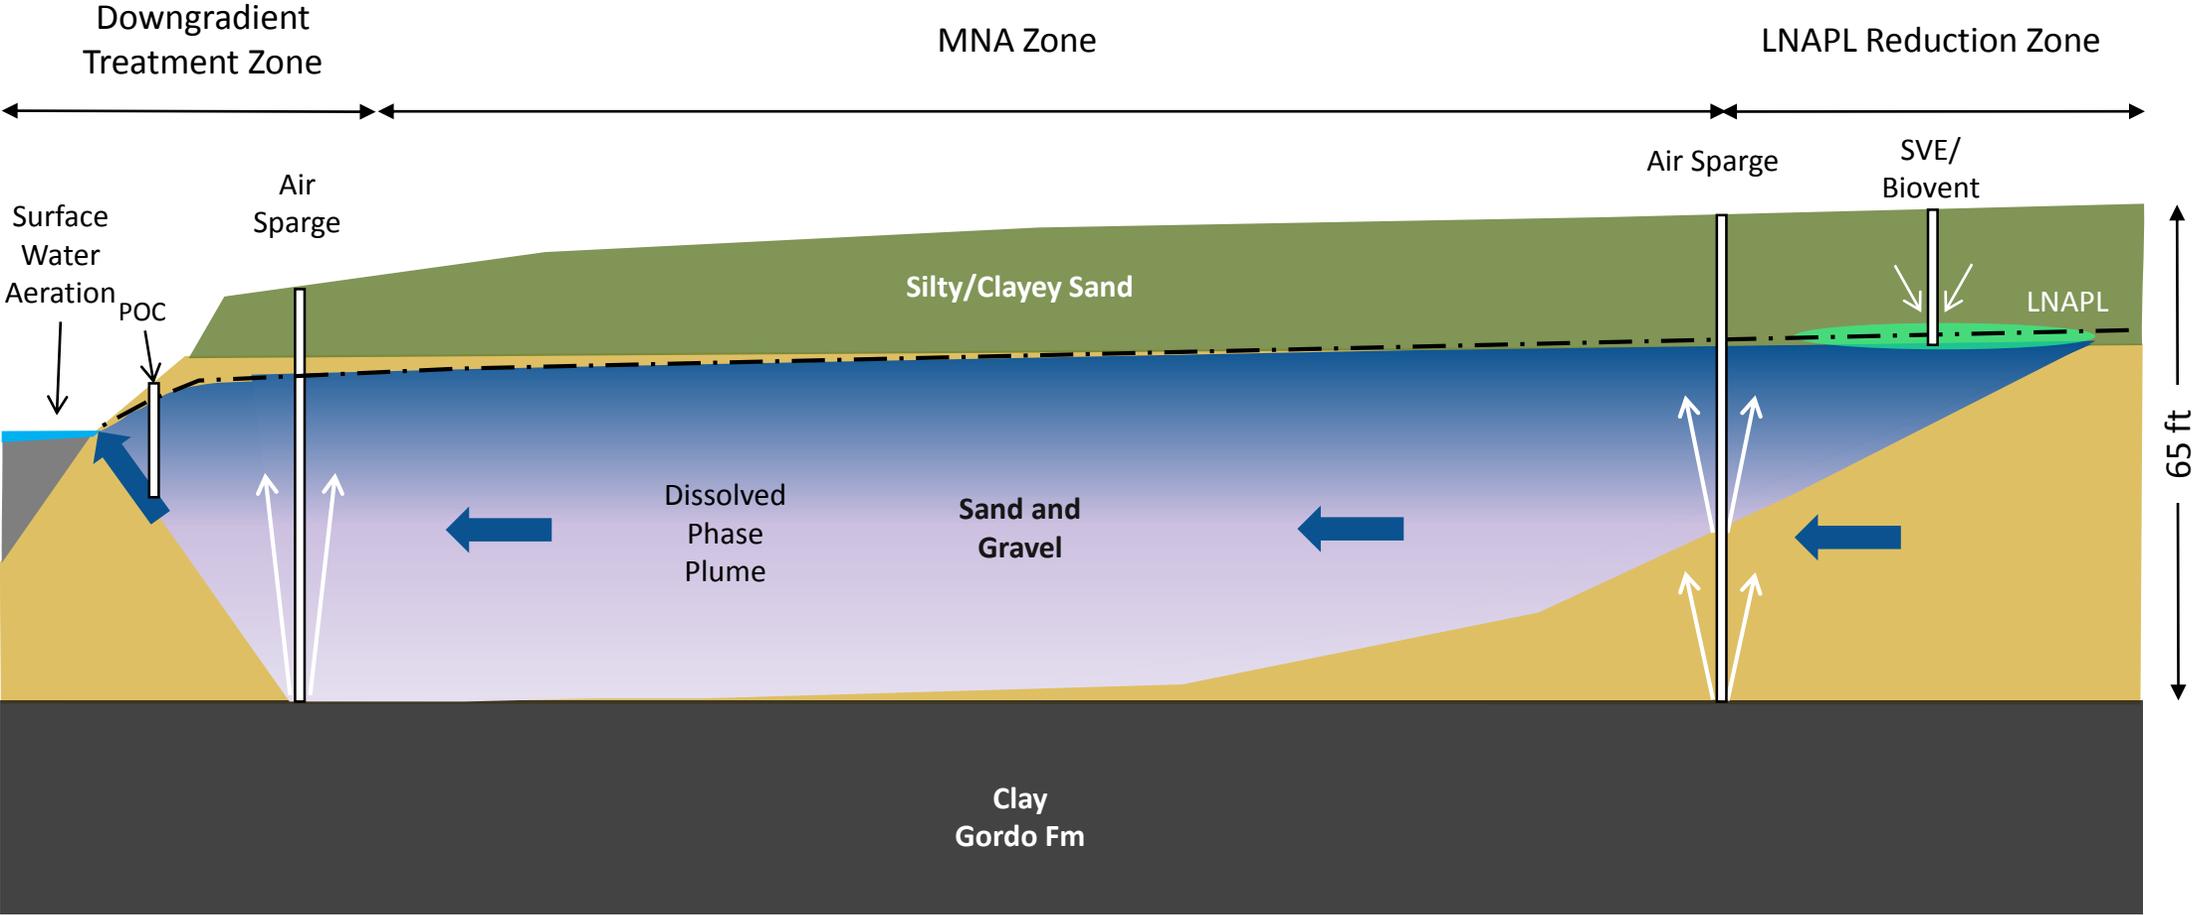
Conceptual Site Model – Cross Section View

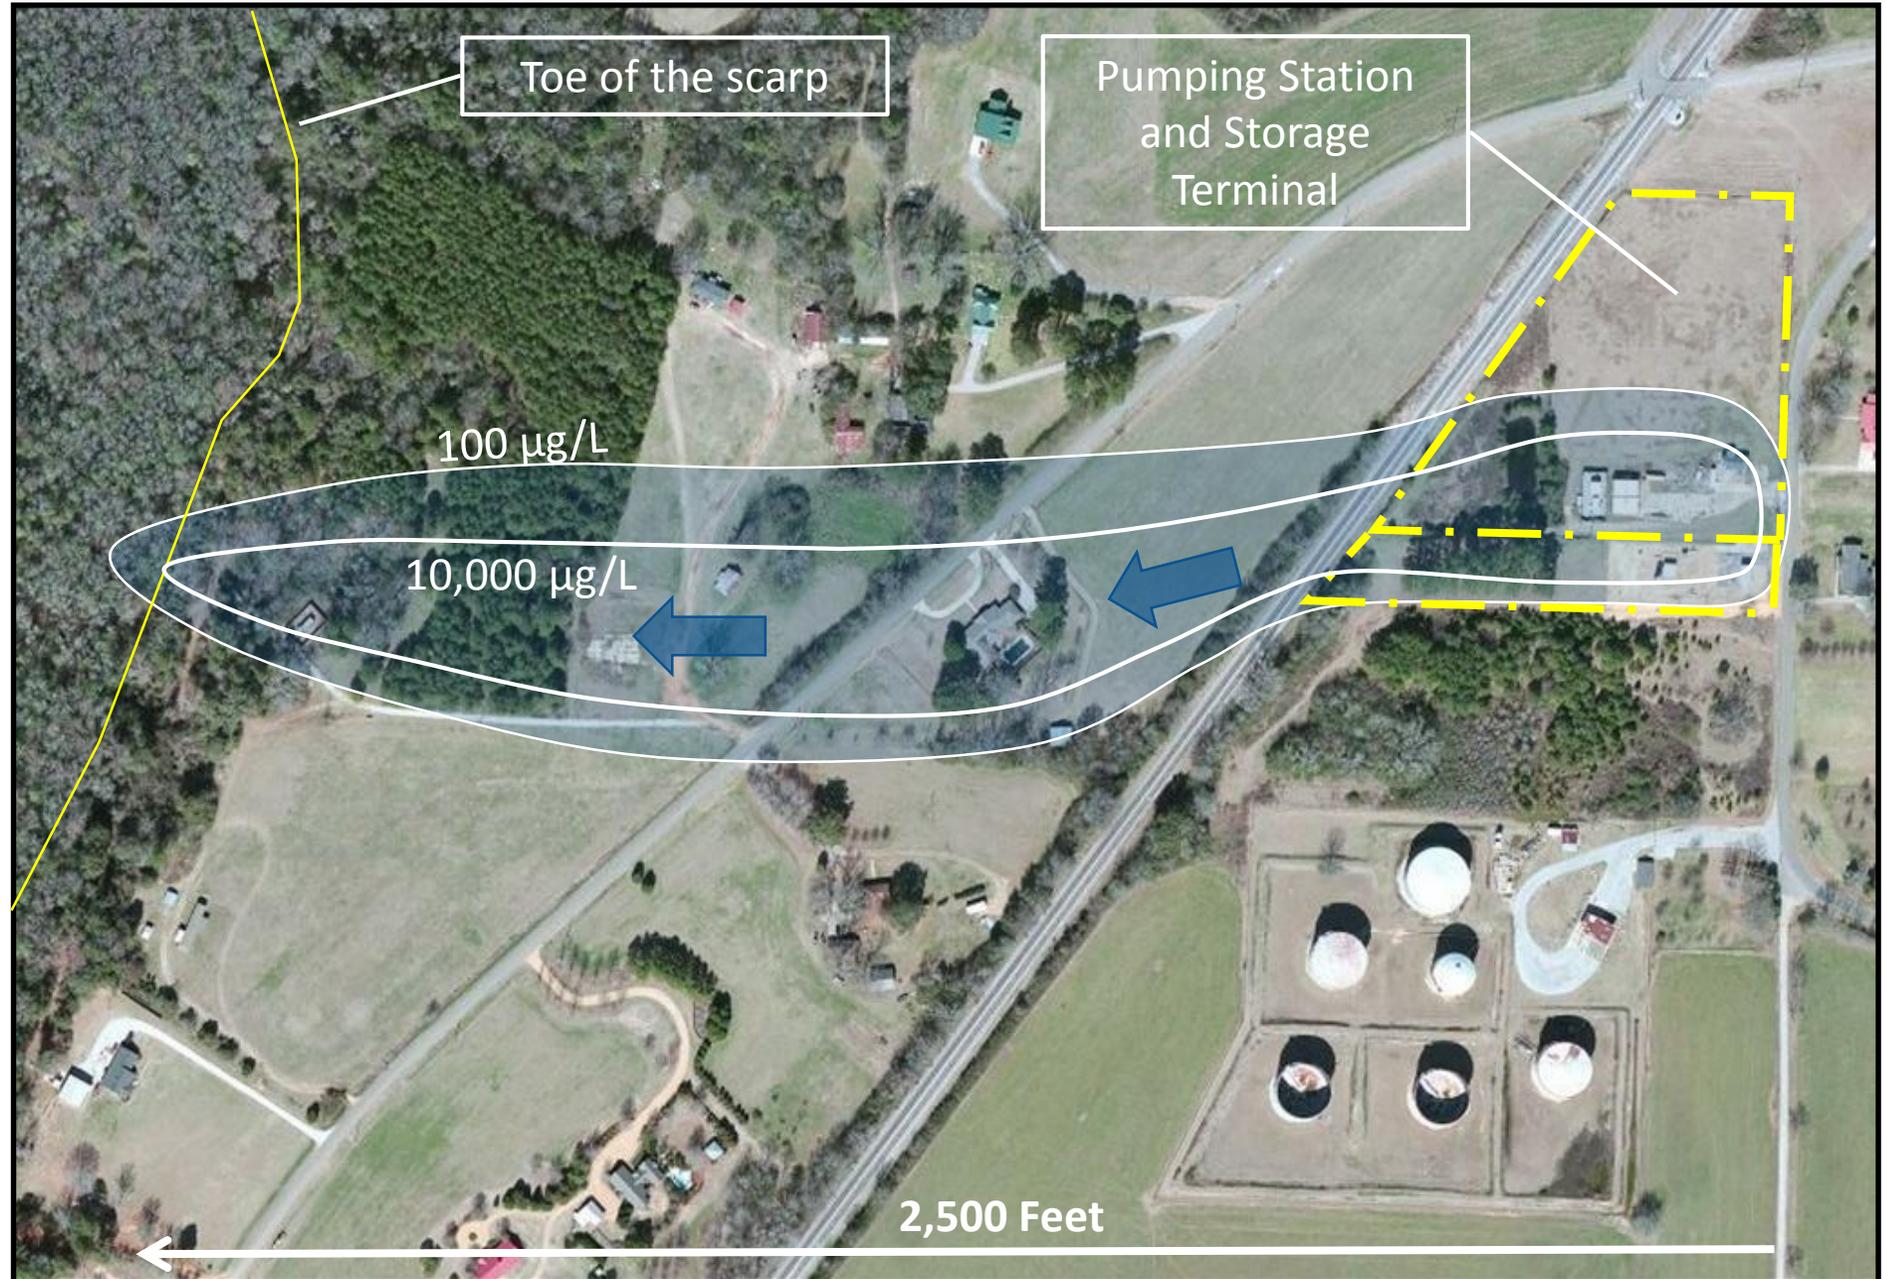
Corrective Action Plan – 1996 Plume Delineation

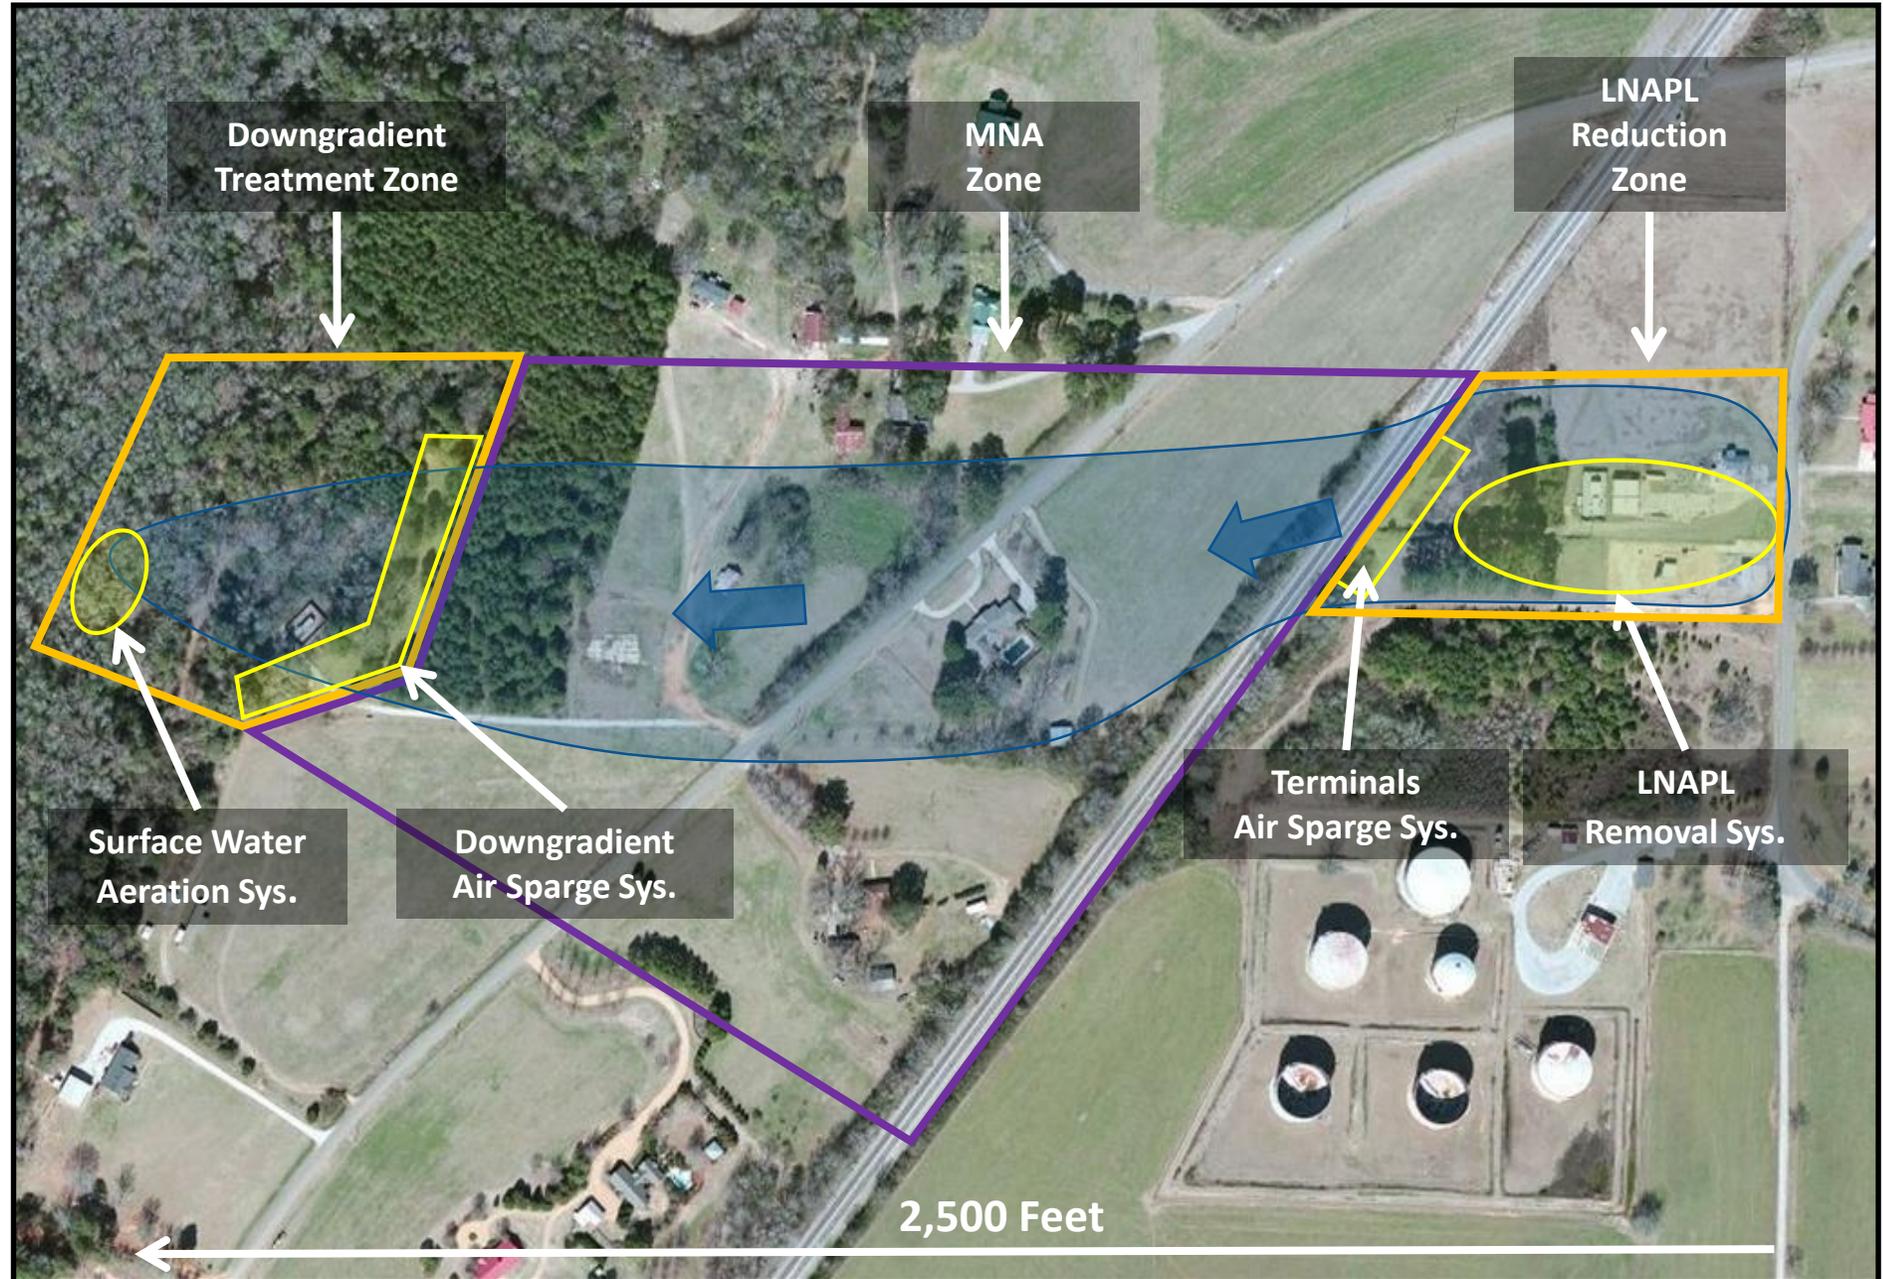
Corrective Action Plan

Remediation Zones

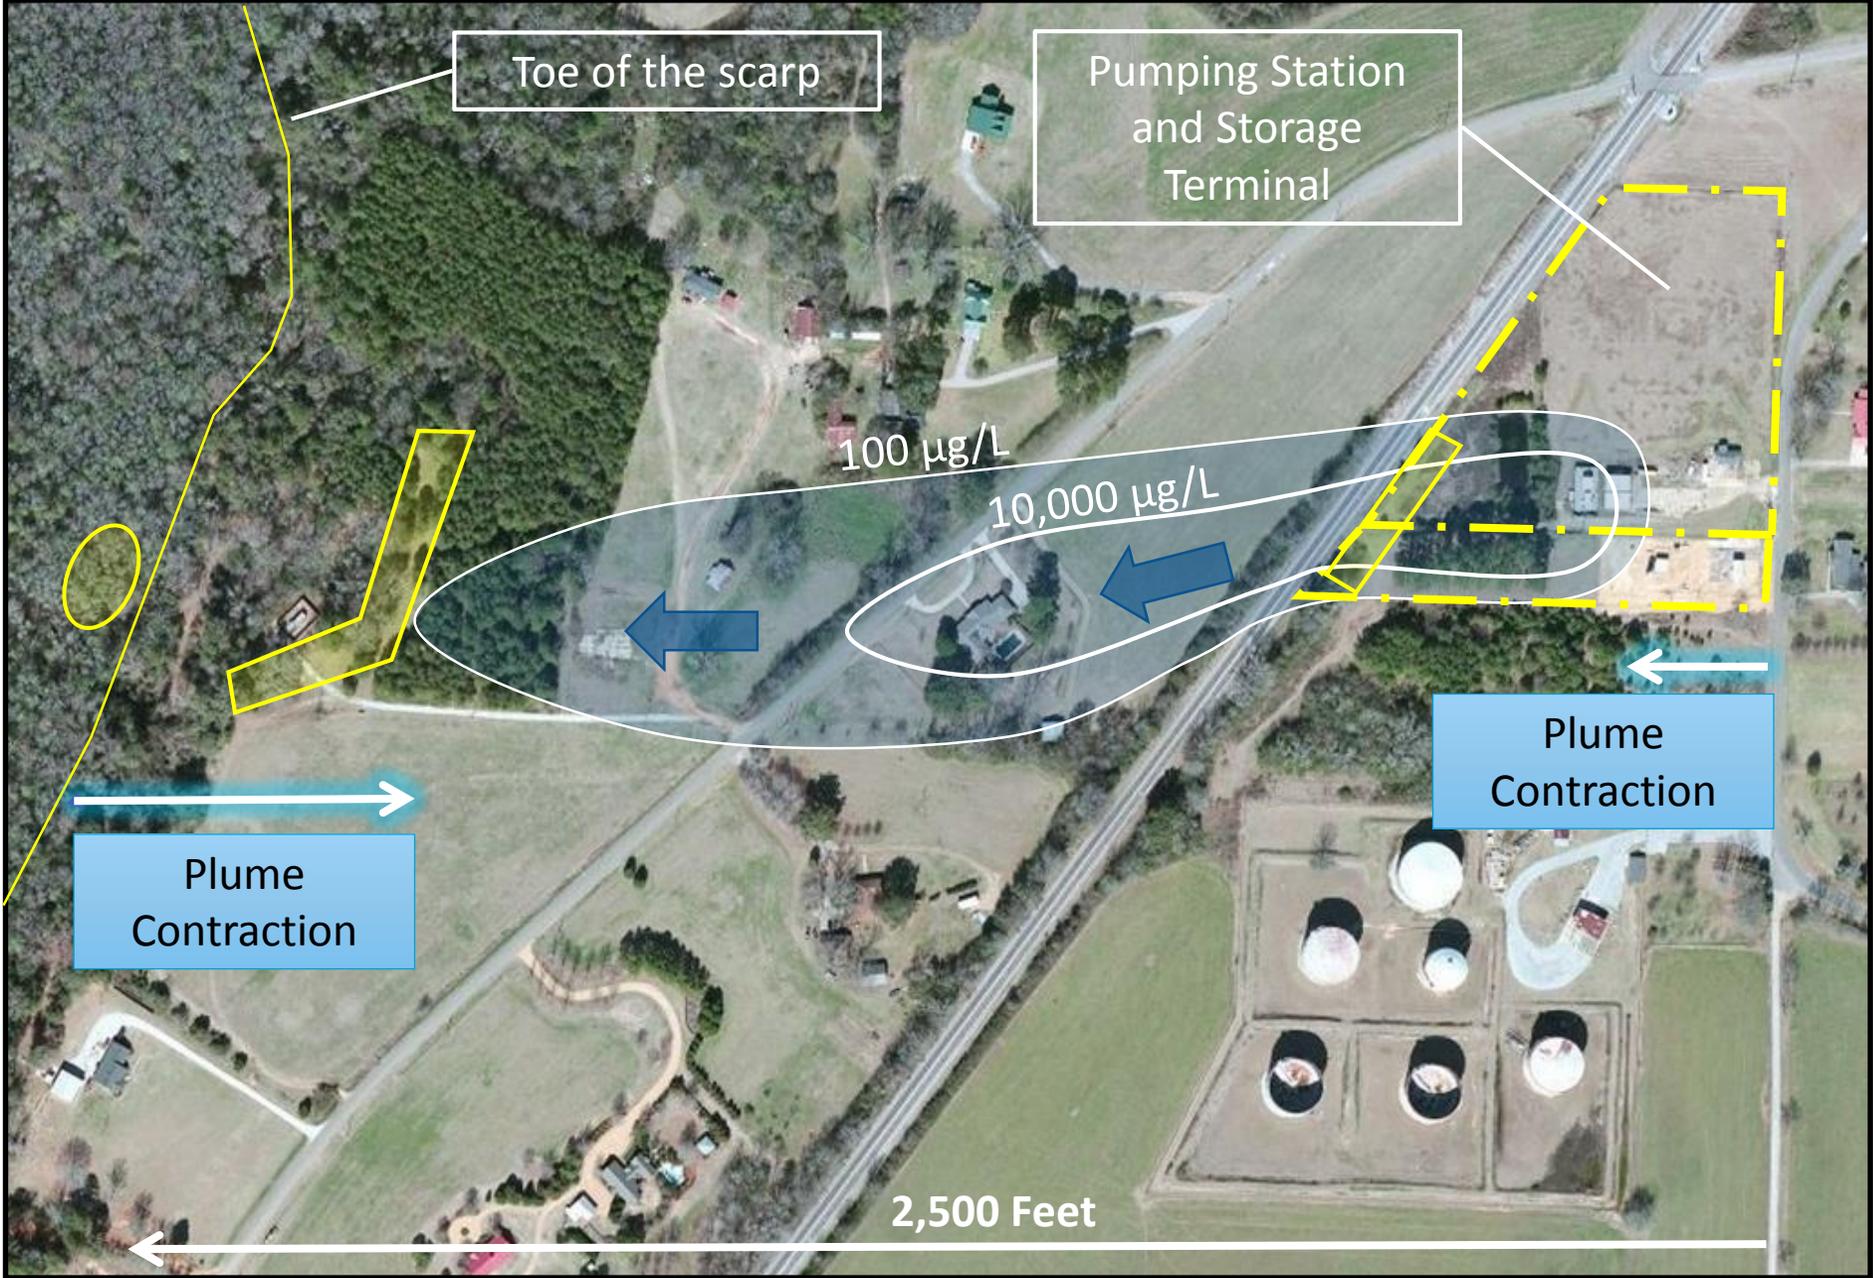
2015 Plume Delineation

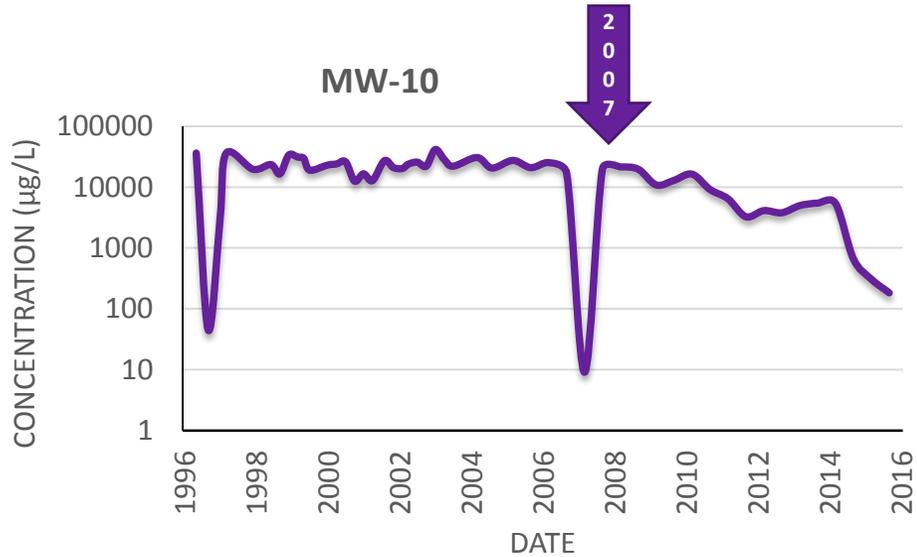
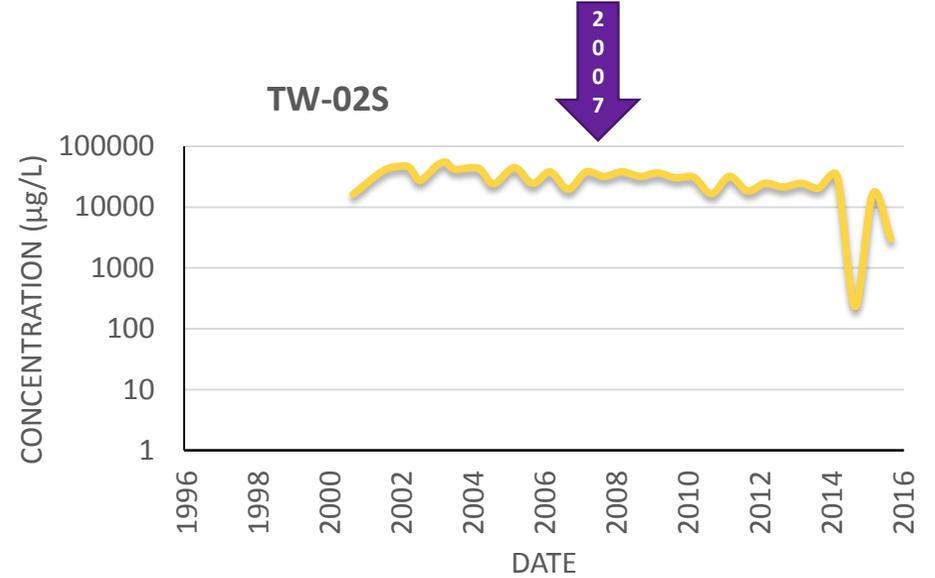
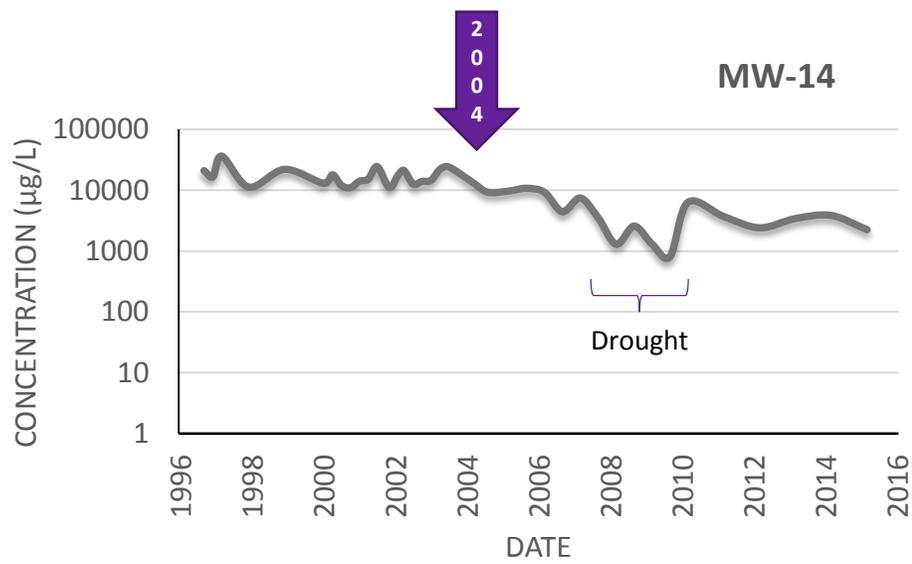
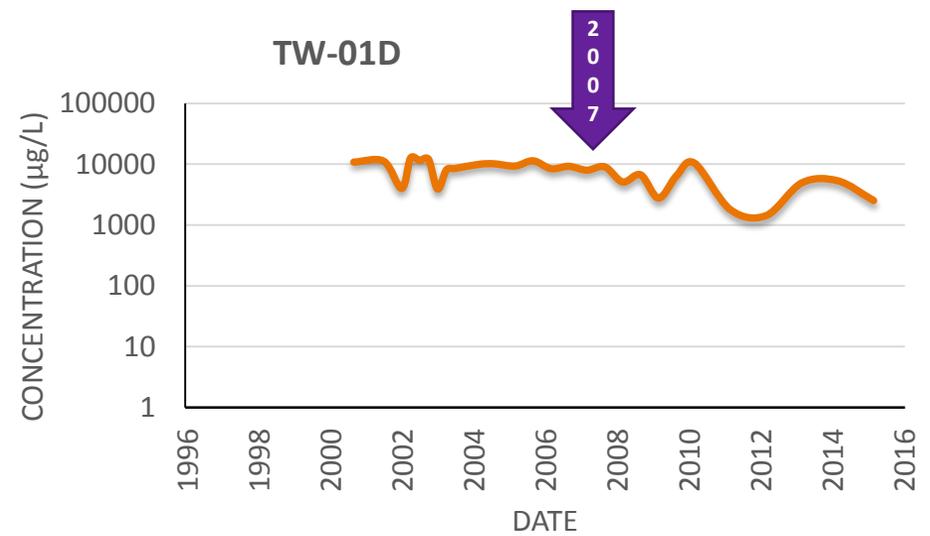
Progress in the MNA Zone (BTEX)

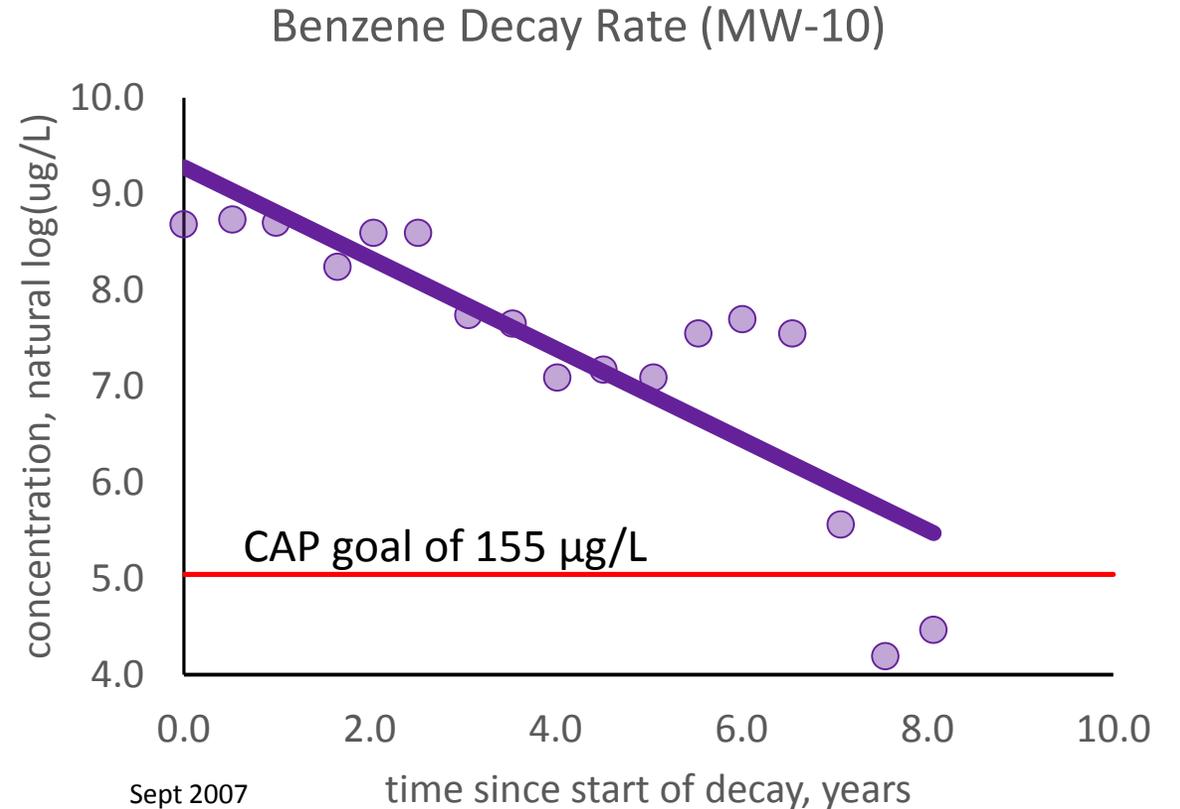
Rates of Attenuation

- First order decay calculation of attenuation
- Regression curve fitting method for an exponential curve
- Terminals air sparging began in 2003

Well	Distance from Terminals	Decay Rate (yr ⁻¹)	Half Life (yrs)	Year Decay Observed
MW-14	420	-0.21	3.3	2004
TW-1D	700	-0.11	6.5	2007
TW-2S	700	-0.42	1.6	2007
MW-10	1300	-0.47	1.5	2007
