**Lane Park Commercial Property
Mountain Brook, Alabama
ADEM VCP Site #: 461-9585**

**REVISED VOLUNTARY CLEANUP WORK PLAN
ALRERA SITE # 461- 9585
Lane Park Shopping Center - Approximately 5.04 Acres
Mountain Brook, Jefferson County, Alabama**

January 20, 2020

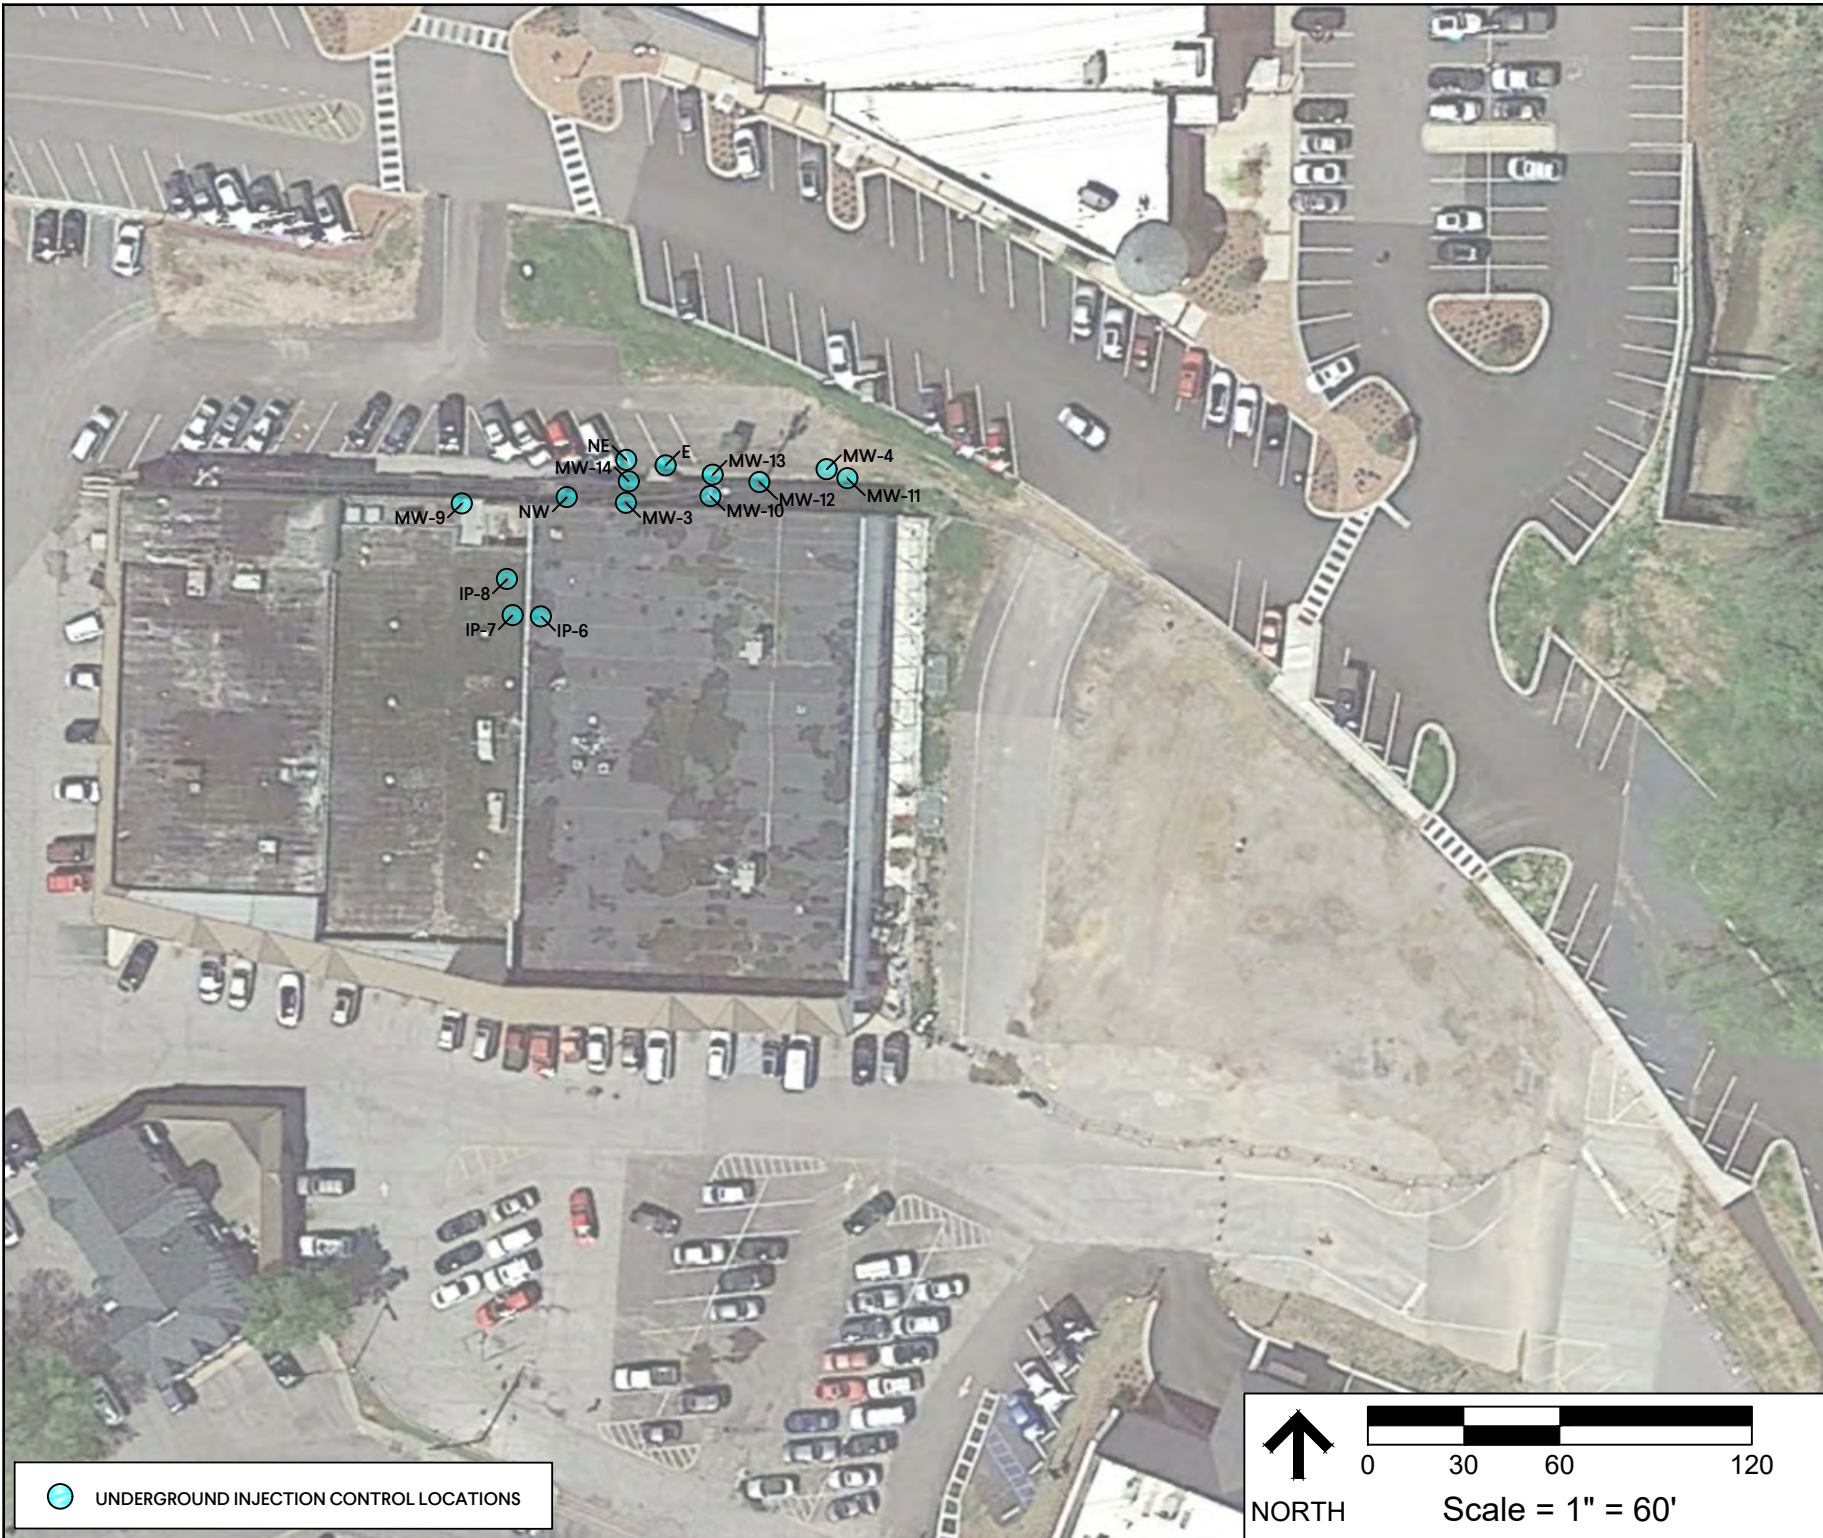
FIGURE 2

UNDERGROUND INJECTION CONTROL LOCATIONS

UIC LOCATIONS
 GMC #
 DATE: 11/20/2018
 DRAWN BY: SDD

As part of the approved cleanup plan, vapor extraction units were installed on MW-3 and MW-4 in September of 2012 to reduce the potential for any off-gassing of contaminants to the businesses at the site. The vapor extraction units ran continuously from September 2012 to May 2018. The remedial approach for this project included in-situ chemical oxidation utilizing sodium persulfate. A total of four (4) separate groundwater injections of sodium persulfate were conducted in monitoring wells in the areas closest to the former dry cleaner. The injections occurred in February 2013, October 2013, February 2015, and July 2018. The purpose of the groundwater injections was to accelerate and complete the degradation process to reduce the contaminant concentrations of the chlorinated solvents. Soil and groundwater samples were collected prior to the injections to establish baseline conditions at the site and following injections to determine the effectiveness of the chemical injections over a period of time (see Section 2.5 and 2.6).

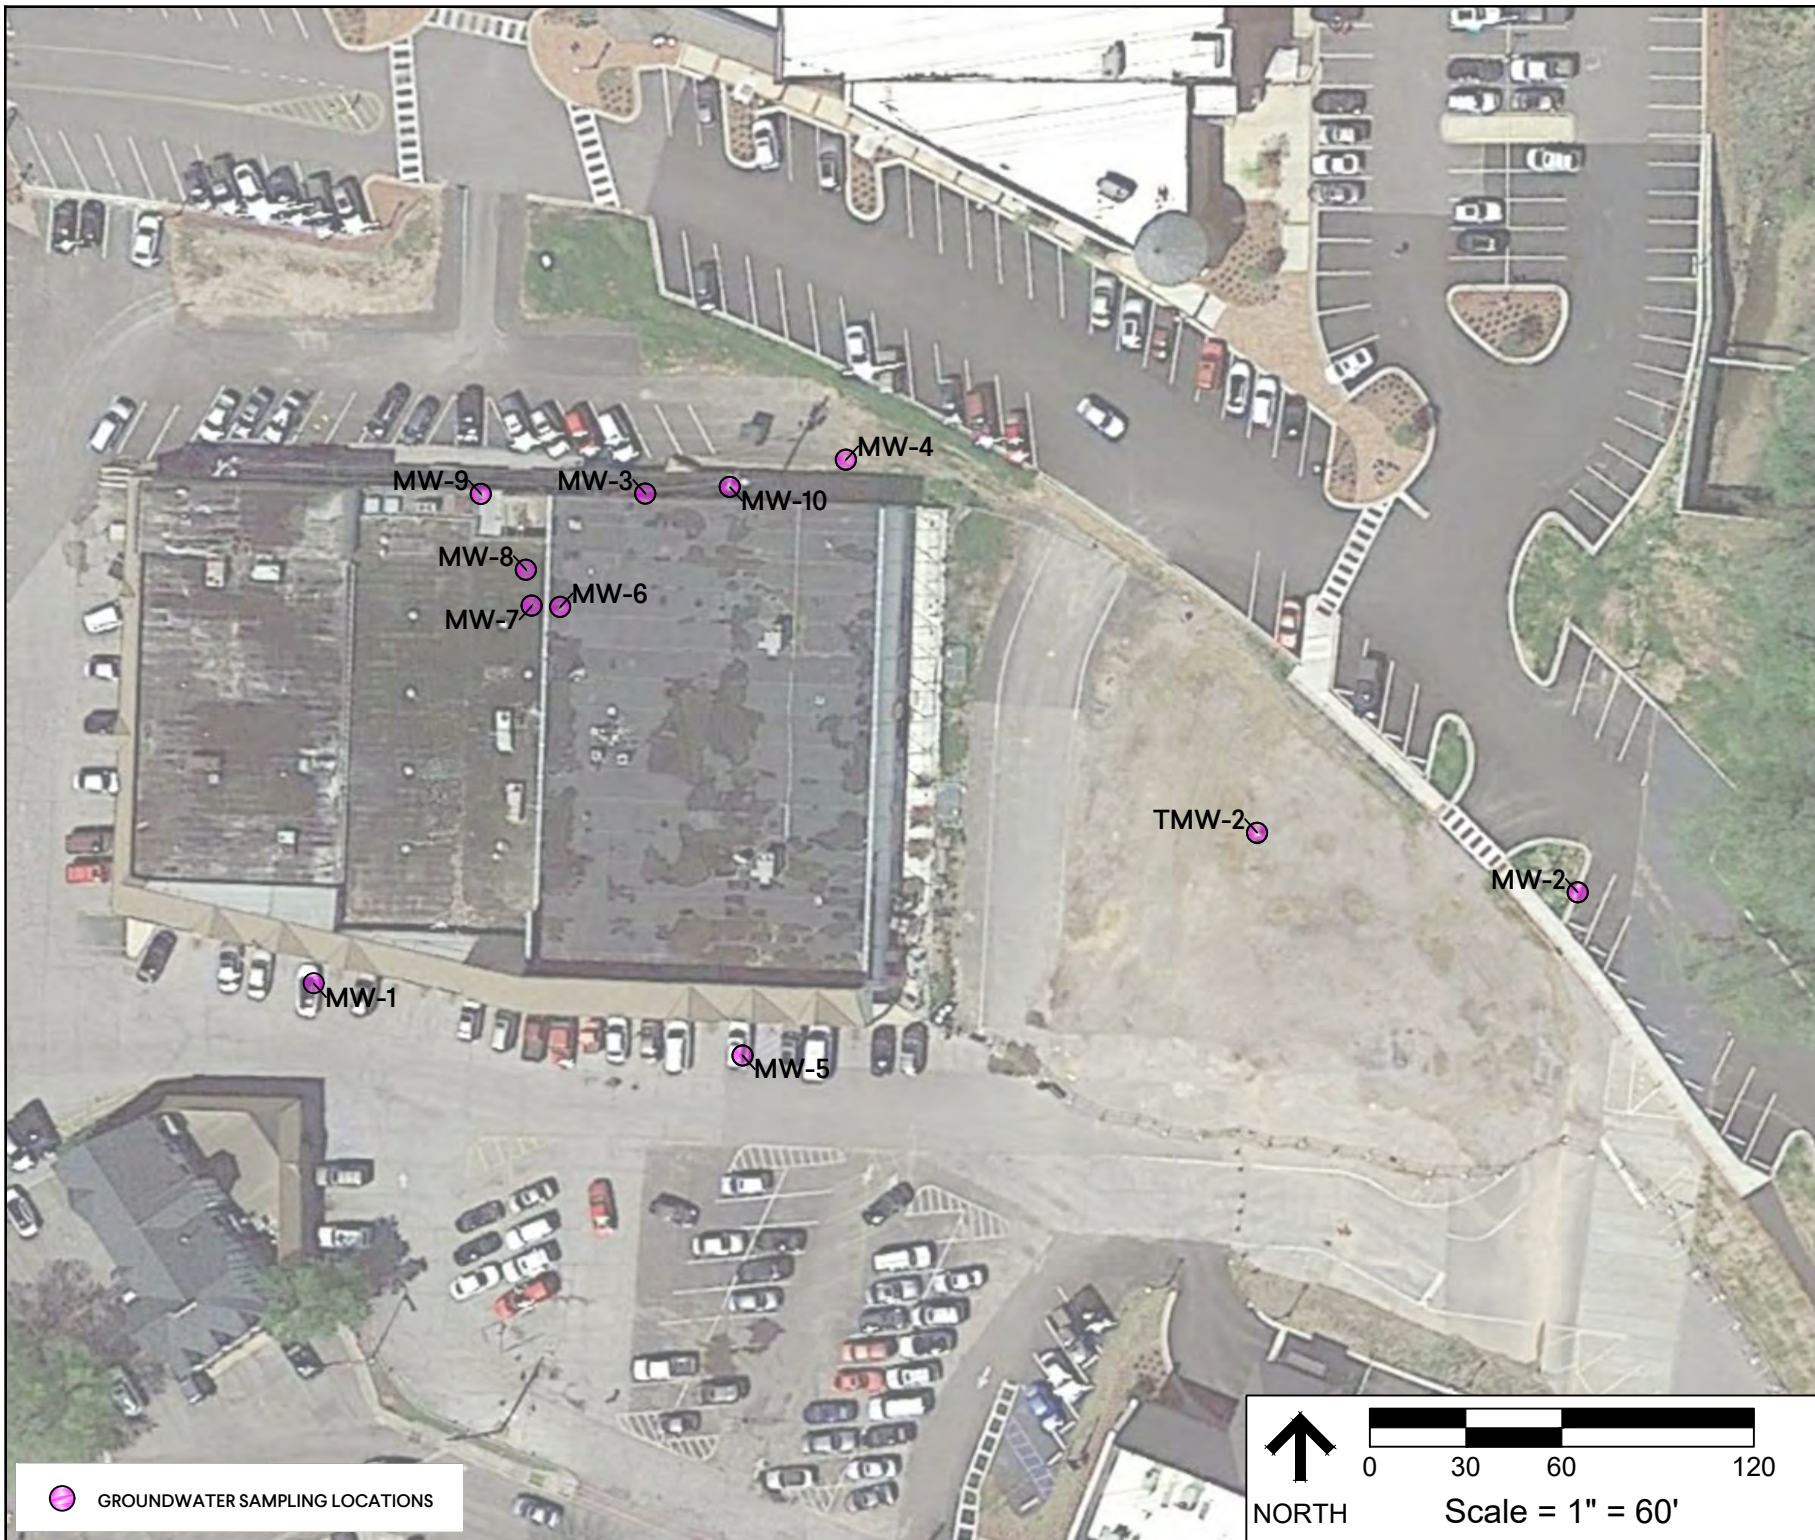
FIGURE 3

GROUNDWATER SAMPLING LOCATIONS

GW SAMPLE LOCATIONS

GMC has conducted numerous groundwater monitoring events since 2010. All groundwater samples were collected and analyzed for VOCs (chlorinated solvents). As previously noted, the groundwater samples were collected prior to and after the injection events to determine the effectiveness of remedial actions. GMC conducted a trend analysis based on the results of the groundwater analyses. The results of trend analysis indicate that several constituents of concern were still present at concentrations that exceeded the U.S. EPA Regional Screening Levels or Maximum Contaminant Levels. However, MW-3, MW-6, MW-9, and MW-10 show a decrease in concentrations of COCs. MW-4 was initially the furthest away from the area of the most aggressive injection treatment until July 2018 when multiple injections were performed in MW-4 and into newly drilled wells in the vicinity of MW-4. The October 2018 groundwater sampling shows a significant decrease in concentrations of chlorinated solvents in MW-4. This is an indication that the injection of chemical oxidants into the groundwater have been successful at reducing the concentrations of chlorinated solvents in the groundwater. A more detailed description of the injection process and groundwater sampling results can be found in the report submitted to ADEM titled "Site Assessment Summary" dated November 20, 2018.

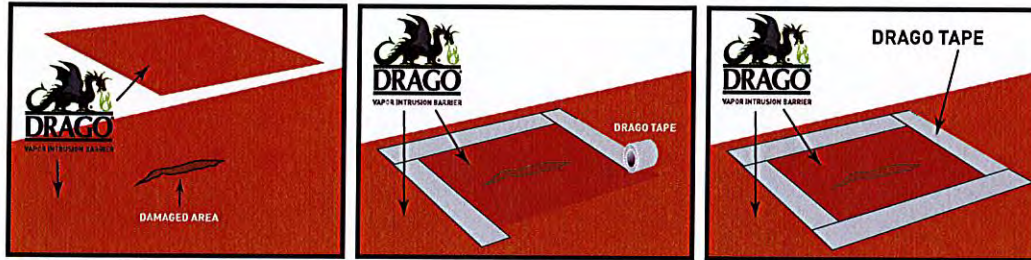
4. In the event that Drago Wrap is damaged during or after installation, repairs must be made. Cut a piece of Drago Wrap to a size and shape that covers any damage by a minimum of 6 inches in all directions. Clean all adhesion areas of dust, dirt, moisture, and frost. Tape down all edges using Drago Tape. (Fig. 3)

Fig. 3: SEALING DAMAGED AREAS

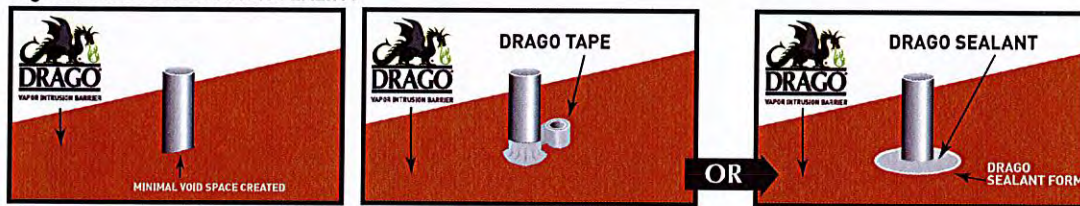
5. **IMPORTANT: ALL PENETRATIONS MUST BE SEALED.** All pipe, ducting, rebar, and block outs should be sealed using Drago Wrap, Drago Tape, and/or Drago® Sealant and Drago® Sealant Form. (Fig. 4a)

Fig. 4a: PIPE PENETRATION SEALING
