**MODIFIED CORRECTIVE ACTION PLAN
FOR REMEDIATION BY NATURAL ATTENUATION WITH MOBILE
ENHANCED MULTI-PHASE EXTRACTION, AND ADDITIONAL
RECOVERY WELL INSTALLATION**

**Rickey's Grocery
11542 County Road 49
Heflin, Cleburne County, Alabama**

**Facility I.D. No. 22329-029-015532
Incident No. UST15-05-02
TTL Project Number 690215-003**

April 17, 2019

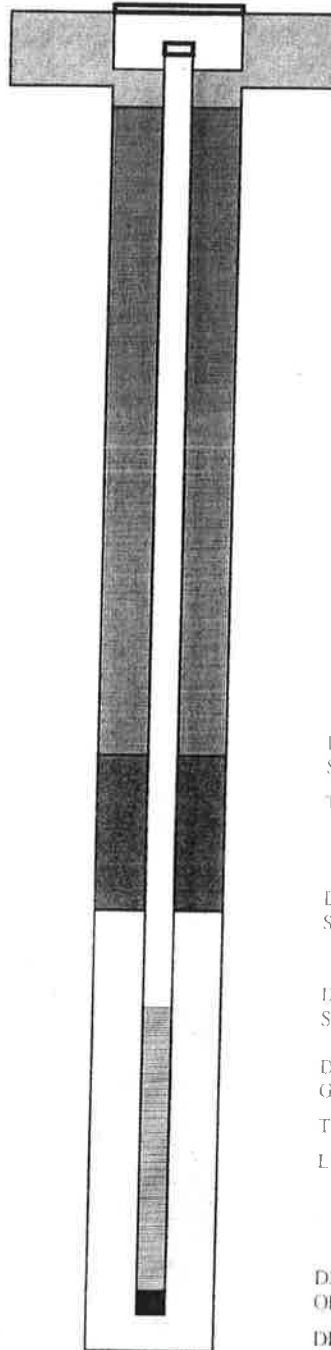
DEPTH OF TOP OF SEAL 1'
 TYPE OF SEAL bentonite
 DEPTH OF TOP OF SAND PACK 2.5'
 DEPTH OF TOP OF SCREEN 4.5'
 DEPTH OF TOP OF GROUNDWATER 5'
 TYPE OF SCREEN 0.015 slots
 LENGTH OF SCREEN 10'
 DEPTH TO BOTTOM OF SCREEN 14.5'
 DEPTH TO BOTTOM OF BORING 15'

DATE INSTALLED
5/7/2007

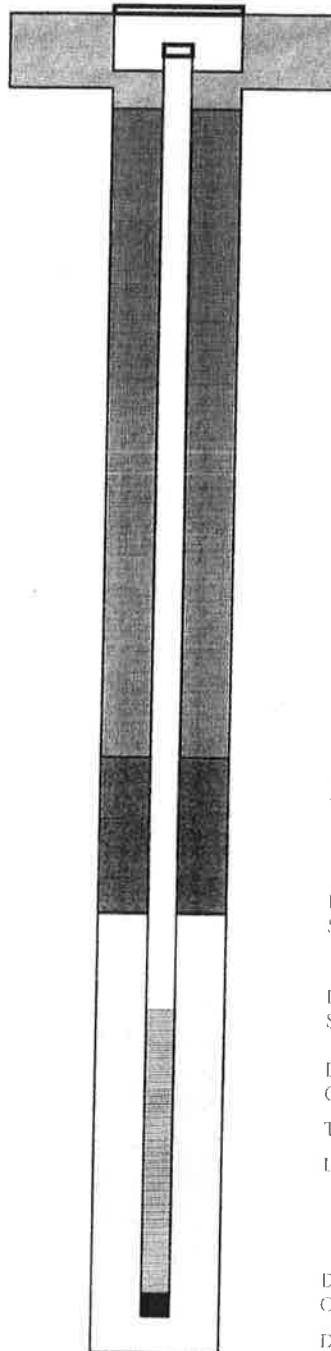
DEPTH OF TOP OF SEAL 1'
 TYPE OF SEAL Bentonite
 DEPTH OF TOP OF SAND PACK 2'
 DEPTH OF TOP OF SCREEN 3.5'
 DEPTH OF TOP OF GROUNDWATER 3'
 TYPE OF SCREEN 0.01 in slots
 LENGTH OF SCREEN 10'
 DEPTH TO BOTTOM OF SCREEN 13.5'
 DEPTH TO BOTTOM OF BORING 15'

DATE INSTALLED
5/7/2007

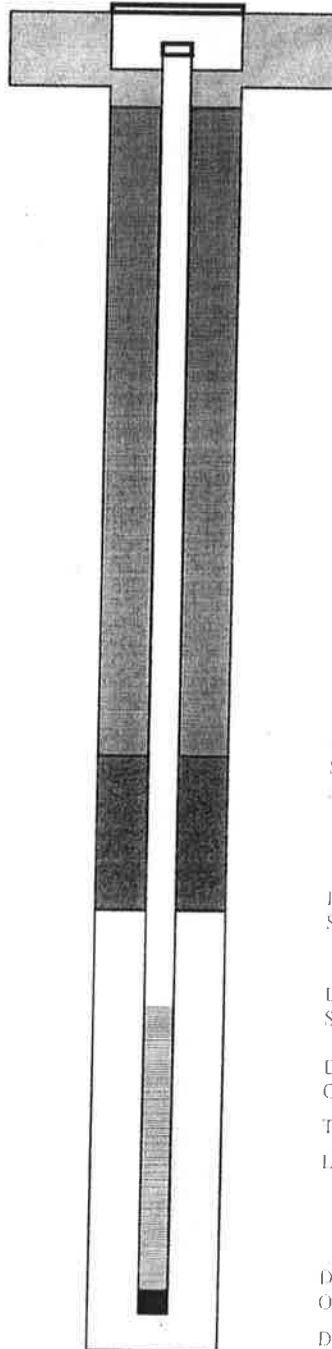
DRILLER Technical Drlg
 DRILLING METHOD Hollow-stem augers
 DEVELOPMENT METHOD Pump

RISER PIPE ID 2"
 TYPE OF RISER PIPE Sched 40 PVC

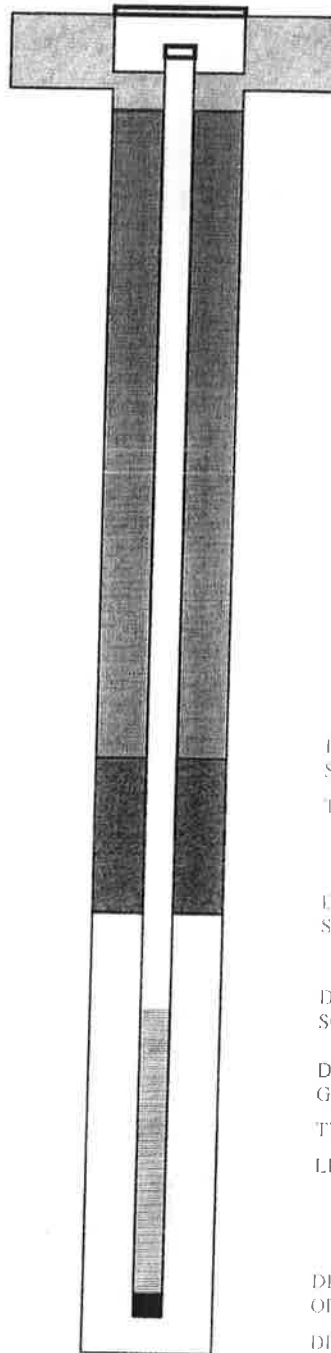
DEPTH OF TOP OF SEAL 2'
 TYPE OF SEAL Bentonite pellets
 DEPTH OF TOP OF SAND PACK 4'
 DEPTH OF TOP OF SCREEN 6'
 DEPTH OF TOP OF GROUNDWATER 9'
 TYPE OF SCREEN 0.01 in slots
 LENGTH OF SCREEN 10
 DEPTH TO BOTTOM OF SCREEN 16'
 DEPTH TO BOTTOM OF BORING 16'

DATE INSTALLED
5/7/2007
