Final  
Delisting Decision  
For

Joes Branch

**Siltation**

Alabama Department of Environmental Management  
Water Quality Branch  
Water Division  
April 2020

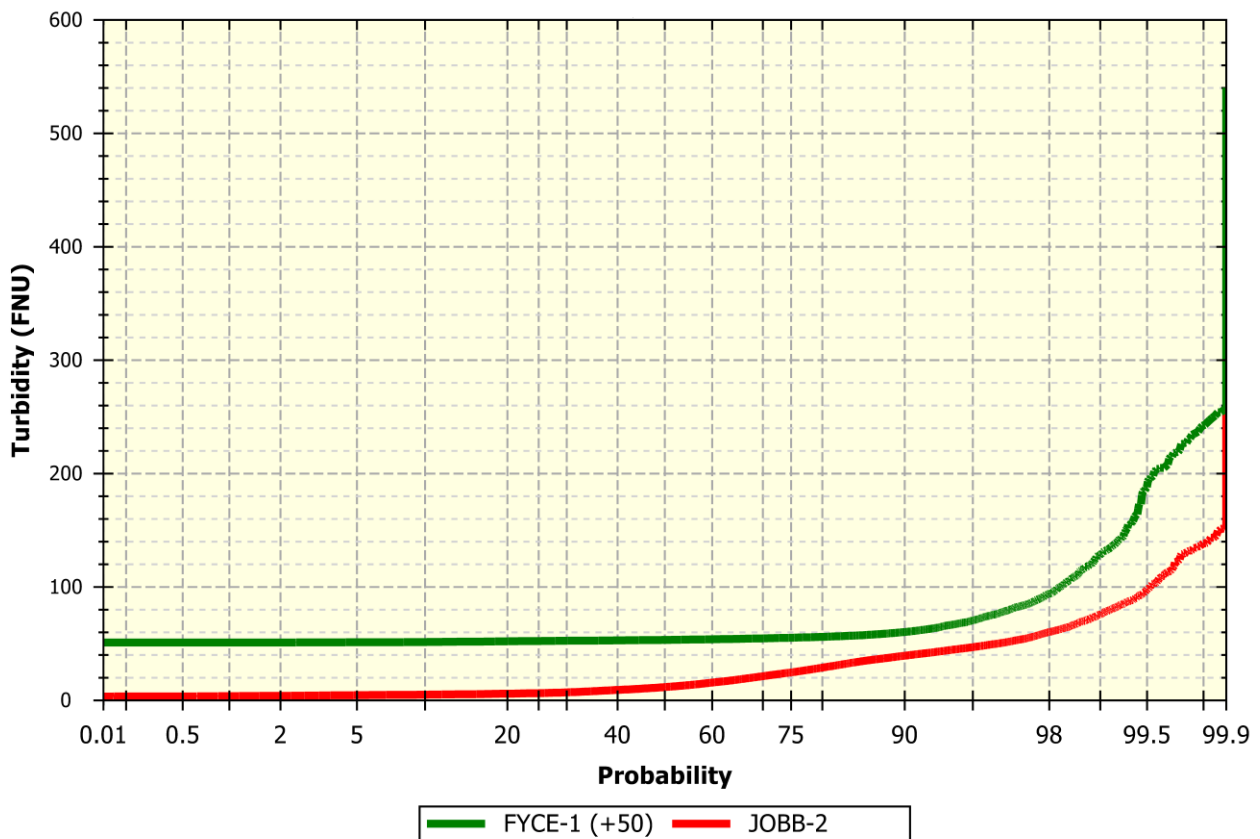
**Figure 4.2.1.1 Continuous In-situ Turbidity: FYCE-1 (+50) vs. JOBB-2**

The figure below illustrates a probability plot of the available continuous Joes Branch turbidity results compared to the numeric turbidity criterion described above (FYCE-1 Turbidity plus 50 NTUs). Based on the results illustrated in the graph, the instream turbidity results from station JOBB-2 are less than the applicable criterion. At station JOBB-2, a total of 24,910 individual turbidity samples were recorded during the time frame of February 4, 2019 to December 19, 2019. The graph below illustrates that 96.24% of the 24,910 individual continuous in-situ turbidity results are less than 50 NTUs.

Station ID	Min	Max	Mean	Median	Pct 0.5	Pct 2	Pct 5	Pct 20	Pct 40	Pct 60	Pct 75	Pct 90	Pct 98	Pct 99.5	Pct 99.9
FYCE-1 (+50)	51	540	56.8	53.3	51	51	51.2	52	52.9	53.8	55.2	60.2	93.9	187.1	270.0
JOBB-2	10.1	342.2	26.9	22.2	3.5	4	10.7	5.8	9.16	15.6	34.8	45.5	60.2	97.0	177.4

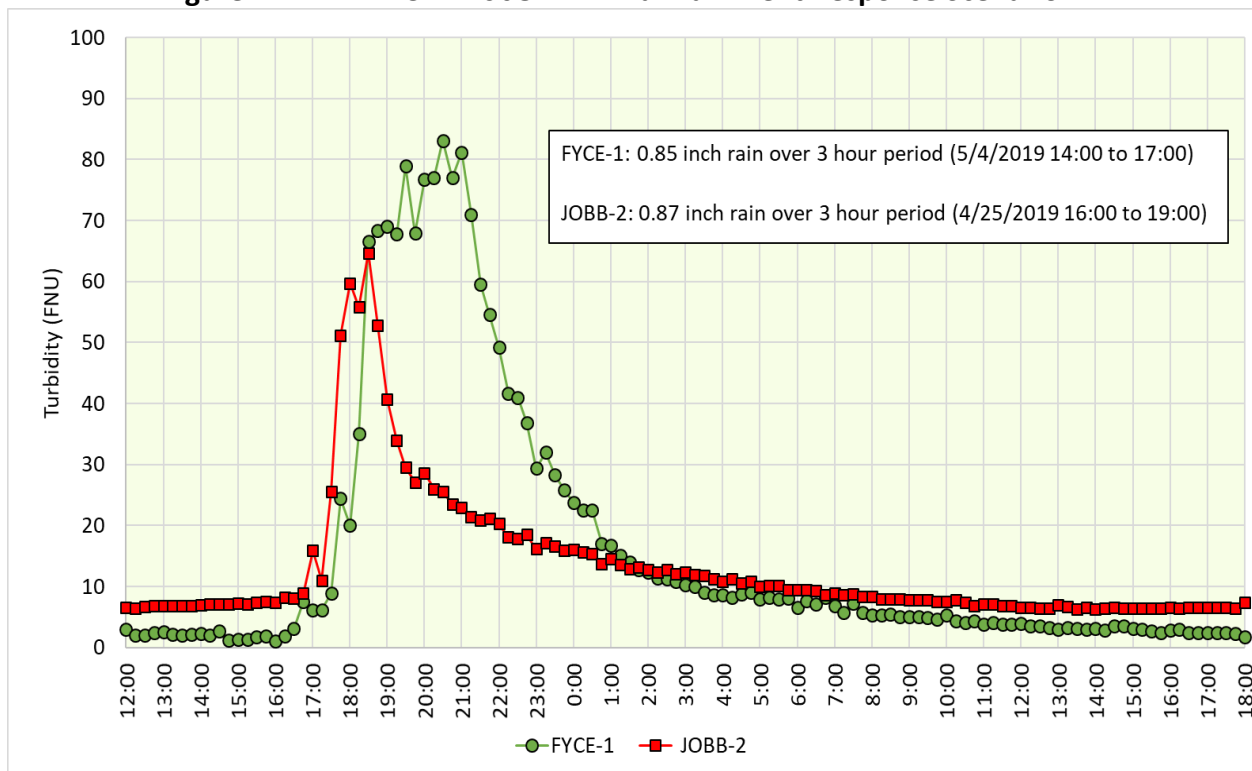
**Figure 4.2.1.2 FYCE-1 vs JOBB-2: Rainfall Event Response Scenario #1**

The figure below illustrates the turbidity response from a nearly 1 inch rain over a three hour time period that occurred in both watersheds. As illustrated in the figure below, the maximum instream turbidity recorded at station JOBB-2 is less than the maximum instream turbidity result recorded at the reference station FYCE-1. Furthermore, the total elapsed time for the instream turbidity to return to “baseflow” conditions within both waterbodies is very similar.

The Department also evaluated how the instream turbidity within the listed segment of Joes Branch and the ecoreference stream Folley Creek react to rainfall events of similar magnitude and duration in the watershed. This analysis encompasses how the turbidity results respond along the entire streamflow hydrograph. Precipitation gages were set up near the Joes Branch and Folley Creek watersheds to record rainfall events. Note, the figures below do not depict the identical rainfall event within both watersheds. Rather, the intent of this analysis is to present the instream turbidity response for a given rainfall event of similar magnitude and duration.

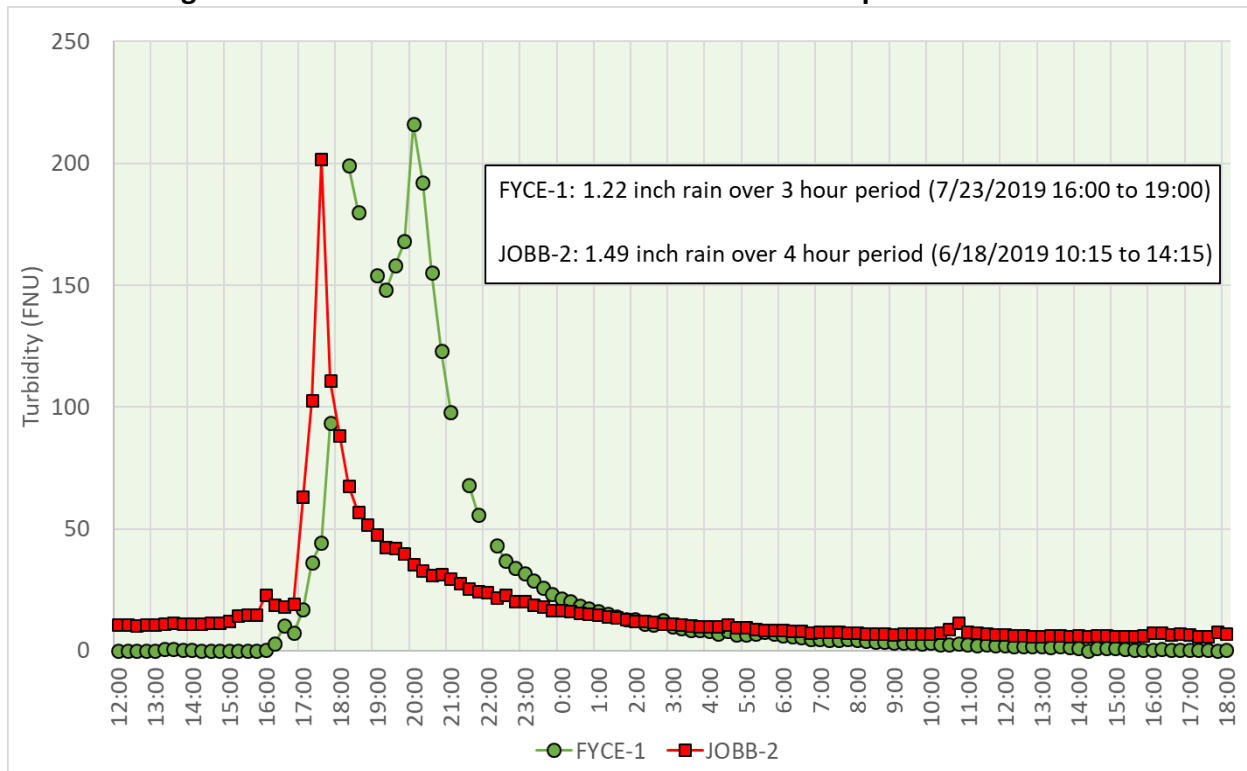
**Figure 4.2.1.3 FYCE-1 vs JOBB-2: Rainfall Event Response Scenario #2**

Similarly, the figure on the following page illustrates the turbidity response from a nearly 1.5 inch rain over a three to four hour time period that occurred in both watersheds. As illustrated in the figure below, the maximum instream turbidity recorded at station JOBB-2 is comparable to the instream turbidity results recorded at the reference station FYCE-1. Furthermore, the total elapsed time for the instream turbidity to return to “baseflow” conditions within both waterbodies is very similar.

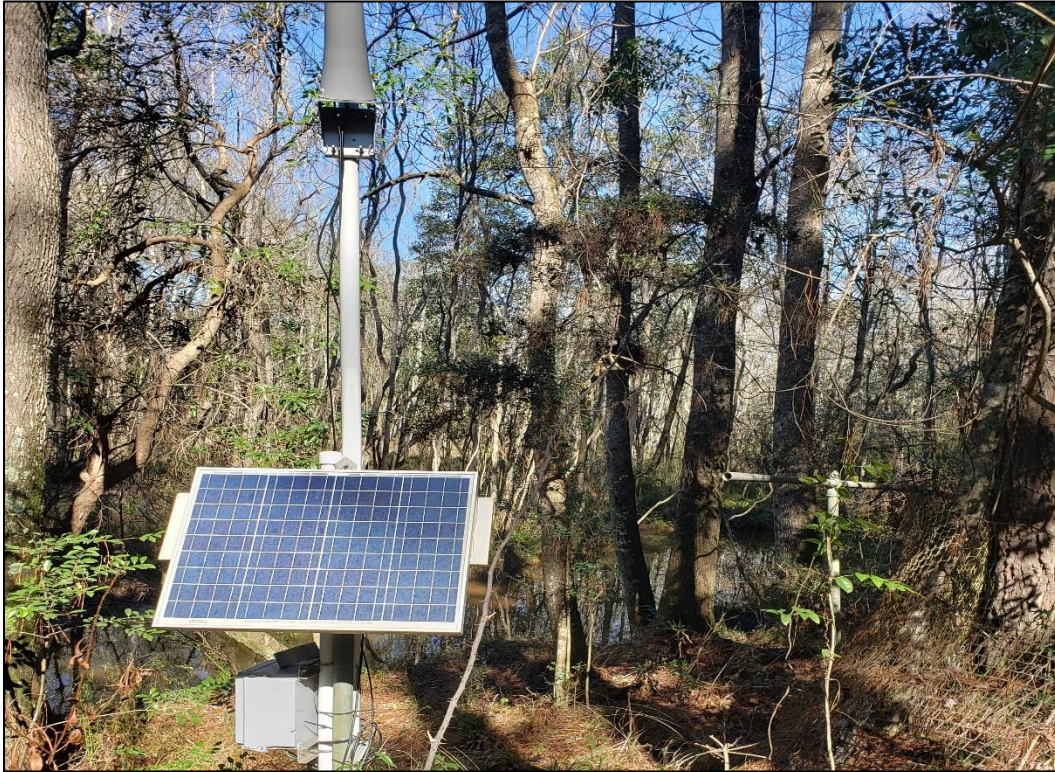
**Figure C.5 Joes Branch Station JOBB-2: Continuous In-Situ Turbidity Station**

The assessment of the siltation impairment on Joes Branch was based upon the evaluation of the continuous in-situ turbidity data collected at station JOBB-2 in comparison to continuous in-situ turbidity data from the eco-reference stream station FYCE-1 during the available period. This assessment consisted of a multi-faceted approach analyzing how instream turbidity in both Joes Branch and the reference stream Folley Creek respond to varying stream flow conditions, from baseflow to rainfall driven events.

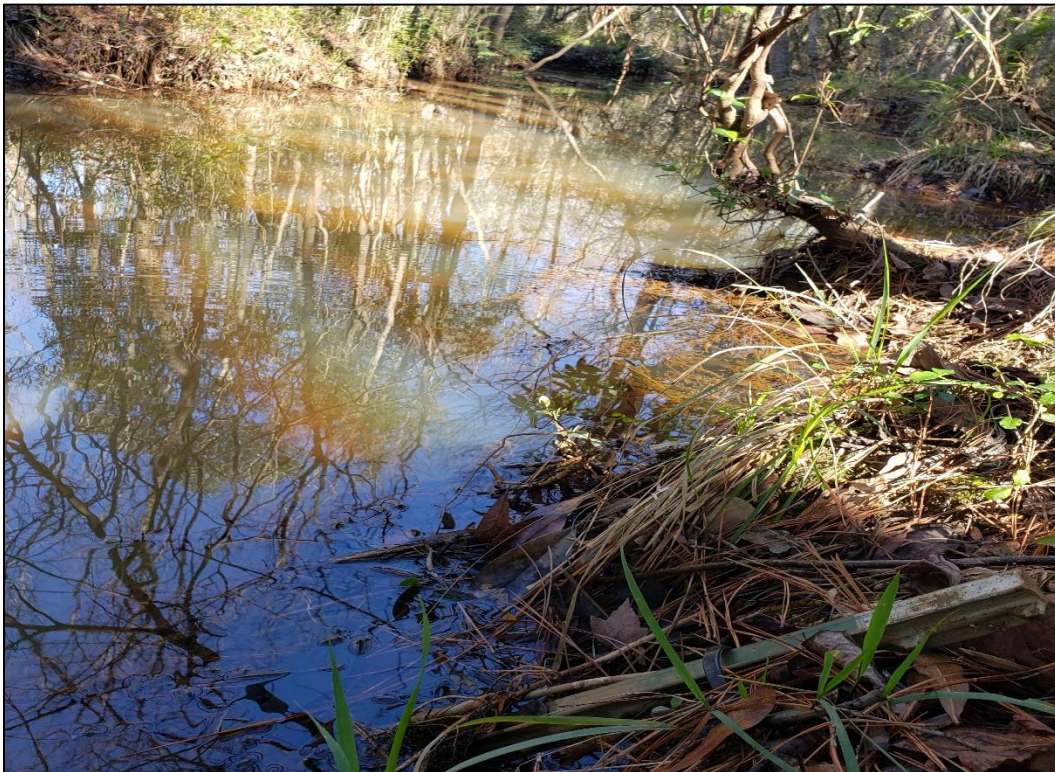
**Figure C.6 Joes Branch Station JOBB-2: FTS DTS-12 Turbidity Sensor**

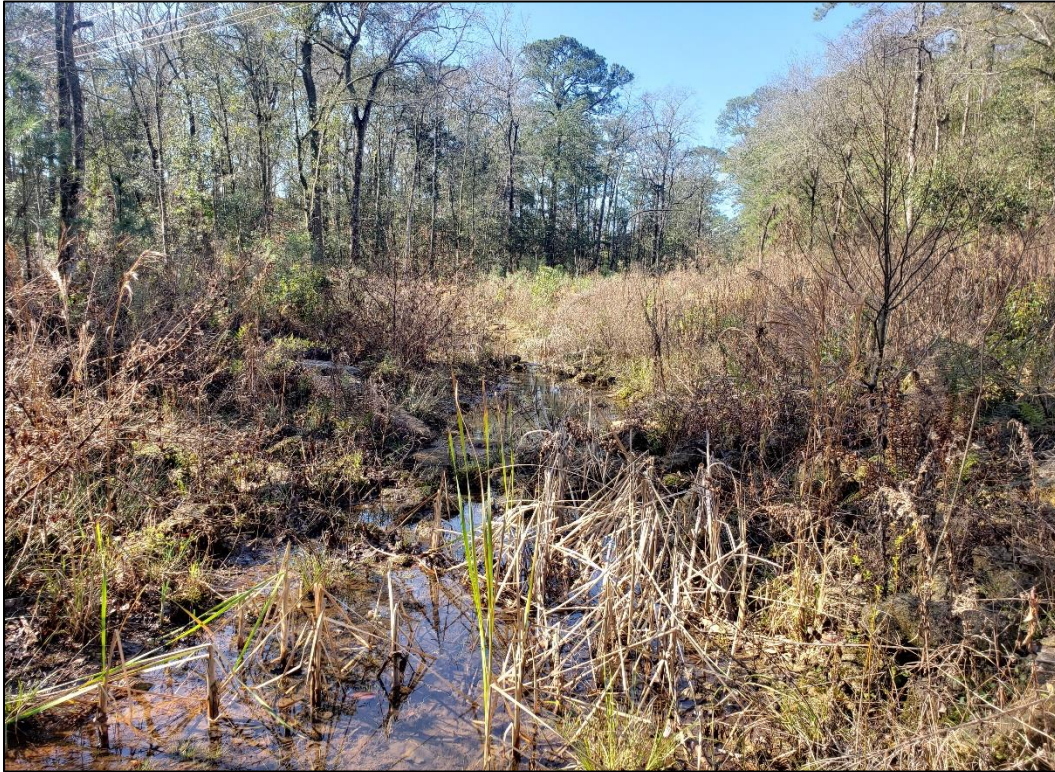
**Figure C.7 Joes Branch Project #2 Westminster Gates Stream Restoration (Downstream)**

- **JB Project 2:** With funding from the National Fish and Wildlife Foundation Gulf Environmental Benefit Fund (NFWF GEBF) for comprehensive restoration of the most critically-degraded streams across the D'Olive Watershed, a head cut advancing towards the toe of the step pool conveyance and threatening sewer infrastructure was the next project to be addressed. Thompson designed hybrid measures, including elevating the stream bed, expanding the flood plain, using rock to stabilize stream banks, and installing rock weirs and energy dissipating log structures. This project, constructed by North State Environmental, restored 1,400-linear feet of stream and eight acres of wetland and flood plains, was substantially completed in August 2015. The Alabama Department of Transportation also provided funding for JB 2. Of note: Geological Survey of Alabama sampling indicates that the Step Pool Conveyance and JB Project 2 were successful in reducing sediment loads by over 90%.

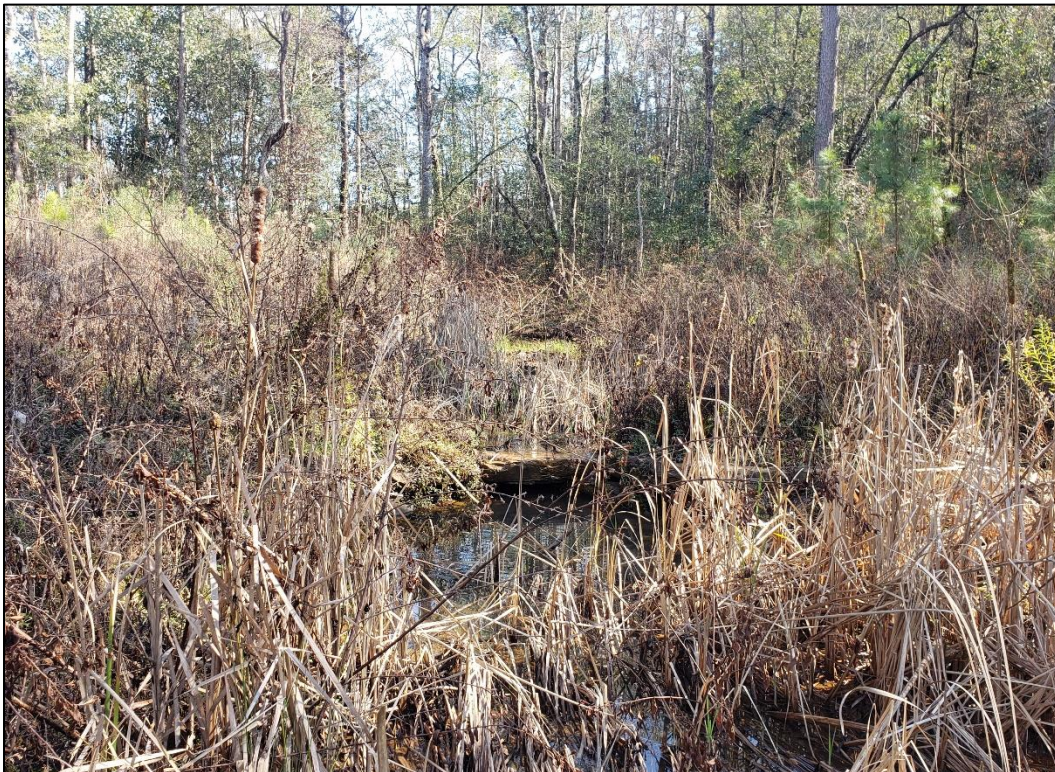
**Figure C.8 Joes Branch Project #2 Westminster Gates Stream Restoration (Upstream)**

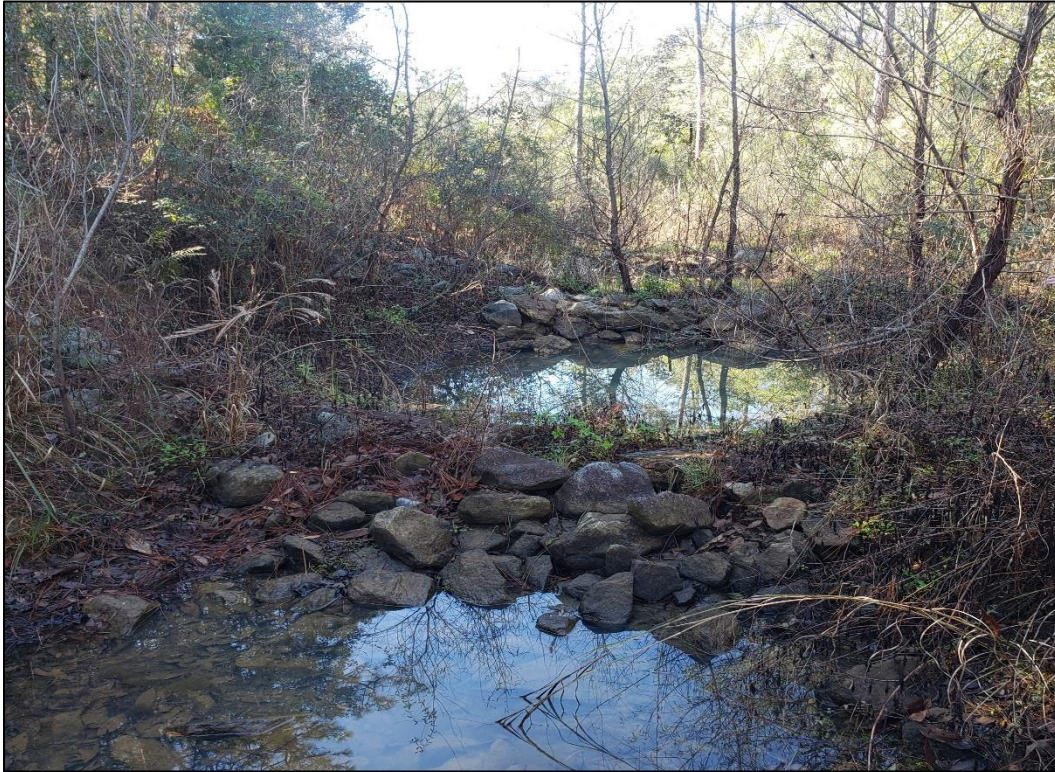
**Figure C.9 Joes Branch UT 2012 Westminster Village Stream Restoration (Downstream)**

- **Joe's Branch (JB) Step Pool Stormwater Conveyance:** In 2011, collapsing banks along an ephemeral (only wet after rains) Spanish Fort tributary on Westminster Village property threatened residences and Highway 31 and delivered an unprecedented 100,000 tons of sediment per square mile into Mobile Bay. MBNEP secured Clean Water Act Section 319 funding to construct a rock step pool conveyance over a sand infiltration matrix down the steep 1,000-foot slope to reduce stormwater energy and volume. Southern Excavating was contracted to implement this Thompson Engineering design. This successful restoration project won a 2015 Gulf Guardian Award for Partnerships and survived the April 29, 2014, 500-year rain event.

The restoration technique used is called a Step Pool Storm Conveyance (SPSC) system. The SPSC system is an aesthetically-pleasing approach that uses a porous sand/woodchip mixture beneath the primary flow channel to retain and filter stormwater during lower flow events. The system's flow path itself is constructed by a network of rock riffles and pools to stabilize the eroded channel and dissipate energy during higher flow events. The project also included restoration of the degraded wetlands severely impacted by sedimentation from the prior erosion immediately downstream of SPSC rock structures.

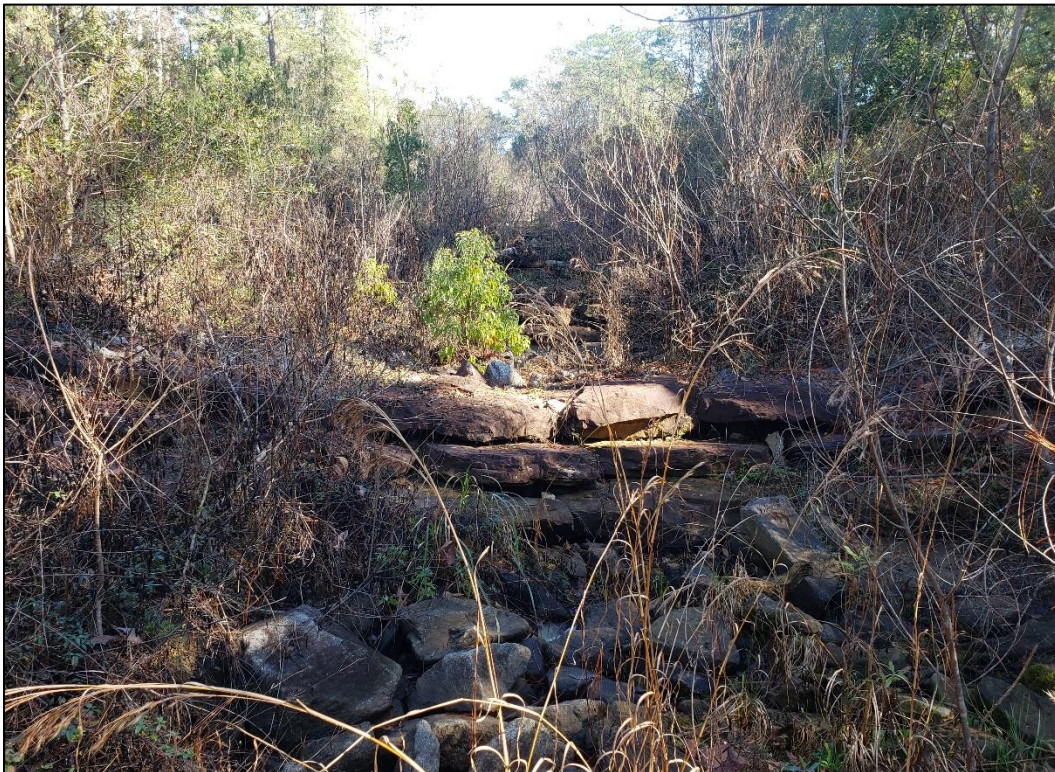
**Figure C.10 Joes Branch UT 2012 Westminster Village Stream Restoration (Upstream)**

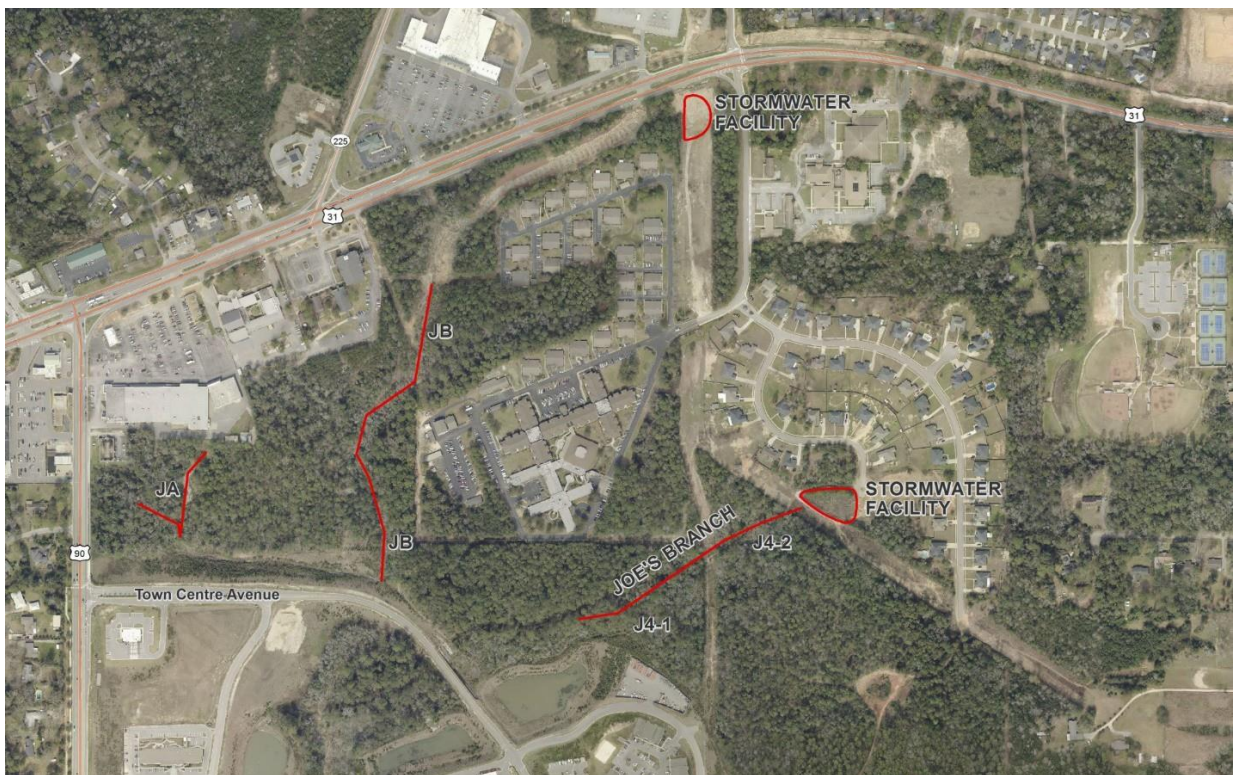
Project Maps:

- Gully erosion repair for three gullies in JA Lower Reach (western area near Hwy. 98) which included installation of vegetated wall systems / Flex MSE ditch checks.
- Installation of a 50-ft x 100-ft. plunge pool with an outfall.
- Installation of 300 LF of 48" diameter Class III RCP pipe to channel stormwater through a non- historic streambed area into the plunge pool. The piping system contained four junction boxes to change direction of flow.

- J-SWMF involved restoring (to its original dimensions) an existing detention pond previously constructed for the Westminster Gates Subdivision
