2006 Monitoring Summary

Indian Creek at Hwy 72 bridge in Madison County (34.7502/-86.6976)

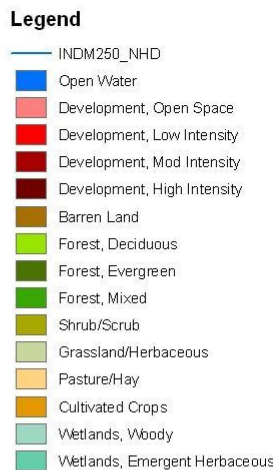
Figure 1. Sampling location and watershed of Indian Creek at INDM-250.

Watershed characteristics are summarized in Table 1. Land cover within the watershed is illustrated in Figure 1. Indian Creek at INDM-250 is a small watershed located within the Eastern Highland Rim Ecoregion (71g) (Griffith et al. 2001). Twenty percent of the watershed is composed of forest. About 50% of the land cover consisted of cultivated crops, pasture/hay and grasslands. Development accounted for 21% of the land cover. One hundred and sixty-two permits have been issued within the watershed.

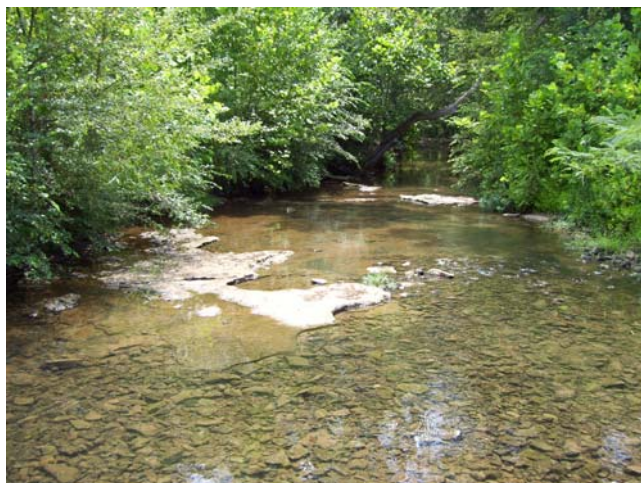
Figure 2. Indian Creek at INDM-250, August 7, 2007.

General observations (Table 2) and a habitat assessment (Table 3) were completed during the macroinvertebrate assessment. In comparison with reference reaches in the same ecoregion, they give an indication of the physical condition of the site and the quality and availability of habitat. Indian Creek at INDM-250 is a mostly-shaded stream reach characterized by bedrock, cobble, and gravel substrates (Fig. 2). Overall habitat quality was rated as *optimal*.
