2006 Monitoring Summary

Vaughn Creek at Alabama Highway 10 (32.11227/-88.13110)

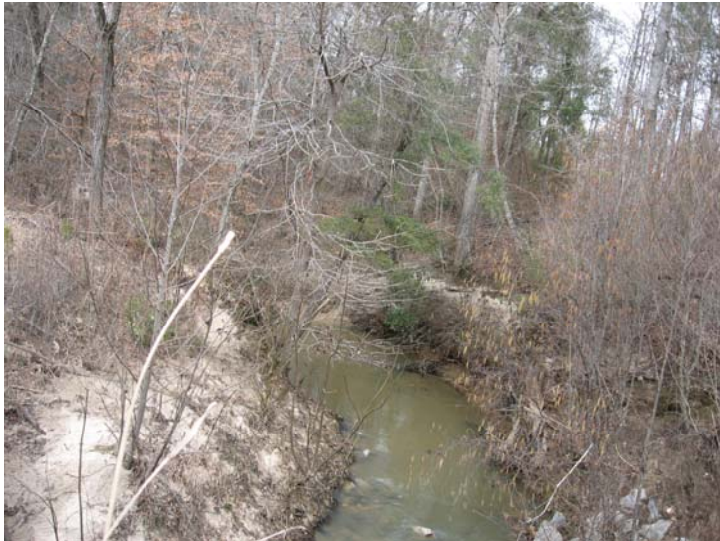
Figure 1. Vaughn Creek at VANC-1, February, 2010.

General observations (Table 2) and a habitat assessment (Table 3) were completed during the macroinvertebrate assessment. In comparison with reference reaches in the same ecoregion, they give an indication of the physical condition of the site, as well as the quality and availability of habitat. Vaughn Creek at VANC-1 is a low-gradient, sand-bottomed stream in the Lower Tombigbee River basin. The habitat assessment categorized the stream as *marginal* due to poor instream habitat quality and a straight stream channel.
