2008 Monitoring Summary

Mayo Mill Creek at Nalty Road in Escambia County (31.06273/-86.96919)

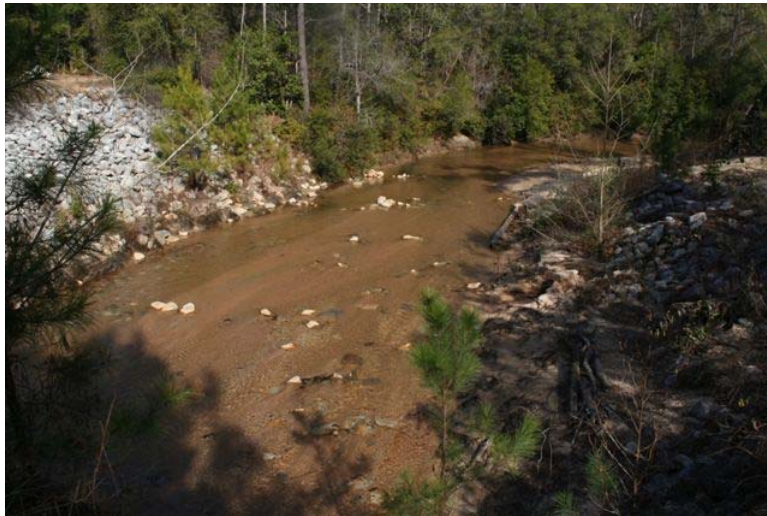
Figure 1. Reach Characteristics of Mayo Mill watershed at MMCE-1.

[General observations](#) (Table 2) and a [habitat assessment](#) (Table 3) were completed during the macroinvertebrate assessment. In comparison with reference reaches in the same ecoregion, they give an indication of the physical condition of the site and the quality and availability of habitat. Mayo Mill Creek at MMCE-1 is a low-gradient, sand bottomed stream reach (Figure 1). Habitat within the reach was rated as *marginal* for supporting biological communities due to a lack of in-stream habitat.
