# 2008 Monitoring Summary

Basin Assessment Site

# Mill Creek at Lee Road 246 (32.51223/-85.08752)

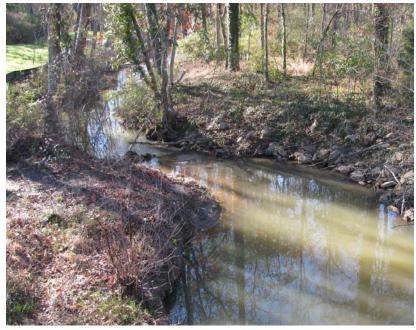
Figure 1. Reach Characteristics of Mill Creek watershed at MICR-2.

<u>General observations</u> (Table 2) and a <u>habitat assessment</u> (Table 3) were completed during the macroinvertebrate assessment. In comparison with reference reaches in the same ecoregion, they give an indication of the physical condition of the site and the quality and availability of habitat. Mill Creek at MICR-2 is a shallow, low-gradient stream reach characterized by sand and gravel substrates (Figure 1). Overall habitat quality was categorized as *optimal* for supporting macroinvertebrate communities. However, the reach was also characterized by unstable banks and marginal riparian buffer, which contributes to impacts from sedimentation and scouring and minimizes available habitat for aquatic life to populate.
