2010 Monitoring Summary

Hillabee Creek at Tallapoosa County Road 5 (Near Hackneyville) (33.06635/-85.87993)

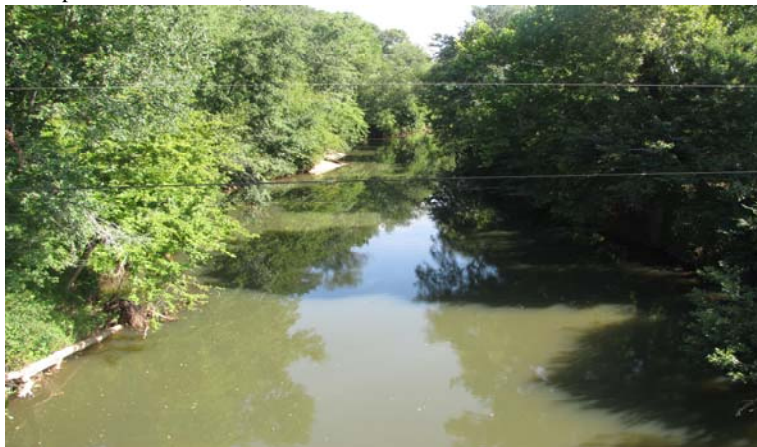
Figure 1. Hillabee Creek at HILT-2, July 13, 2010.

General observations (Table 2) and a habitat assessment (Table 3) were completed during the macroinvertebrate assessment. In comparison with reference reaches in the same ecoregion, they give an indication of the physical condition of the site and the quality and availability of habitat. Hillabee Creek is a wide, high-gradient, riffle-run stream characterized by gravel and sand substrates (Figure 1). Overall habitat was rated as *optimal* for supporting macroinvertebrate communities. The reach contains plentiful varieties of instream habitats, strong bank stability, and minimal riparian buffer interference.
