2010 Monitoring Summary

Paint Creek at Little Toms Rd (Coosa Co.; 33.01838/-86.44741)

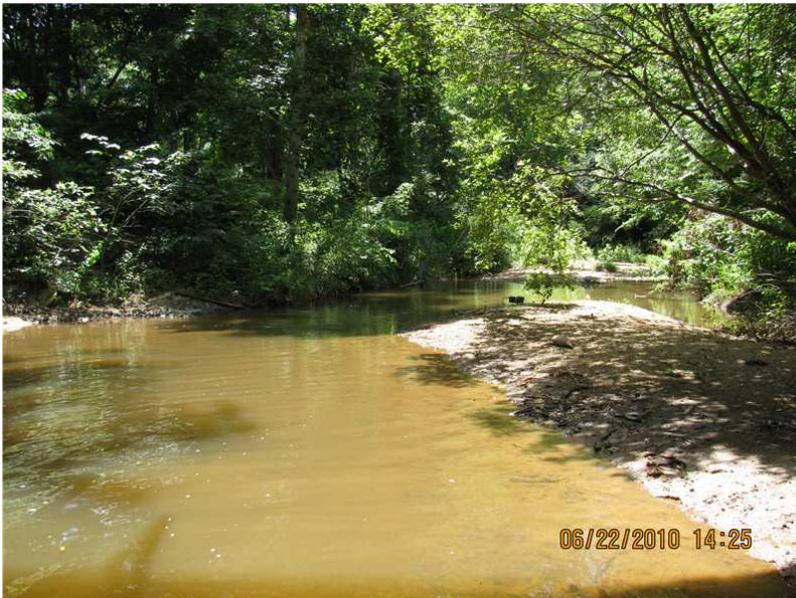
Figure 1. Paint Creek at PNTC-11, June 22, 2010.

Paint Creek at PNTC-11 is a high-gradient, riffle-run stream with a bottom substrate dominated by sand and gravel (Figure 1). Habitat quality and availability were rated as *sub-optimal* for supporting diverse aquatic macroinvertebrate communities due to limited riffle habitat.
