2010 Monitoring Summary

Shoal Creek at FS Road 500 Talladega National Forest (Cleburne County) (33.72529/-85.60115)

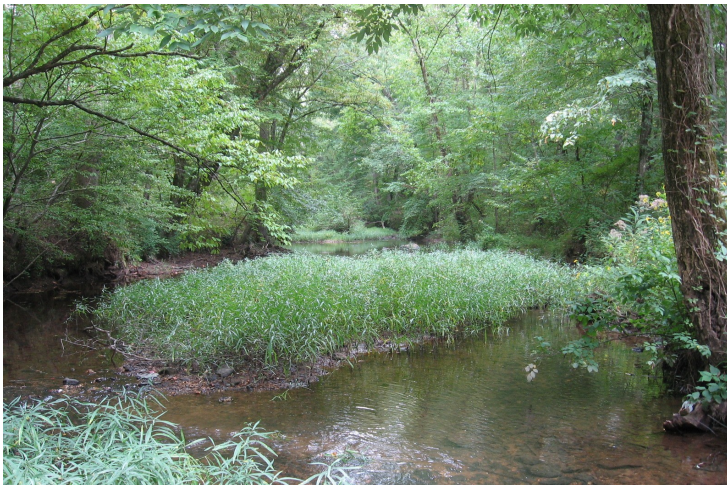
Figure 1. Upstream view of Shoal Creek at SHLC-3, September 8, 2010.

General observations (Table 2) and a habitat assessment (Table 3) were completed during the macroinvertebrate assessment. In comparison with reference reaches in the same ecoregion, they give an indication of the physical condition of the site and the quality and availability of habitat. Shoal Creek at SHLC-3 is a high gradient riffle-run stream. Instream substrates are composed of boulder, cobble, gravel, and sand (Figure 1). The habitat assessment resulted in an *optimal* rating in all categories.
