Sipsey Fork at Alabama Highway 33 in Winston County (34.21810/-87.36891)

BACKGROUND

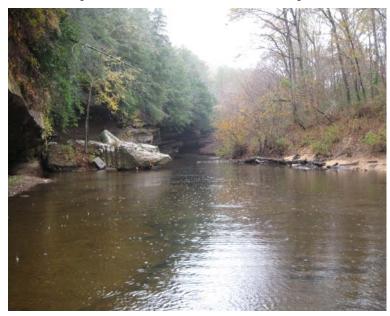
Figure 1. Sipsey Fork at SF-2, November 15, 2010.

General observations (Table 2) and a habitat assessment (Table 3) were completed during the macroinvertebrate assessment. In comparison with reference reaches in the same ecoregion, they give an indication of the physical condition of the site and the quality and availability of habitat. Sipsey Fork at SF-2 is a wide, low-gradient stream characterized by bedrock and sand substrates. Overall habitat quality was categorized as *sub-optimal* (Figure 1) for supporting a diverse aquatic macroinvertebrate community. The reach was also characterized by a relatively straight stream channel with high bluffs on one side, which puts it at risk to impacts from sedimentation and scouring.
