2010 Monitoring Summary

Basin Assessment Site

Terrapin Creek on dirt road 224 off Cleburne County Road 49 (33.89420/-85.46410)

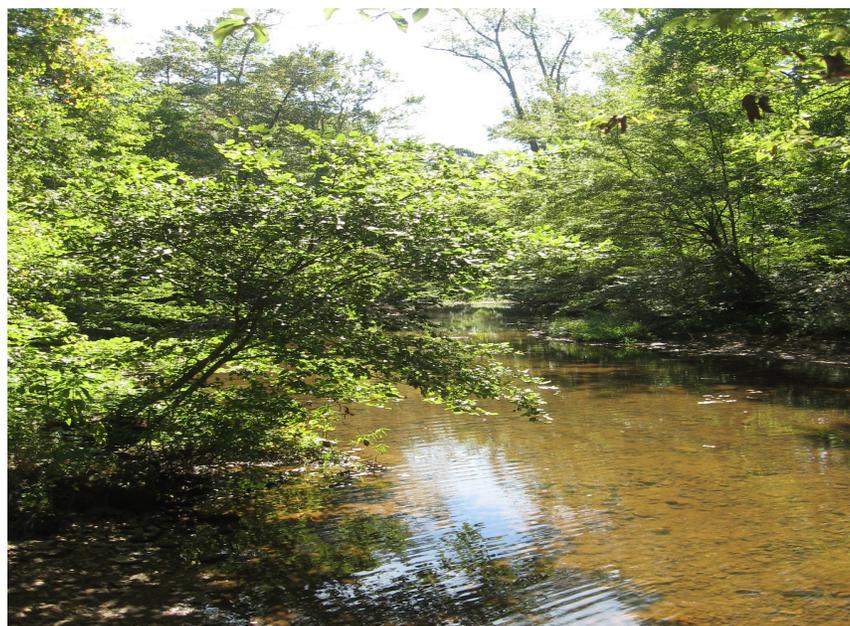
Figure 1. Reach Characteristics of Terrapin Creek at TEPC-1A, September 9, 2010.

General observations (Table 2) and a habitat assessment (Table 3) were completed during the macroinvertebrate assessment. In comparison with reference reaches in the same ecoregion, they give an indication of the physical condition of the site and the quality and availability of habitat. Terrapin Creek at TEPC-1A is characterized by gravel, cobble, boulder, sand, and bedrock substrates (Figure 1). Overall habitat quality was categorized as *optimal*.
