2010 Monitoring Summary

Ambient Monitoring Site

Uphapee Creek at AL Hwy 81 in Macon County (32.47751/-86.69554)

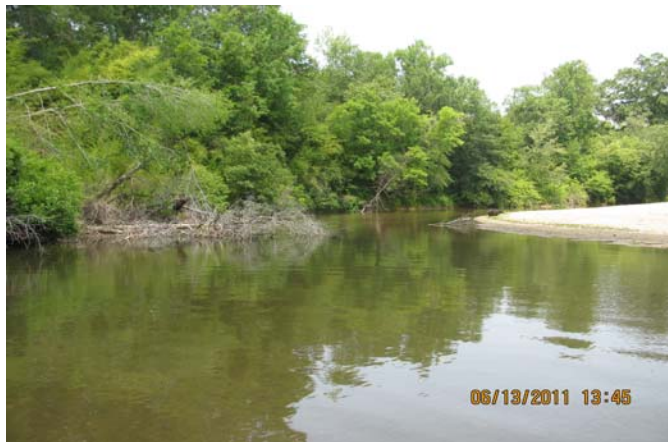
Figure 1. Uphapee Creek at UPHM-3, June 13, 2011.

General observations (Table 2) and a habitat assessment (Table 3) were completed during the macroinvertebrate assessment. In comparison with reference reaches in the same ecoregion, they give an indication of the physical condition of the site and the quality and availability of habitat. Uphapee Creek at UPHM-3 (Figure 1) is a *Fish & Wildlife (F&W)* stream. It is a wide, high-gradient stream characterized by sand and gravel substrates. Overall habitat quality was categorized as *optimal* for supporting macroinvertebrate communities.
