2011 Monitoring Summary

Brushy Creek upstream of Lawrence County Road 73 (34.33070/-87.28620)

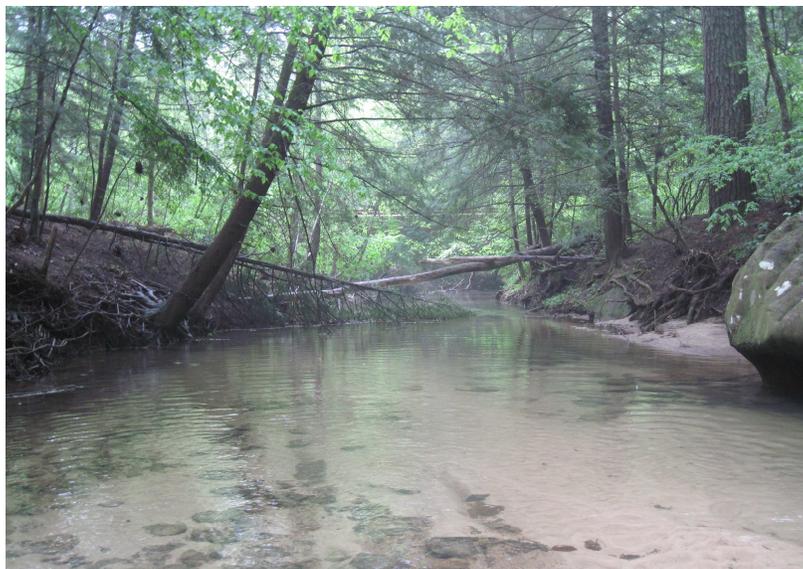
Figure 1. Brushy Creek at BRSL-3, April 26, 2011.

General observations (Table 2) and a habitat assessment (Table 3) were completed during the macroinvertebrate assessment. In comparison with reference reaches in the same ecoregion, they give an indication of the physical condition of the site and the quality and availability of habitat. Brushy Creek at BRSL-3 is a high-gradient, riffle-run stream. Dominant substrates in the reach consist of sand, cobble and gravel (Figure 1). Overall habitat quality was rated as *optimal* for supporting macroinvertebrate communities.
