2011 Monitoring Summary

Inman Creek at unnamed Forest Service Road in Bankhead National Forest, Winston County (34.21590/-87.22400)

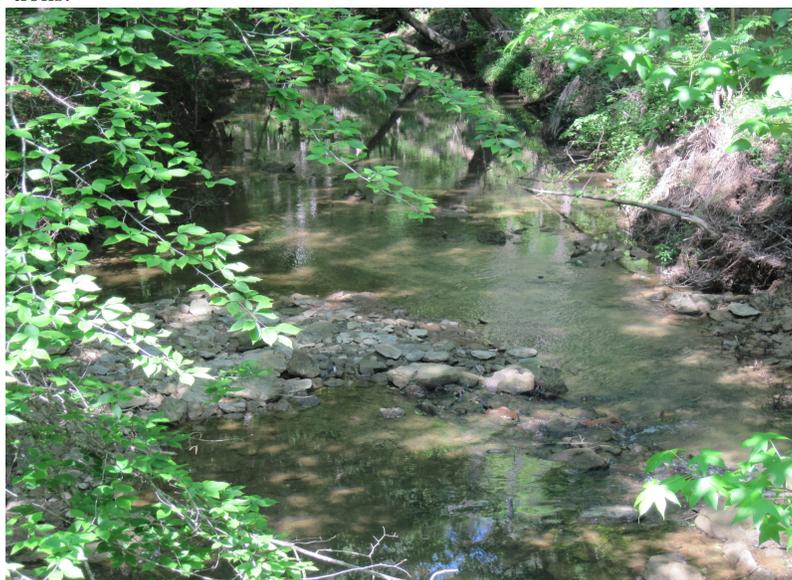
Figure 1. Inman Creek at INMW-1, May 11, 2011.

General observations (Table 2) and a habitat assessment (Table 3) were completed during the macroinvertebrate assessment. In comparison with reference reaches in the same ecoregion, they give an indication of the physical condition of the site and the quality and availability of habitat. Inman Creek at INMW-1 is a high-gradient, riffle-run stream. Dominant substrates in the reach consists of cobble, gravel and bedrock (Figure 1). Overall habitat quality was rated as *optimal* for supporting macroinvertebrate communities.
