2012 Monitoring Summary

Carthage Branch at dirt road off Cherokee Bend Drive (Tuscaloosa County) (33.00681/-87.62212)

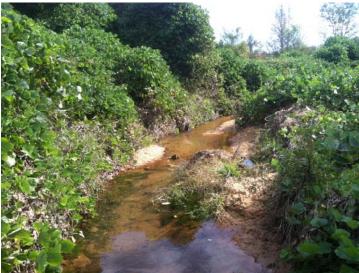
Figure 1. Carthage Branch at CRTT-1 on October 25, 2012.

General observations (Table 2) and a habitat assessment (Table 3) were completed during the macroinvertebrate assessment. In comparison with reference reaches in the same ecoregion, they give an indication of the physical condition of the site and the quality and availability of habitat. Carthage Branch at CRTT-1 was highly incised; the stream bottom was characterized primarily by sand and gravel substrates (Figure 1). Riffle habitat and the riparian buffer were limited.
