2012 Monitoring Summary

Hendrick Mill Branch at Blount County Road 15 (33.87612/-86.56885)

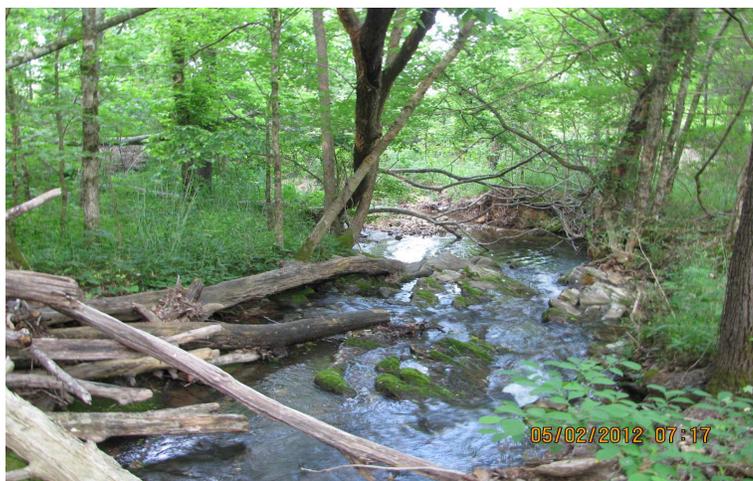
Figure 1. Hendrick Mill Branch at HNMB-4, May 2, 2012

General observations (Table 2) and a habitat assessment (Table 3) were completed during the macroinvertebrate assessment. In comparison with reference reaches in the same ecoregion, they give an indication of the physical condition of the site and the quality and availability of habitat. Hendrick Mill Creek is a high-gradient, riffle-run stream characterized by cobble, gravel, bedrock, and boulder substrates (Figure 1). Overall habitat quality was rated as *optimal* for supporting macroinvertebrate communities.
