# 2013 Monitoring Summary

## Anderson Creek at Lauderdale County Road 156 (34.90568/-87.26564)

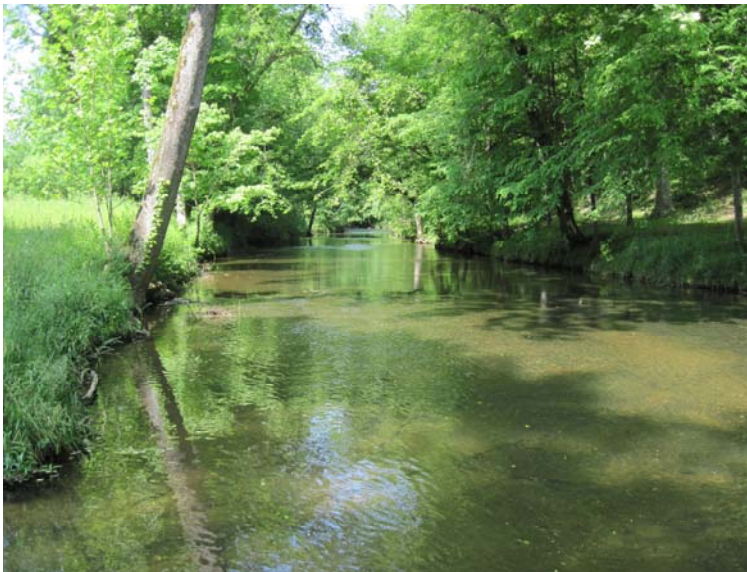
Figure 1. Anderson Creek at ANDL-9, May 21, 2013.

General observations (Table 2) and a habitat assessment (Table 3) were completed during the macroinvertebrate assessment. In comparison with reference reaches in the same ecoregion, they give an indication of the physical condition of the site and the quality and availability of habitat. Anderson Creek at ANDL-9 is a wide, high-gradient stream characterized by bedrock, cobble and gravel substrates. Overall habitat quality was categorized as *optimal* (Figure 1). The reach was also characterized by a relatively straight stream channel with high instream habitat quality and low sediment deposition.
