2013 Monitoring Summary

Bluff Creek at Lauderdale County Road 14 (34.88586/-87.90787)

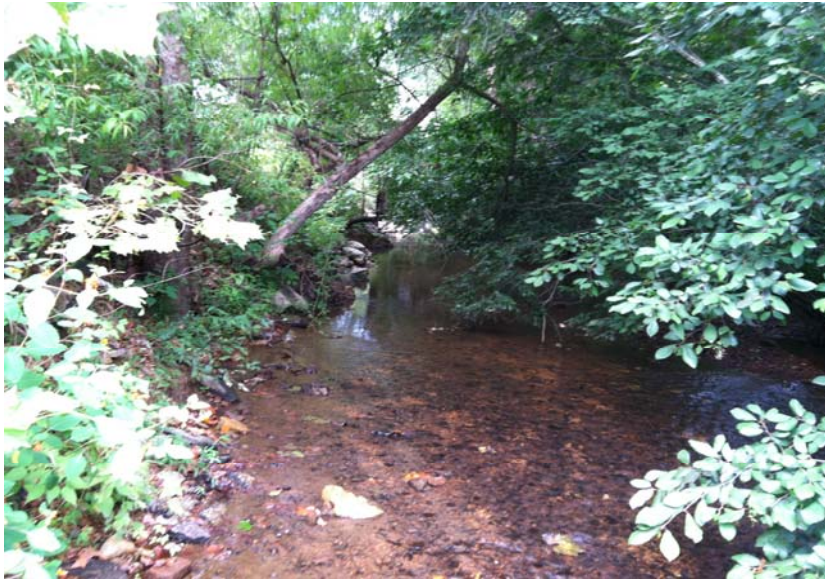
Figure 1. Bluff Creek at BLFL-1, September 10, 2013.

Bluff Creek at BLFL-1 (Figure 1) is a high-gradient, gravel and sand bottomed stream in the Transition Hills ecoregion. Overall habitat quality was categorized as *sub-optimal* due to sediment deposition, sinuosity, and lack of bank and vegetative stability.

Bioassessment results indicated the macroinvertebrate community to be in *good-fair* condition. Overall habitat quality was categorized as *sub-optimal* due to sedimentation, sinuosity, and lack of bank and vegetative stability. The *F&W* Human Health criterion was exceeded during the July and September sampling events. Monitoring should continue to ensure that water quality and biological conditions remain stable.
