# 2013 Monitoring Summary

## Bughall Creek at Bullock County Road 177 (32.16144/-85.83485)

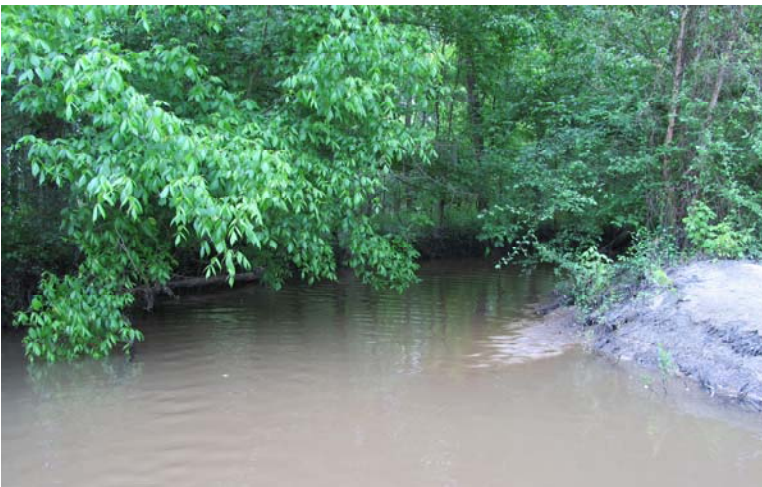
**Figure 1.** Bughall Creek at BGHM-1, April 30, 2013.

General observations (Table 2) and a habitat assessment (Table 3) were completed during the macroinvertebrate assessment. In comparison with reference reaches in the same ecoregion, they give an indication of the physical condition of the site and the quality and availability of habitat. Bughall Creek at BGHM-1 is a glide-pool stream located in the Blackland Prairie ecoregion (65a) (Figure 1). Benthic substrate in the reach consists primarily of sand with some organic matter. Overall habitat quality was rated as *sub-optimal* for supporting macroinvertebrate communities.
