2013 Monitoring Summary

Ecological Reference Reach

Lick Fork at Jackson County Road 3 (34.85242/-86.24377)

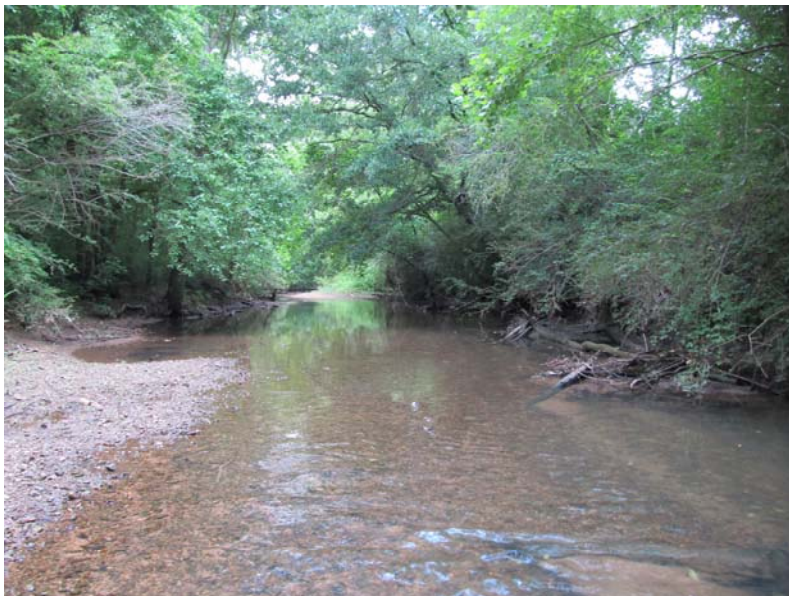
Figure 1. Lick Fork at LICK-1, June 26, 2013.

General observations (Table 2) and a habitat assessment (Table 3) were completed during the macroinvertebrate assessment. In comparison with reference reaches in the same ecoregion, they give an indication of the physical condition of the site and the quality and availability of habitat. Lick Fork at LICK-1 is a riffle-run stream located in the Plateau Escarpment ecoregion (68c) (Figure 1). Benthic substrate in the reach consists primarily of gravel and organic matter. Overall habitat quality was rated as *sub-optimal* for supporting the macroinvertebrate community.
