2013 Monitoring Summary

Little Coon Creek at Jackson County Road 53 (34.87425/-85.91075)

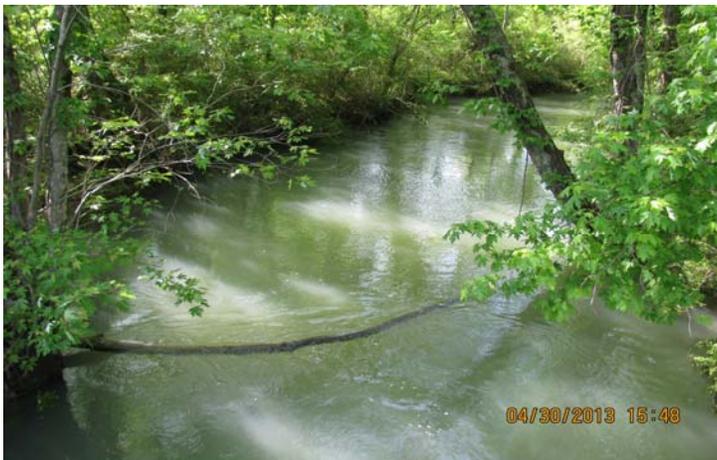
Figure 1. Little Coon Creek at COCJ-1, April 30, 2013.

General observations (Table 2) and a habitat assessment (Table 3) were completed during the macroinvertebrate assessment. In comparison with reference reaches in the same ecoregion, they give an indication of the physical condition of the site and the quality and availability of habitat. Little Coon Creek at COCJ-1 is a low-gradient, glide-pool stream. Predominant instream substrates were sand, silt and hard pan clay (Figure 1). The overall habitat assessment resulted in a *marginal* rating.

Little Coon Creek at COCJ-1 is a slow to medium velocity glide-pool stream. It is located downstream of LCNJ-36 and is located in the Sequatchie Valley sub-ecoregion. Overall habitat quality was rated *marginal*. Sediment loads are high during rain events and streambanks are being eroded, potentially impacting macroinvertebrate populations.

Bioassessment results indicated the macroinvertebrate communities to be in *fair* condition. Monitoring should continue to ensure that water quality and biological conditions meet current standards.
