2013 Monitoring Summary

Mannings Creek at Pike County Road 7718 (31.93409/-85.95741)

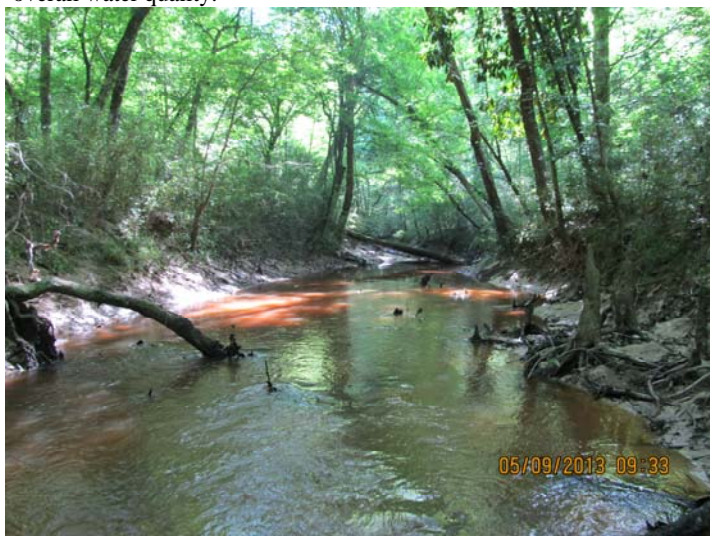
Figure 1. Mannings Creek at MANP-1, May 9, 2013.

General observations (Table 2) and a habitat assessment (Table 3) were completed during the macroinvertebrate assessment. In comparison with reference reaches in the same ecoregion, they give an indication of the physical condition of the site and the quality and availability of habitat. Mannings Creek at MANP-1 is a low-gradient, sand-bottomed stream, typical of other streams within the Southern Hilly Gulf Coastal Plain ecoregion (Figure 1). Overall habitat quality was rated as *sub-optimal*.
