# 2014 Monitoring Summary

## Beaver Creek at Houston County Road 59 (31.21647/-85.48691)

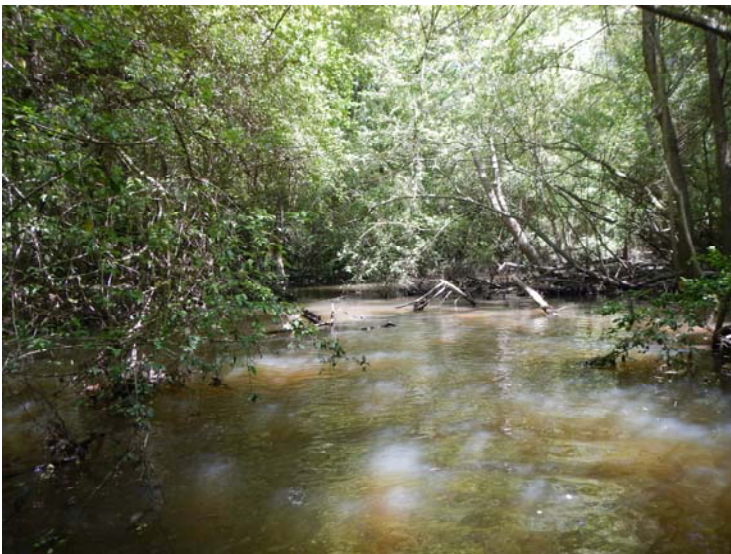
Figure 1. Beaver Creek at BVC-2, May 7, 2014.

General observations (Table 2) and a habitat assessment (Table 3) were completed during the macroinvertebrate assessment. In comparison with reference reaches in the same ecoregion, they give an indication of the physical condition of the site and the quality and availability of habitat. Beaver Creek at BVC-2 is a glide-pool stream located in the Dougherty Plain ecoregion (Figure 1). Bottom substrate consists primarily of sand and organic matter. Overall habitat quality was rated as *marginal* for supporting a diverse aquatic macroinvertebrate community.
