2014 Monitoring Summary

Cypress Creek at WWTP access road (Houston County) (31.15870/-85.37730)

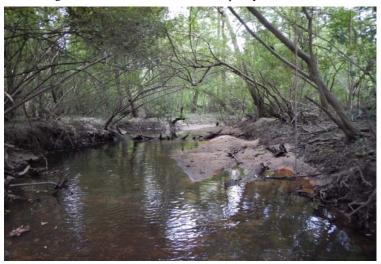
Figure 1. Cypress Creek at CYC-4, July 1, 2014.

General observations (Table 2) and a habitat assessment (Table 3) were completed during the macroinvertebrate assessment. In comparison with reference reaches in the same ecoregion, they give an indication of the physical condition of the site and the quality and availability of habitat. Cypress Creek at CYC-4 is a low gradient, glide-pool stream located in the Dougherty Plain ecoregion (65g) (Figure 1). Benthic substrate consists primarily of sand, organic matter, and silt. Overall habitat quality was rated as *sub-optimal* for supporting the macroinvertebrate community.
