2014 Monitoring Summary

Mill Creek at Broad Street in Phoenix City (Russell County) (34.46560/-85.00078)

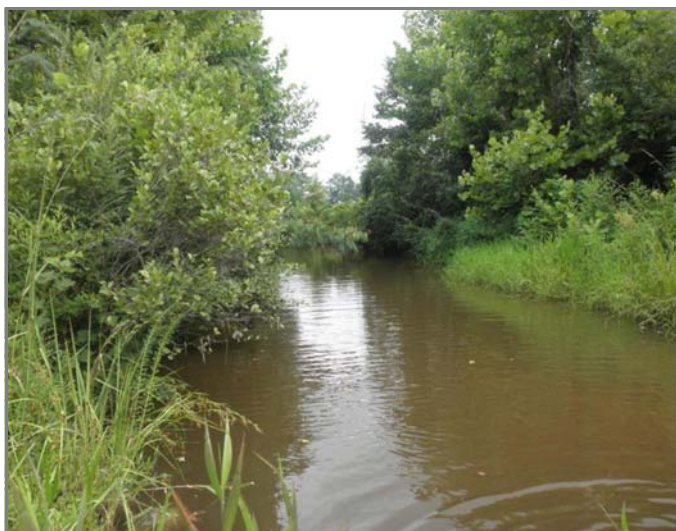
Figure 1. Mill Creek at MICR-1 July 15, 2014

General observations (Table 2) and a habitat assessment (Table 3) were completed during the macroinvertebrate assessment. In comparison with reference reaches in the same ecoregion, they give an indication of the physical condition of the site and the quality and availability of habitat. Mill Creek at MICR-1 is a shallow, high-gradient stream reach characterized by sand, gravel and cobble substrates (Figure 1). Overall habitat quality was categorized as *marginal* due to lack of bank stability.

Bioassessment results indicated the macroinvertebrate community to be in *fair* condition, and indicate a significant improvement in biological conditions since the site was first sampled in 1999. However, overall habitat quality was scored as *marginal*. Additionally, some water quality parameters were higher than expected, based on data from least impaired ecoregional reference reach data collected in ecoregion 65i. Monitoring at Mill Creek at MICR-1 should continue to document trends in physical, biological and water quality conditions within the reach.
