**Total Maximum Daily Load (TMDL)
for
Boggy Branch**

**Assessment Unit IDs AL03140106-0302-202 and
AL03140106-0302-203**

Alabama Department of Environmental Management
Water Quality Branch
Water Division
June 2022

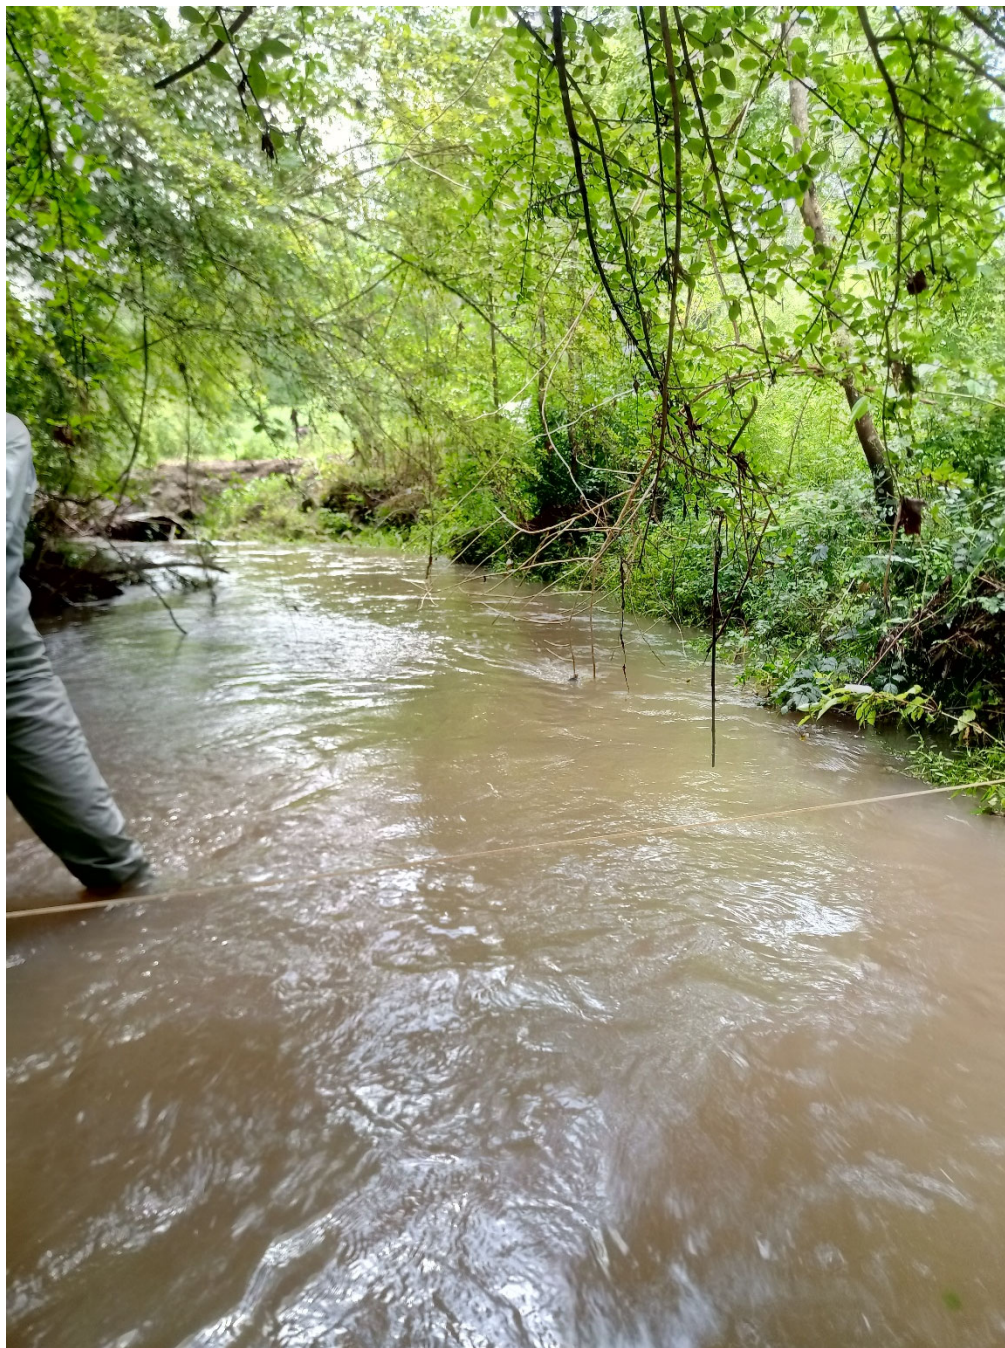
Station BOB-1, Looking Downstream (7/5/2021)

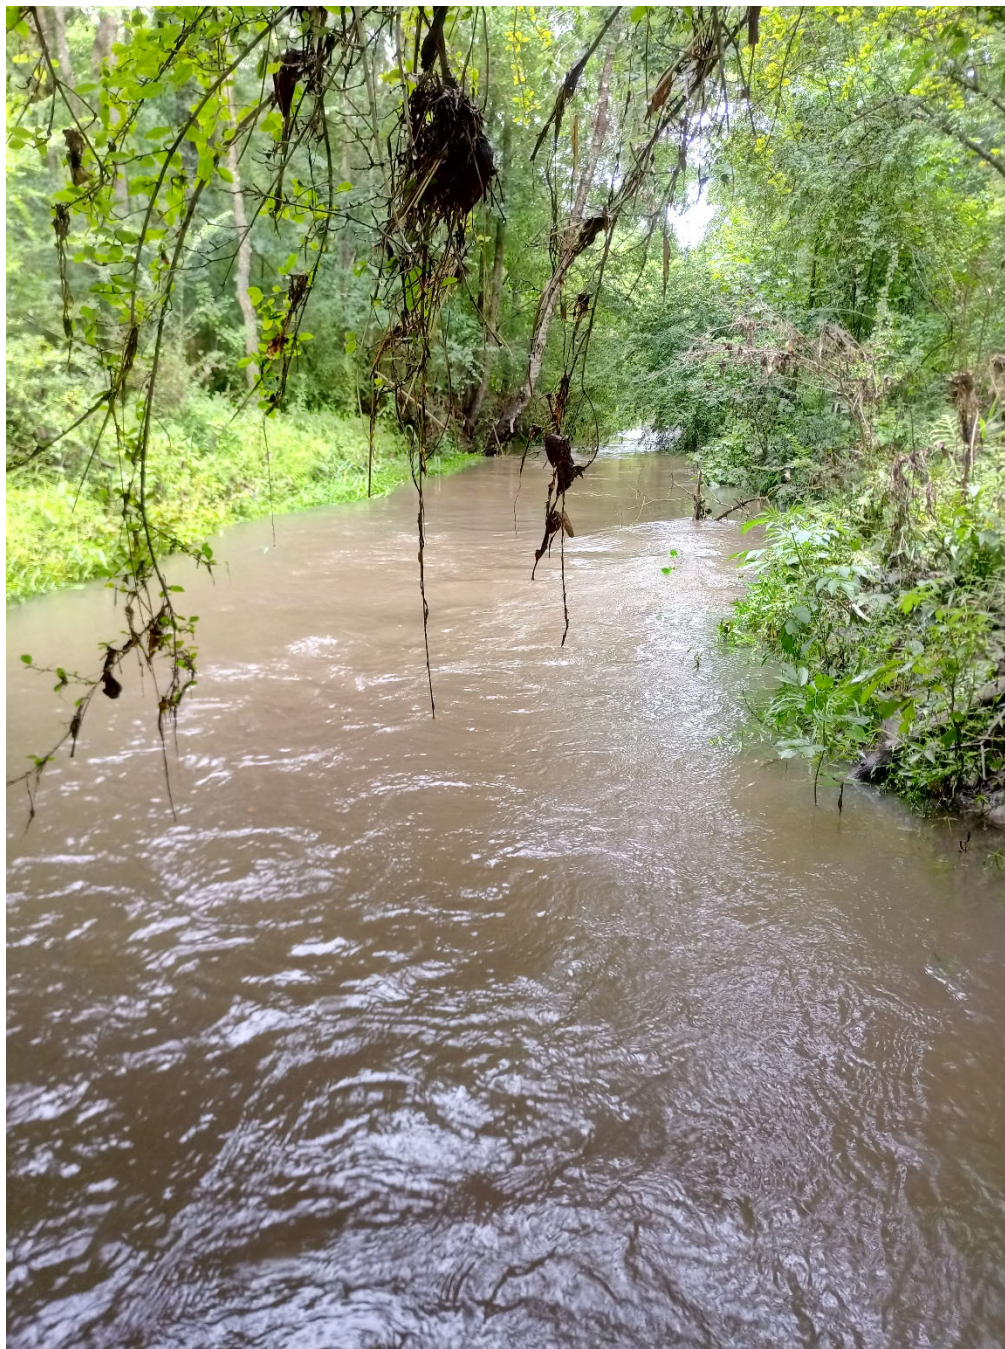
Station BOB-1, Looking Upstream (7/5/2021)

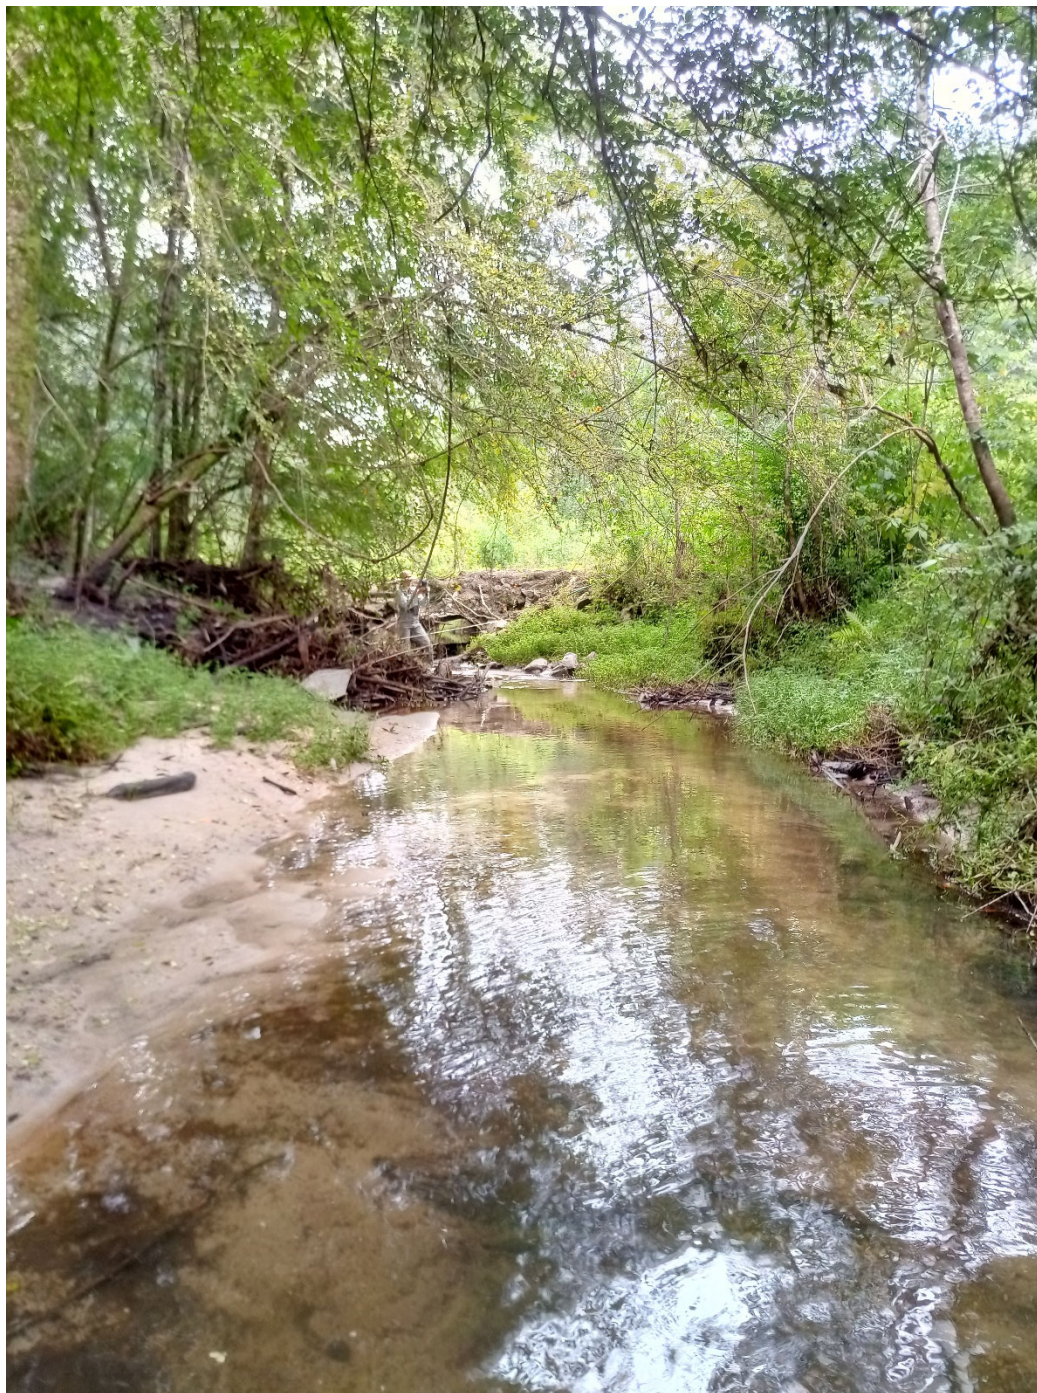
Station BOB-1, Looking Downstream (9/9/2021)

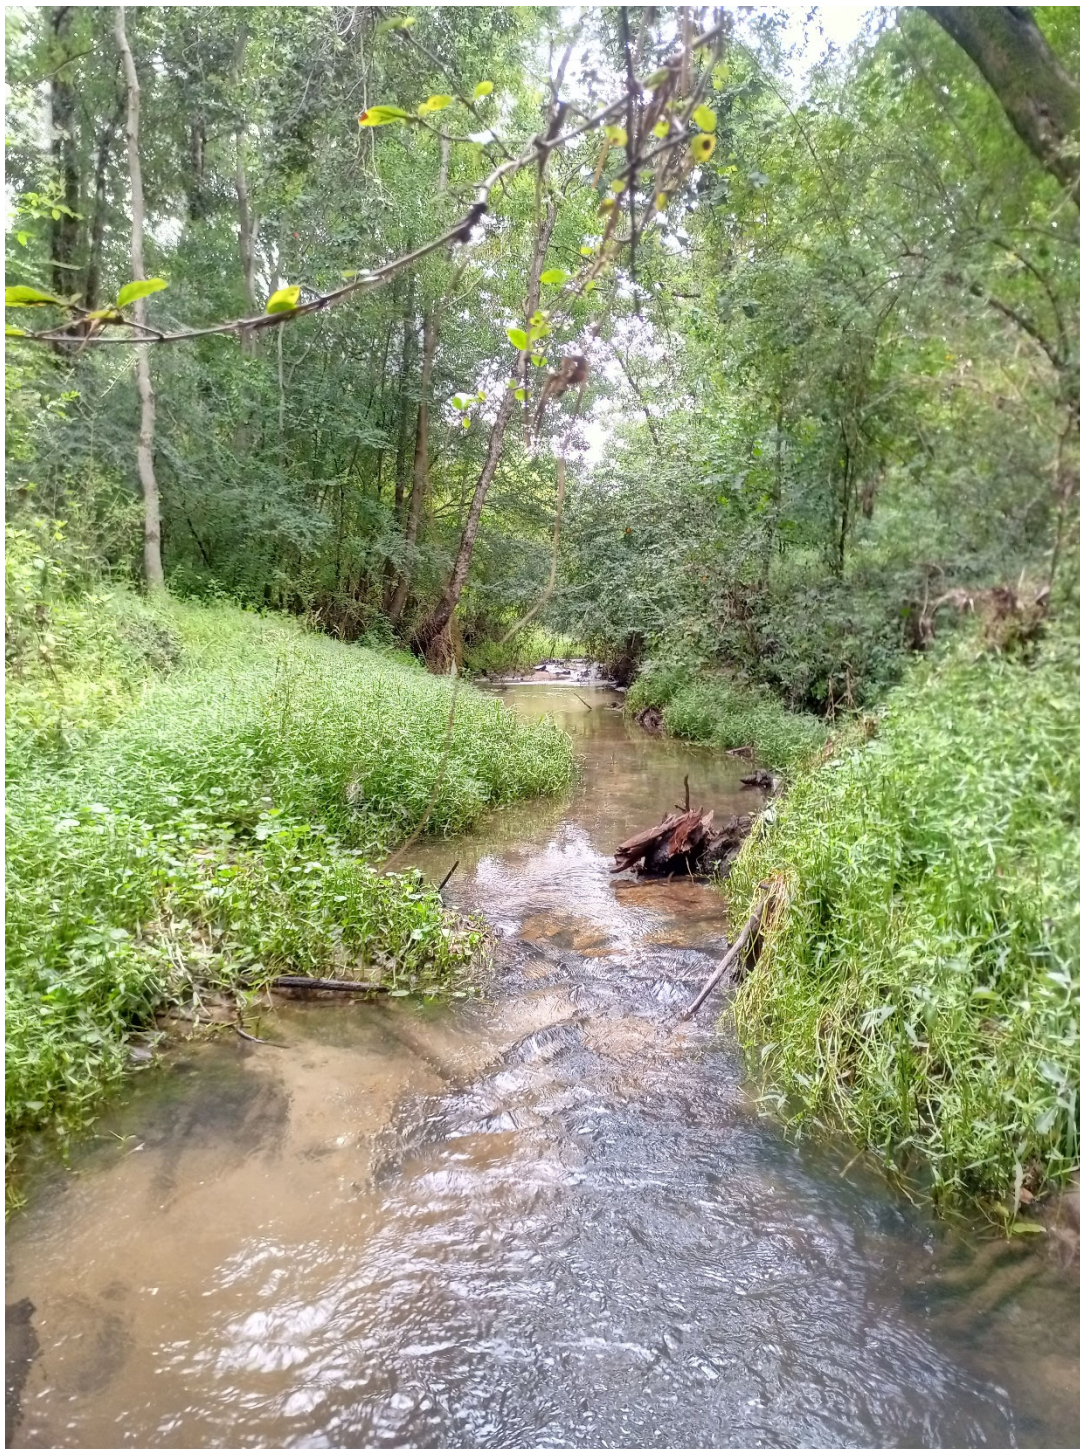
Station BOB-1, Looking Upstream (9/9/2021)

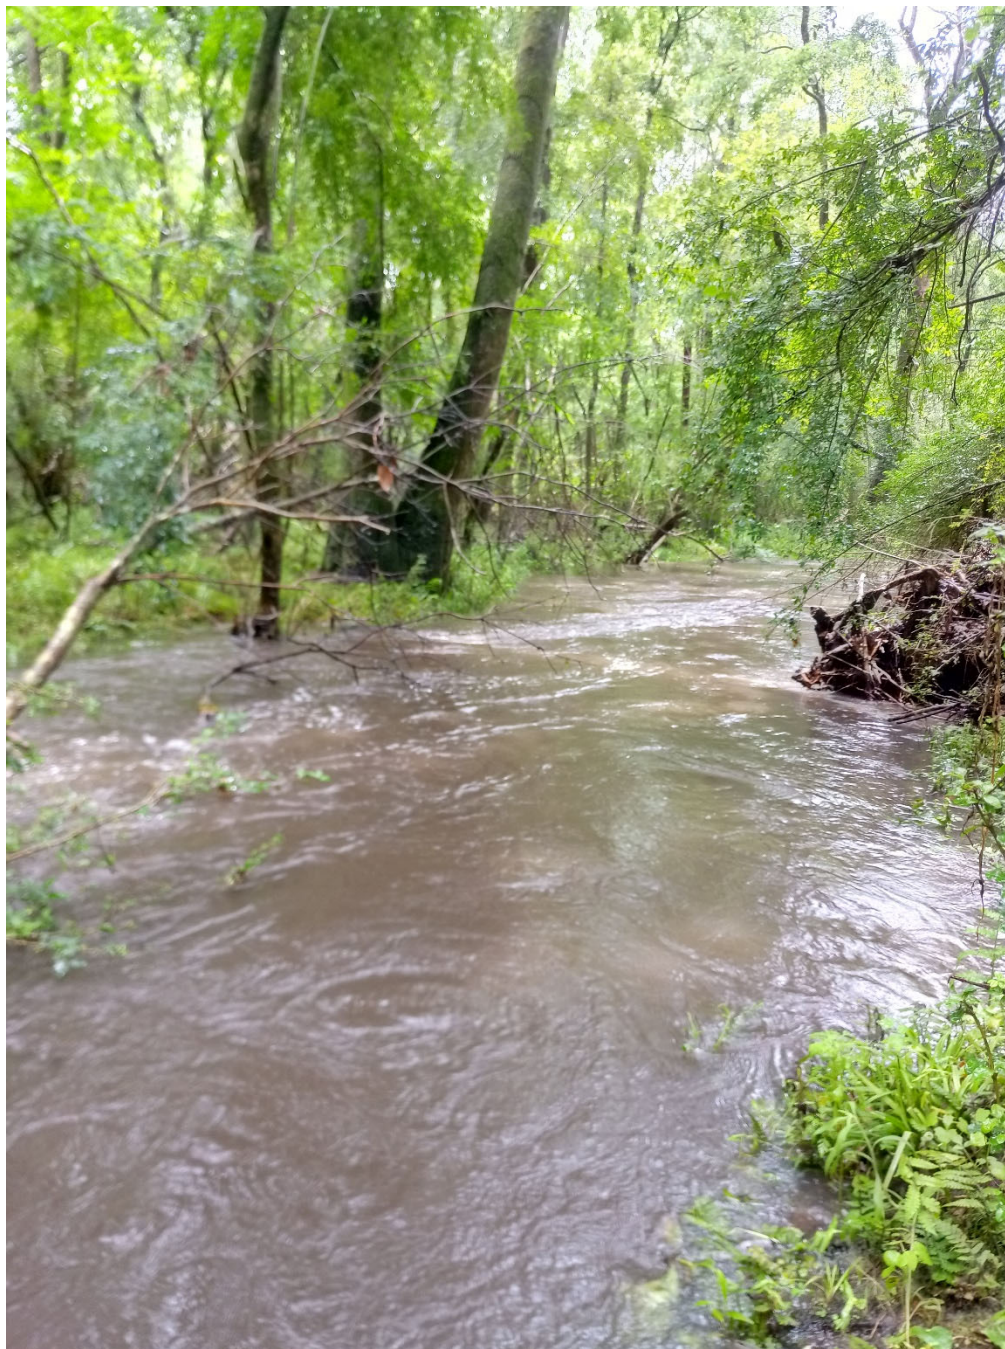
Station BOB-2, Looking Downstream (7/5/2021)

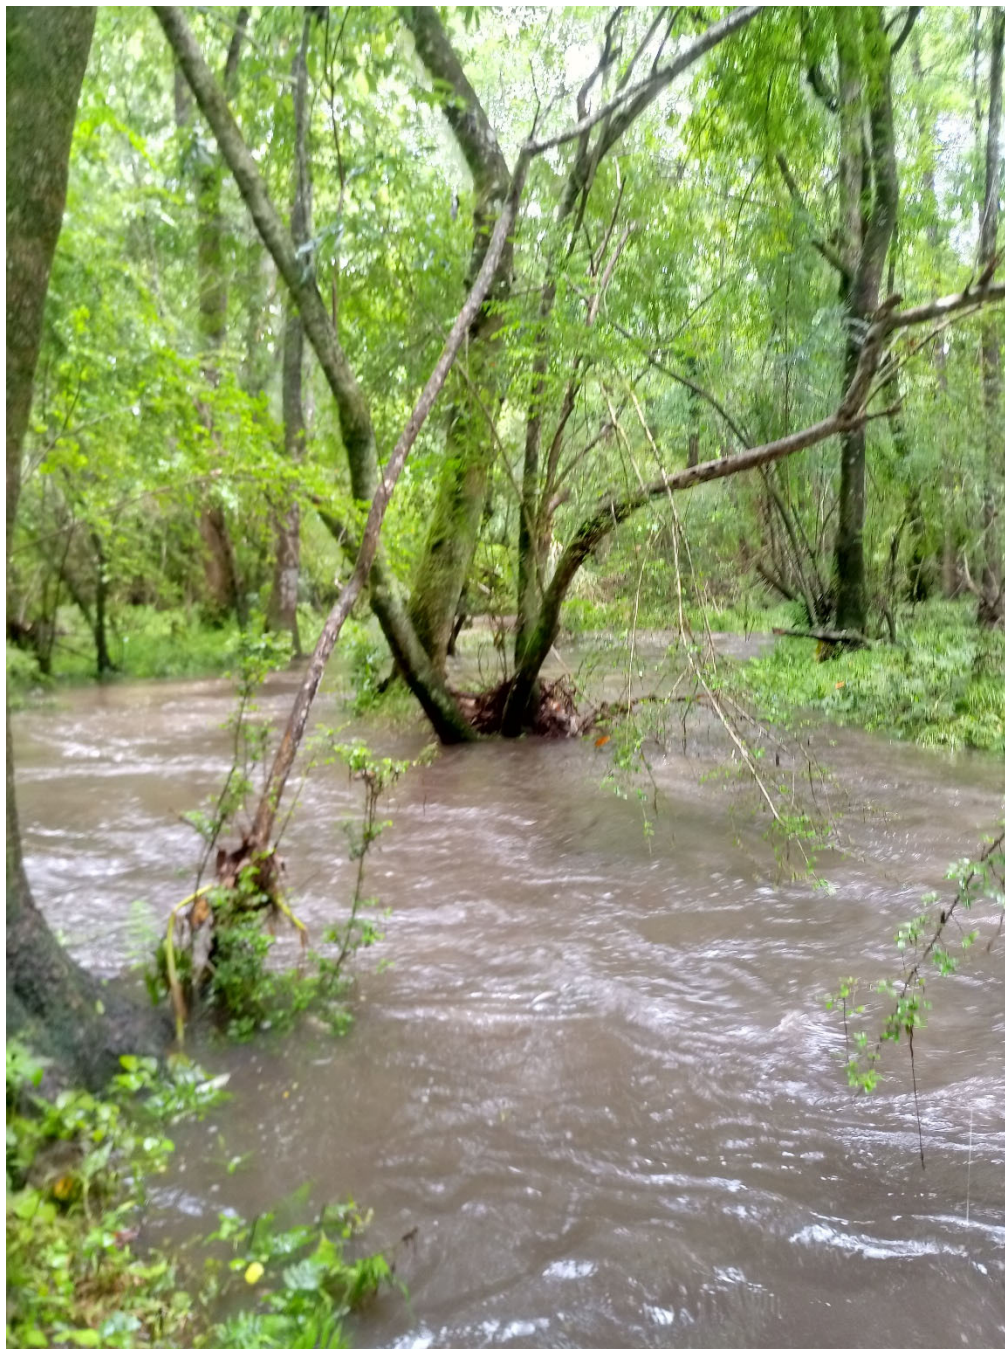
Station BOB-2, Looking Upstream (7/5/2021)

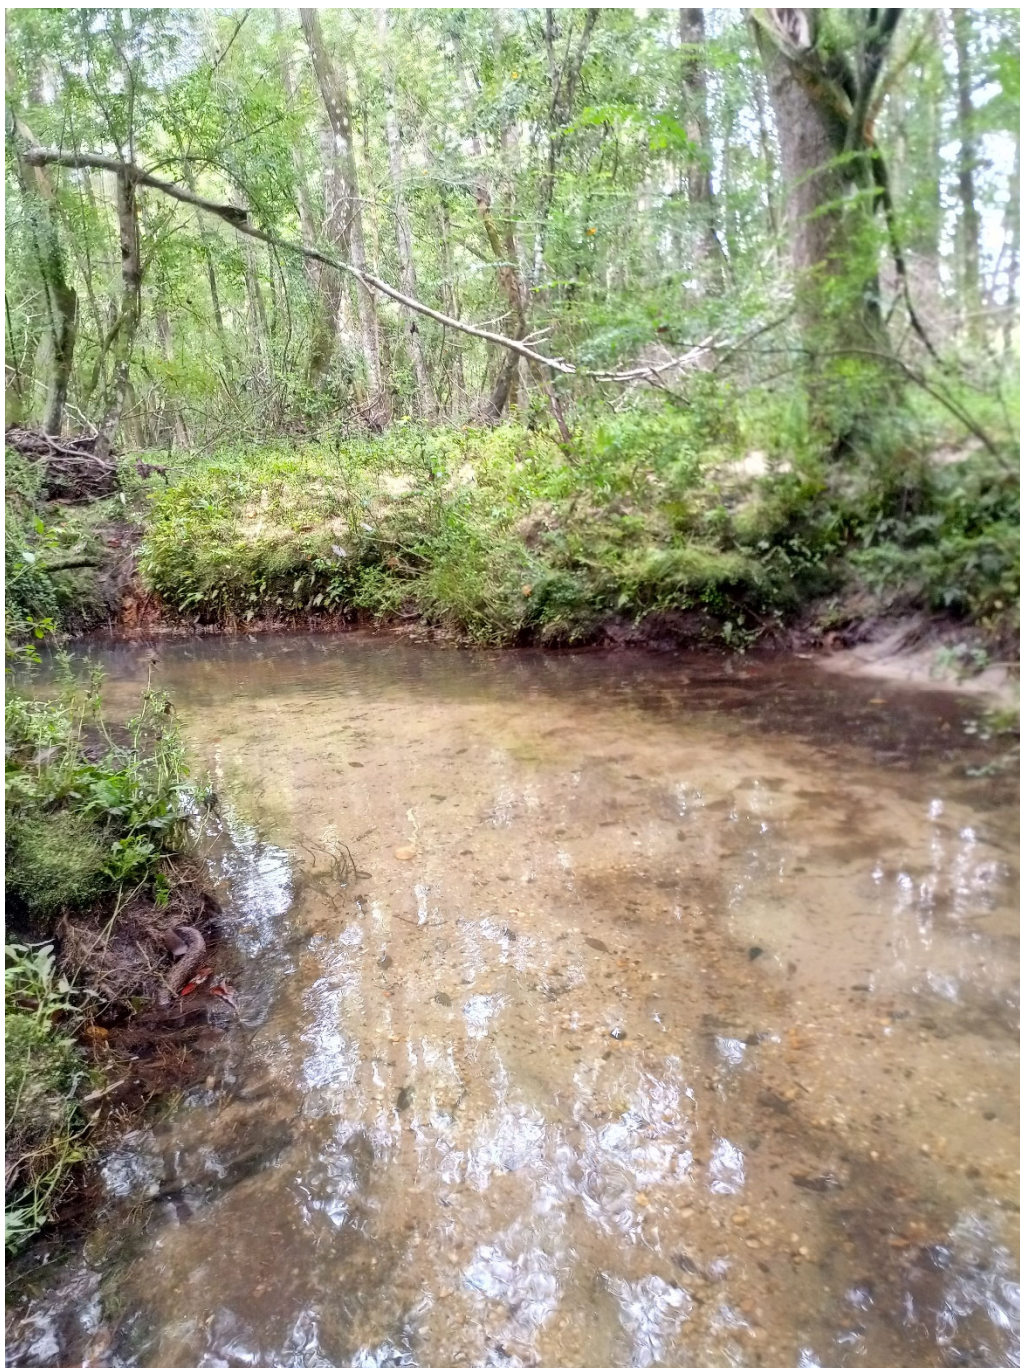
Station BOB-2, Looking Downstream (9/9/2021)

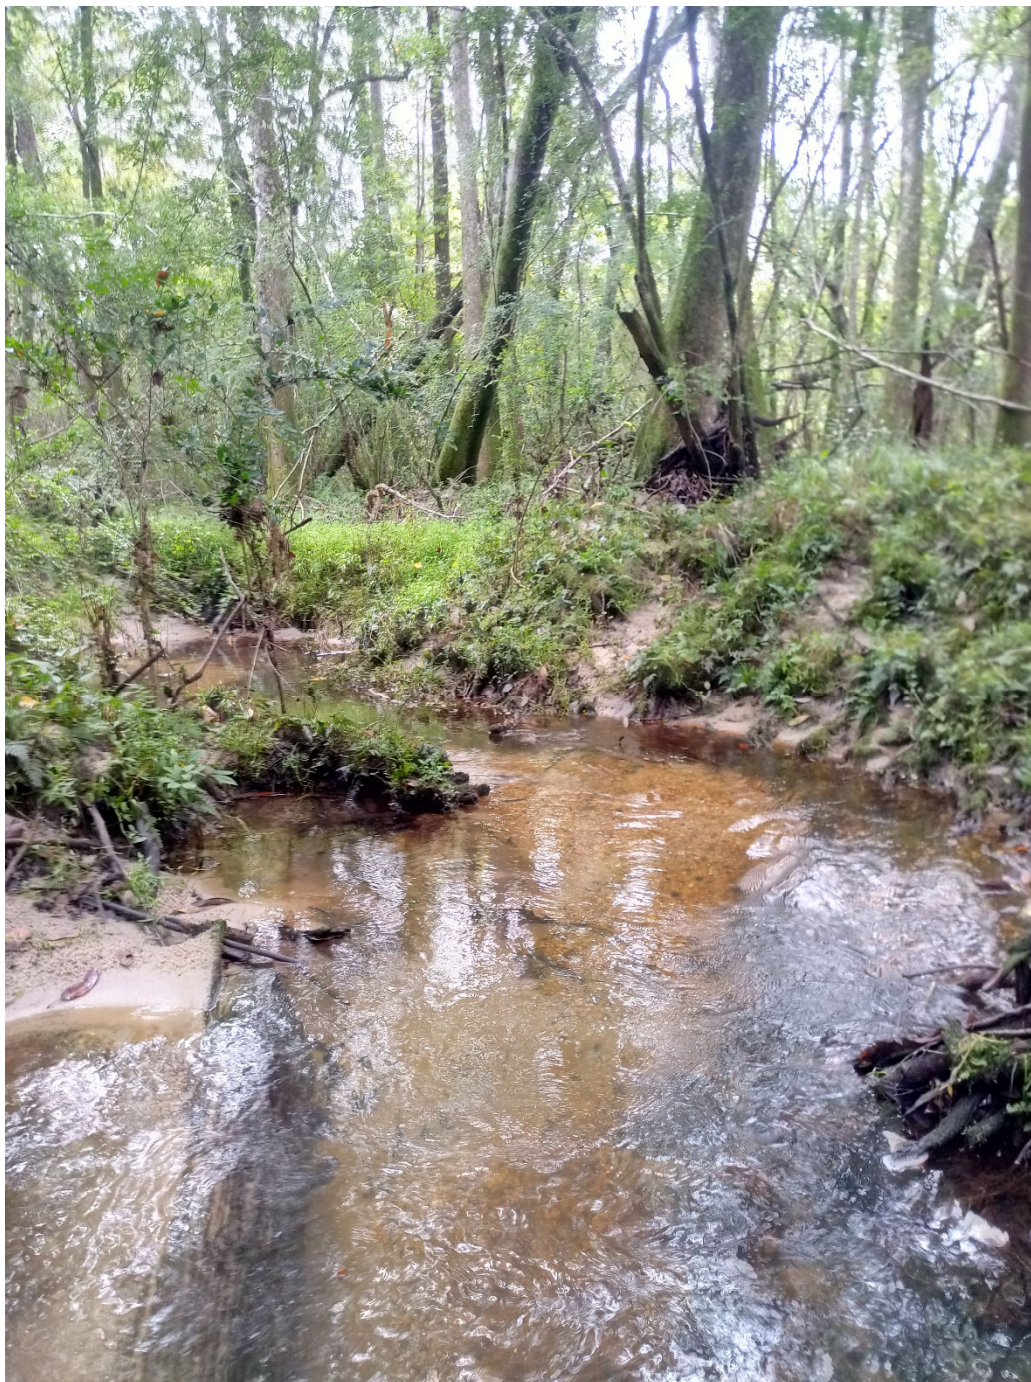
Station BOB-2, Looking Upstream (7/5/2021)
