May 2023

Evaluation of a Rubber Modified Mixture Designed Using a Balanced Design in Lake Guntersville State Park and De Soto State Park

Project Update

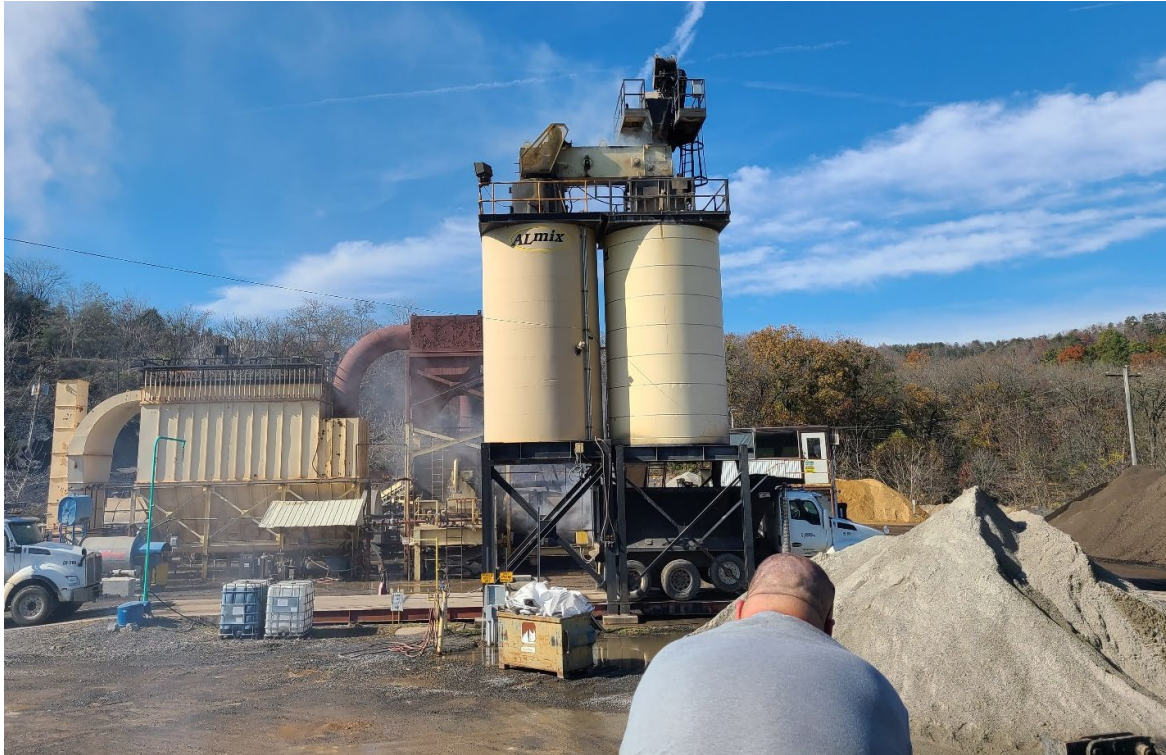
Figure 1. WCC Plant near Guntersville, AL

WCC placed this mix in Guntersville State Park in November 2021. An NCAT representative was onsite on November 11, 2021 to observe operations and to sample the mix for further testing at NCAT. Figures 1-2 contain pictures of the plant and the paving site. The existing surface mix was

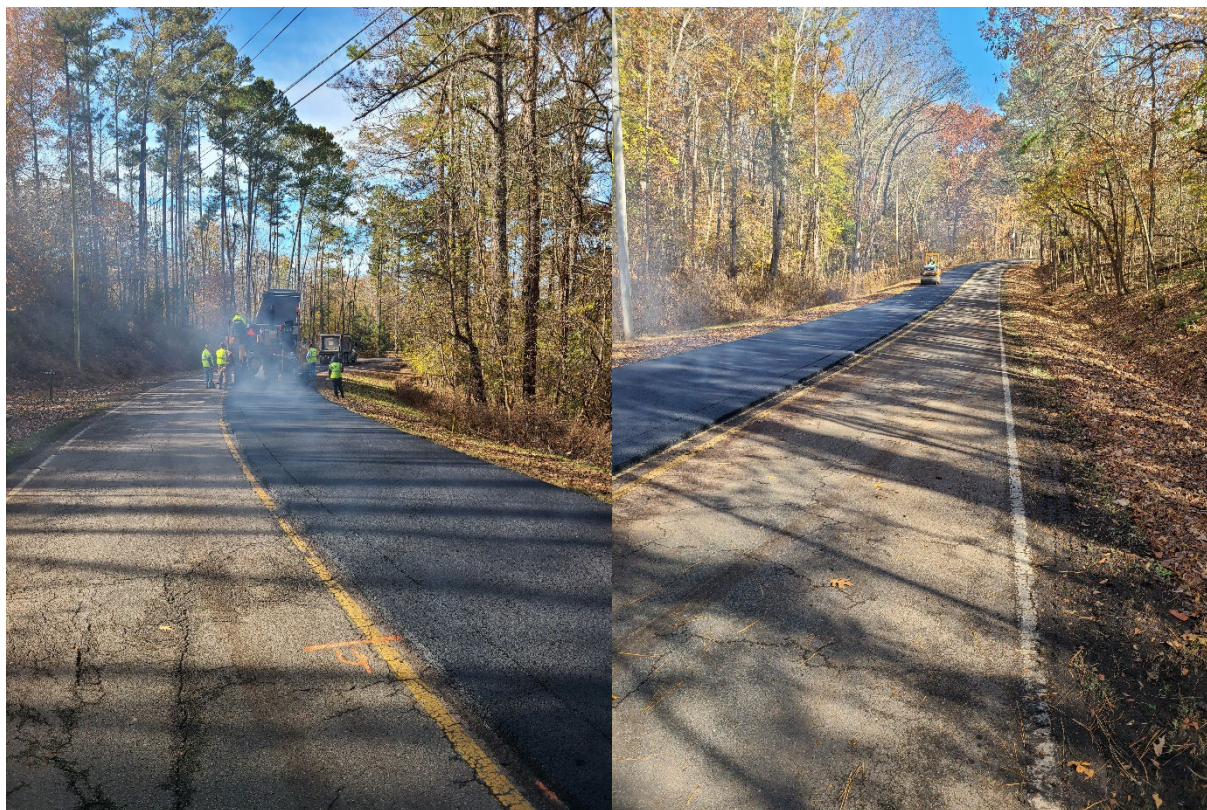
Figure 2. Paving Site in Guntersville State Park

in poor condition and was milled. The existing surface is shown in the lane adjacent to the paving lane in Figure 2.

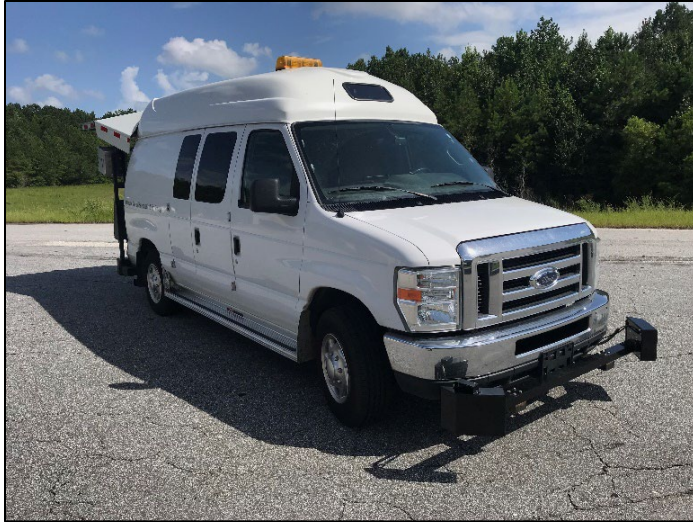
Figure 4. Data Collection Vehicle

This evaluation will be conducted using an automated pavement condition survey vehicle. The data collection vehicle used by NCAT is a fully automated PathRunner vehicle. The van is a class

1 inertial profiler with 3D automated crack and rutting detection system. The van includes an on-board laser package which measure smoothness, rutting, and macrotexture, in addition to front-facing super HD cameras, GPS, and 3D automated crack detection software providing a comprehensive pavement evaluation. The first field evaluation was conducted in February 2023. The results of this evaluation are summarized in the next section.

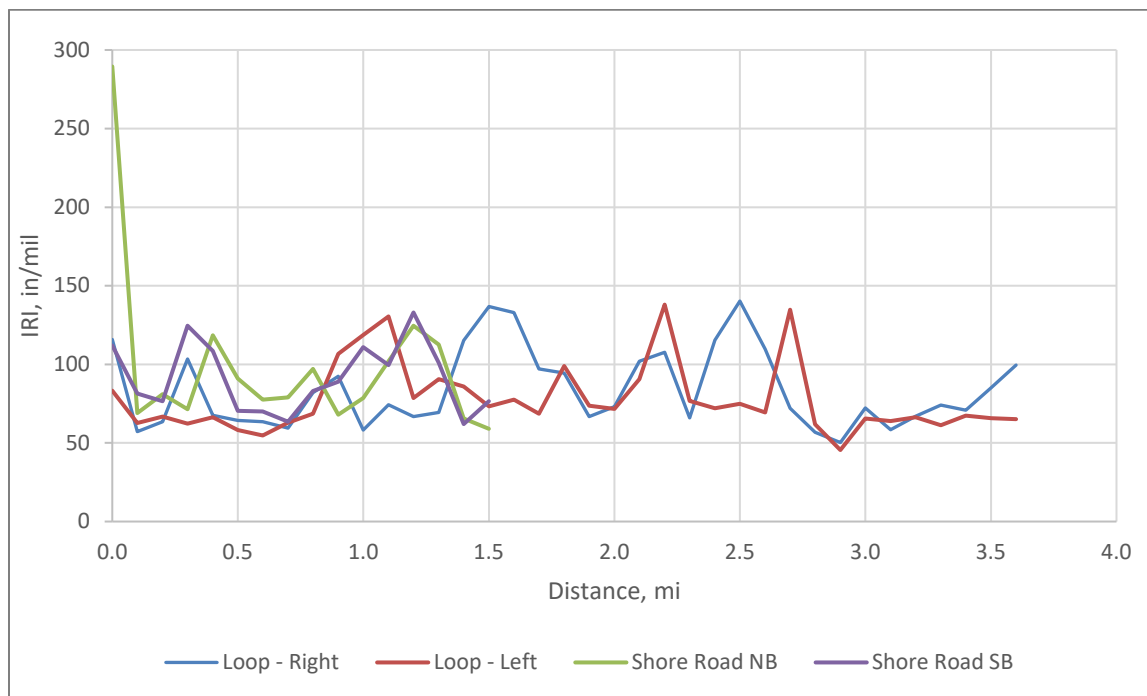
Figure 5. IRI Results for Guntersville Site

The pavement surface appeared to be performing well, with no distresses visible to the survey vehicle. There was also no measured rutting. The average performance data for IRI and texture are shown in Figures 5 and 6. Figures 7 and 8 show examples of the pavement at the time of the one-year visit.

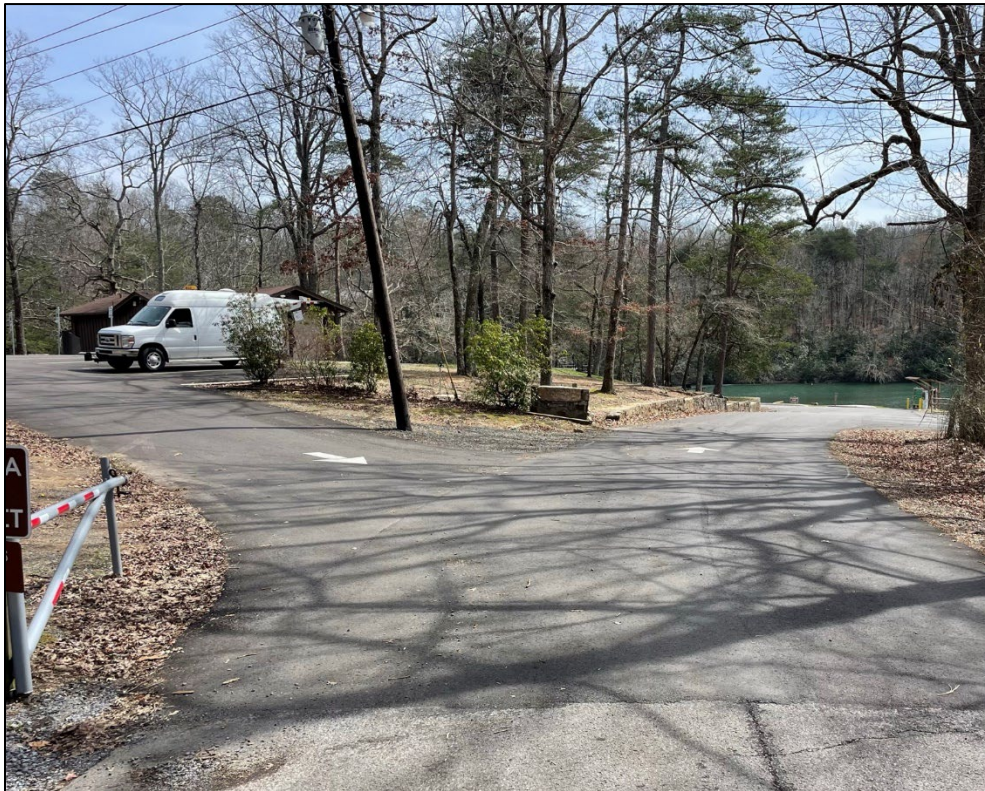
Figure 10. Site Overview at Desoto Falls Site

The same RTR asphalt mix was placed in Desoto State Park in 2021. This site is a parking lot/circular drive for Desoto Falls as shown in Figures 9 and 10. A one-year survey of the site was conducted on March 10, 2023. NCAT's high-speed data collection vehicle was unable to travel at speed due to the geometry of the parking lot. Therefore, IRI could not be accurately measured.

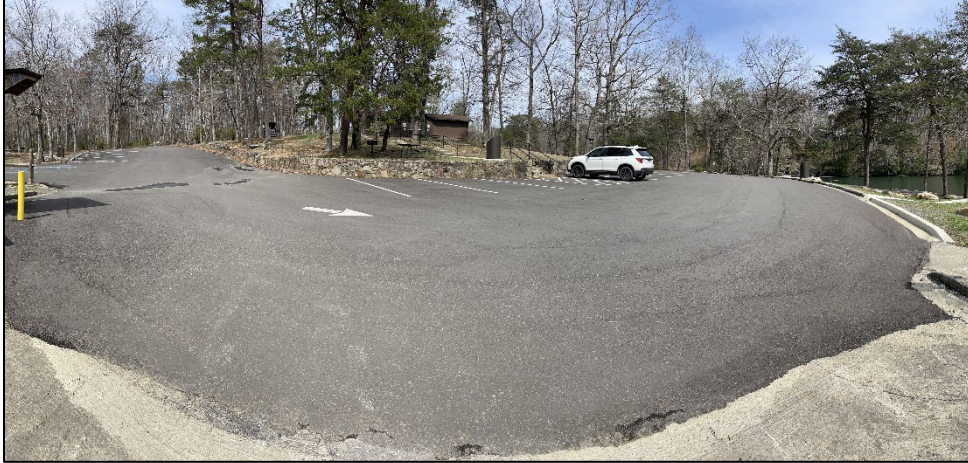
Figure 11. Pavement Example at Desoto Falls Site

A manual survey was conducted, and there was no cracking or rutting visible. The pavement was performing well. Figure 11 show examples of the pavement. There were some roller marks noted coming up the hill as shown in Figure 12. The texture results are shown in Figure 13.
