## Evaluation of a Rubber Modified Mixture Designed Using a Balanced Design in Lake Guntersville State Park and De Soto State Park

### Year 2 Field Evaluation

Carolina Rodezno, and Grant Julian

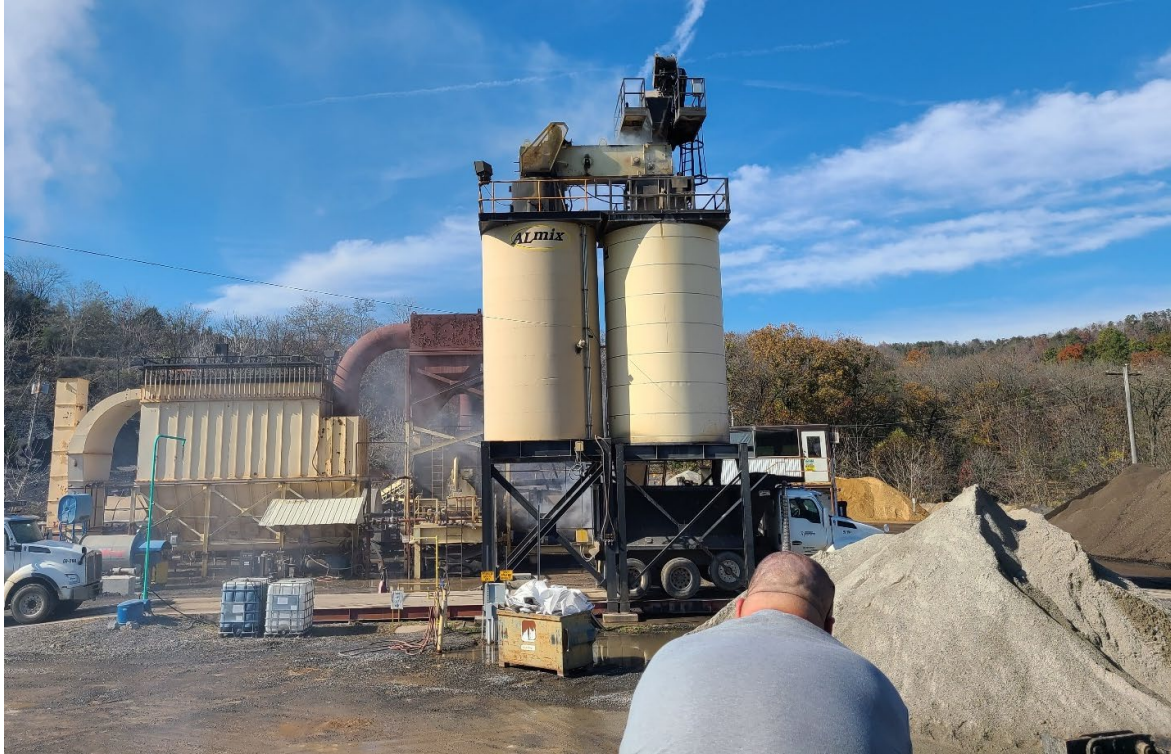
**Figure 1. WCC Plant near Guntersville, AL**

WCC placed this mix in Guntersville State Park in November 2021. An NCAT representative was onsite on November 11, 2021, to observe operations and to sample the mix for further testing at NCAT. Figures 1-2 contain pictures of the plant and the paving site. The existing surface mix was in poor condition and was milled. The existing surface in the lane adjacent to the paving lane in Figure 2.

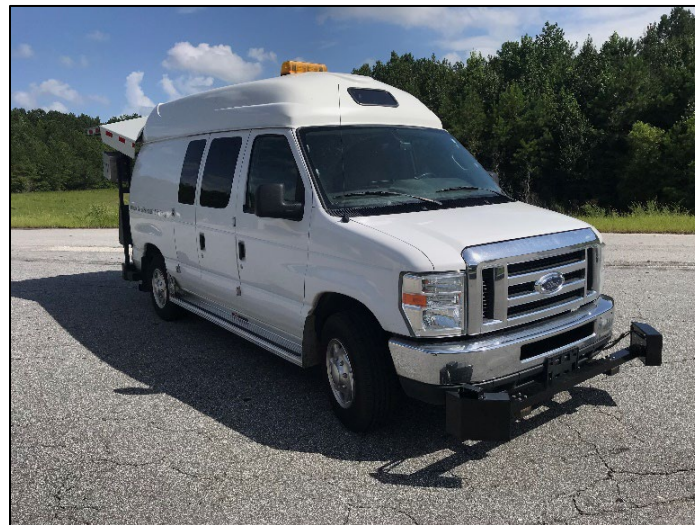
**Figure 4. Data Collection Vehicle**

This evaluation will be conducted using an automated pavement condition survey vehicle. The data collection vehicle used by NCAT is a fully automated PathRunner vehicle. The van is a class 1 inertial profiler with a 3D automated crack and rutting detection system. The van includes an on-board laser package that measures smoothness in terms of International Roughness Index (IRI), rutting, and macrotexture in terms of mean profile depth (MPD), in addition to front-facing super HD cameras, GPS, and 3D automated crack detection software providing a comprehensive pavement evaluation. The first and second field evaluations were conducted in February 2023 and February 2024. The results of the evaluations are summarized in the next section.

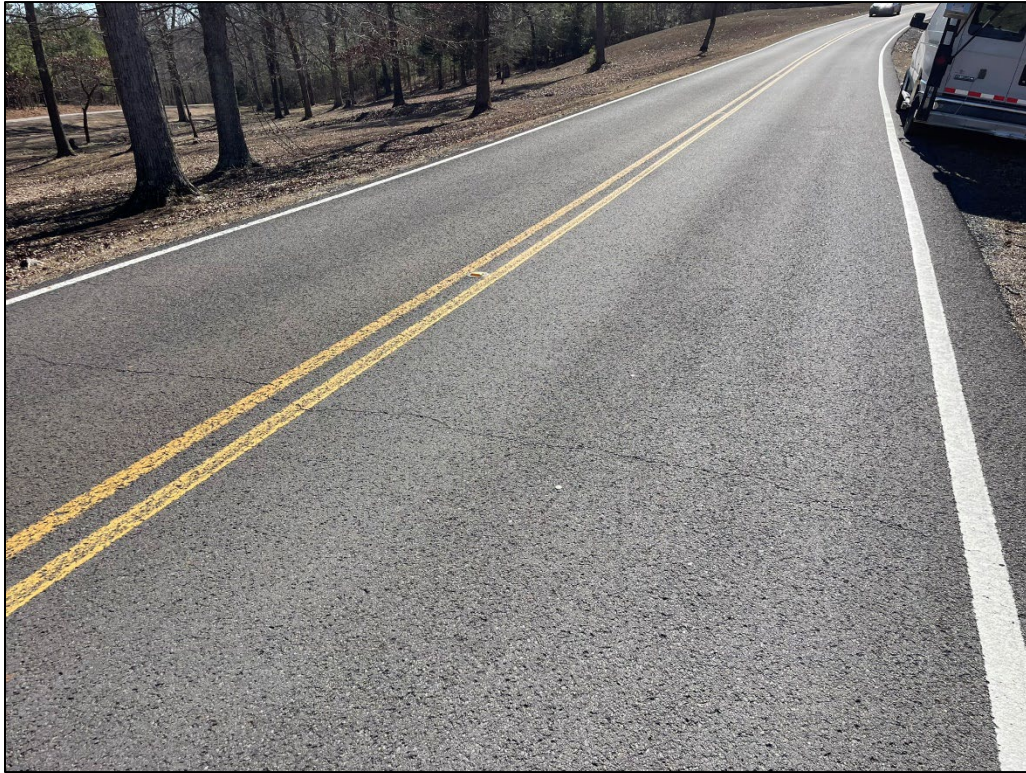
**Figure 5. Example of Cracking Observed at the 2024 Survey**

The pavement surface appeared to be performing well, with no distresses visible to the survey vehicle at the time of the 2023 survey. At the time of the 2024 survey, minimal cracking was detected, but the total cracking was less than 0.5% by lane area for all areas. Figure 5 shows an example of the transverse cracking observed at the time of the 2024 survey.

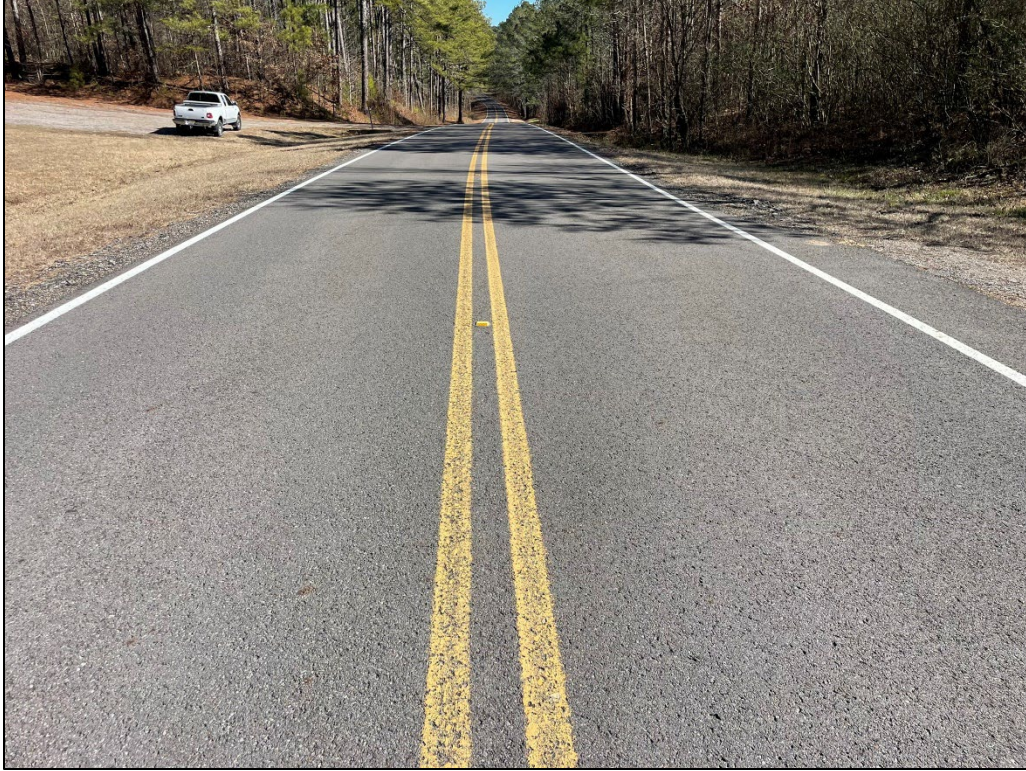
**Figure 6. Pavement Overview during 2024 Survey of Guntersville Site**

There was no measurable rutting at the time of either survey. The average performance data for IRI and texture are shown in Table 4. This data shows there is little change in terms of ride quality and texture between the two surveys except for one portion of the road (Shore Road South Bound) that experienced an increase of 9 in/mi. The results for all sections, nonetheless, are within acceptable ranges. Figure 6 shows an overview of the pavement in 2024, and Figure 7 shows an example of the pavement texture at the time of the 2024 visit.

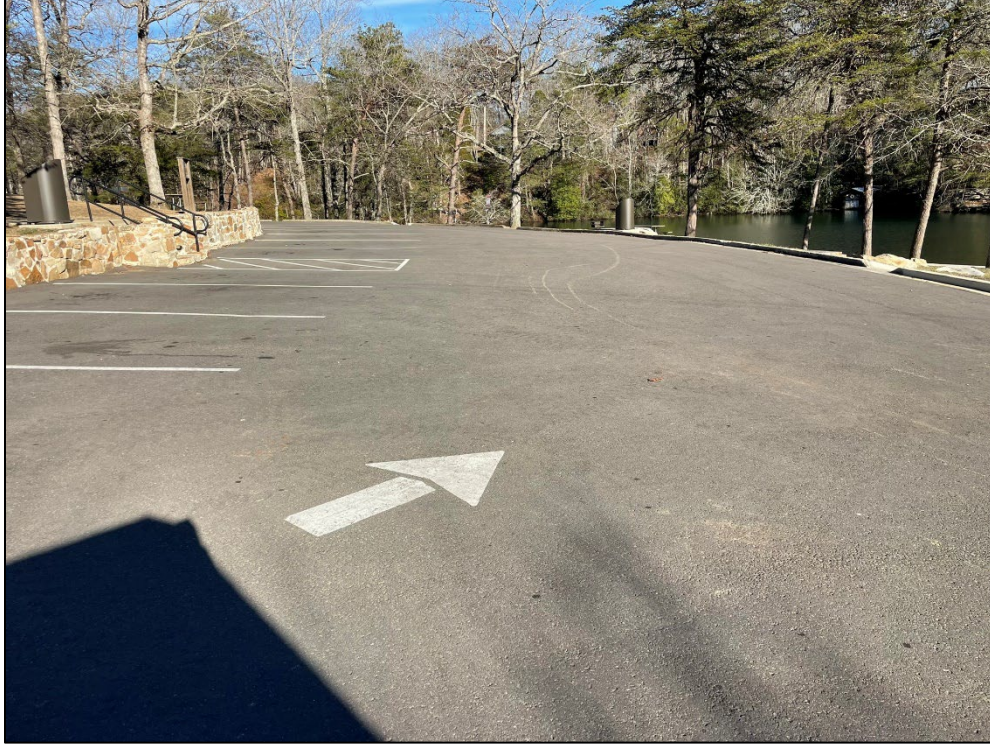
**Figure 3 Pavement Example at Desoto Falls Site in 2024**

A manual survey was conducted, and there was no cracking or rutting visible. The pavement looked to be performing well. Figure 9 shows an example of the pavement at the time of the 2024 visits. The texture results are shown in Table 5. Although the section on the right side shows higher texture, the results are still within normal ranges observed for dense-grade mixes.
