# AT&T BIRMINGHAM REGIONAL DATA CENTER

## REMEDIATION PLAN

AT&T BIRMINGHAM REGIONAL DATA CENTER  
1876 DATA DRIVE  
BIRMINGHAM, JEFFERSON COUNTY, ALABAMA  
FACILITY I.D. 14462-073-012031  
AST INCIDENT NO. AST 25-12-01

PROJECT NO.: US-EI-0041468.2272  
DATE: JUNE 26, 2025

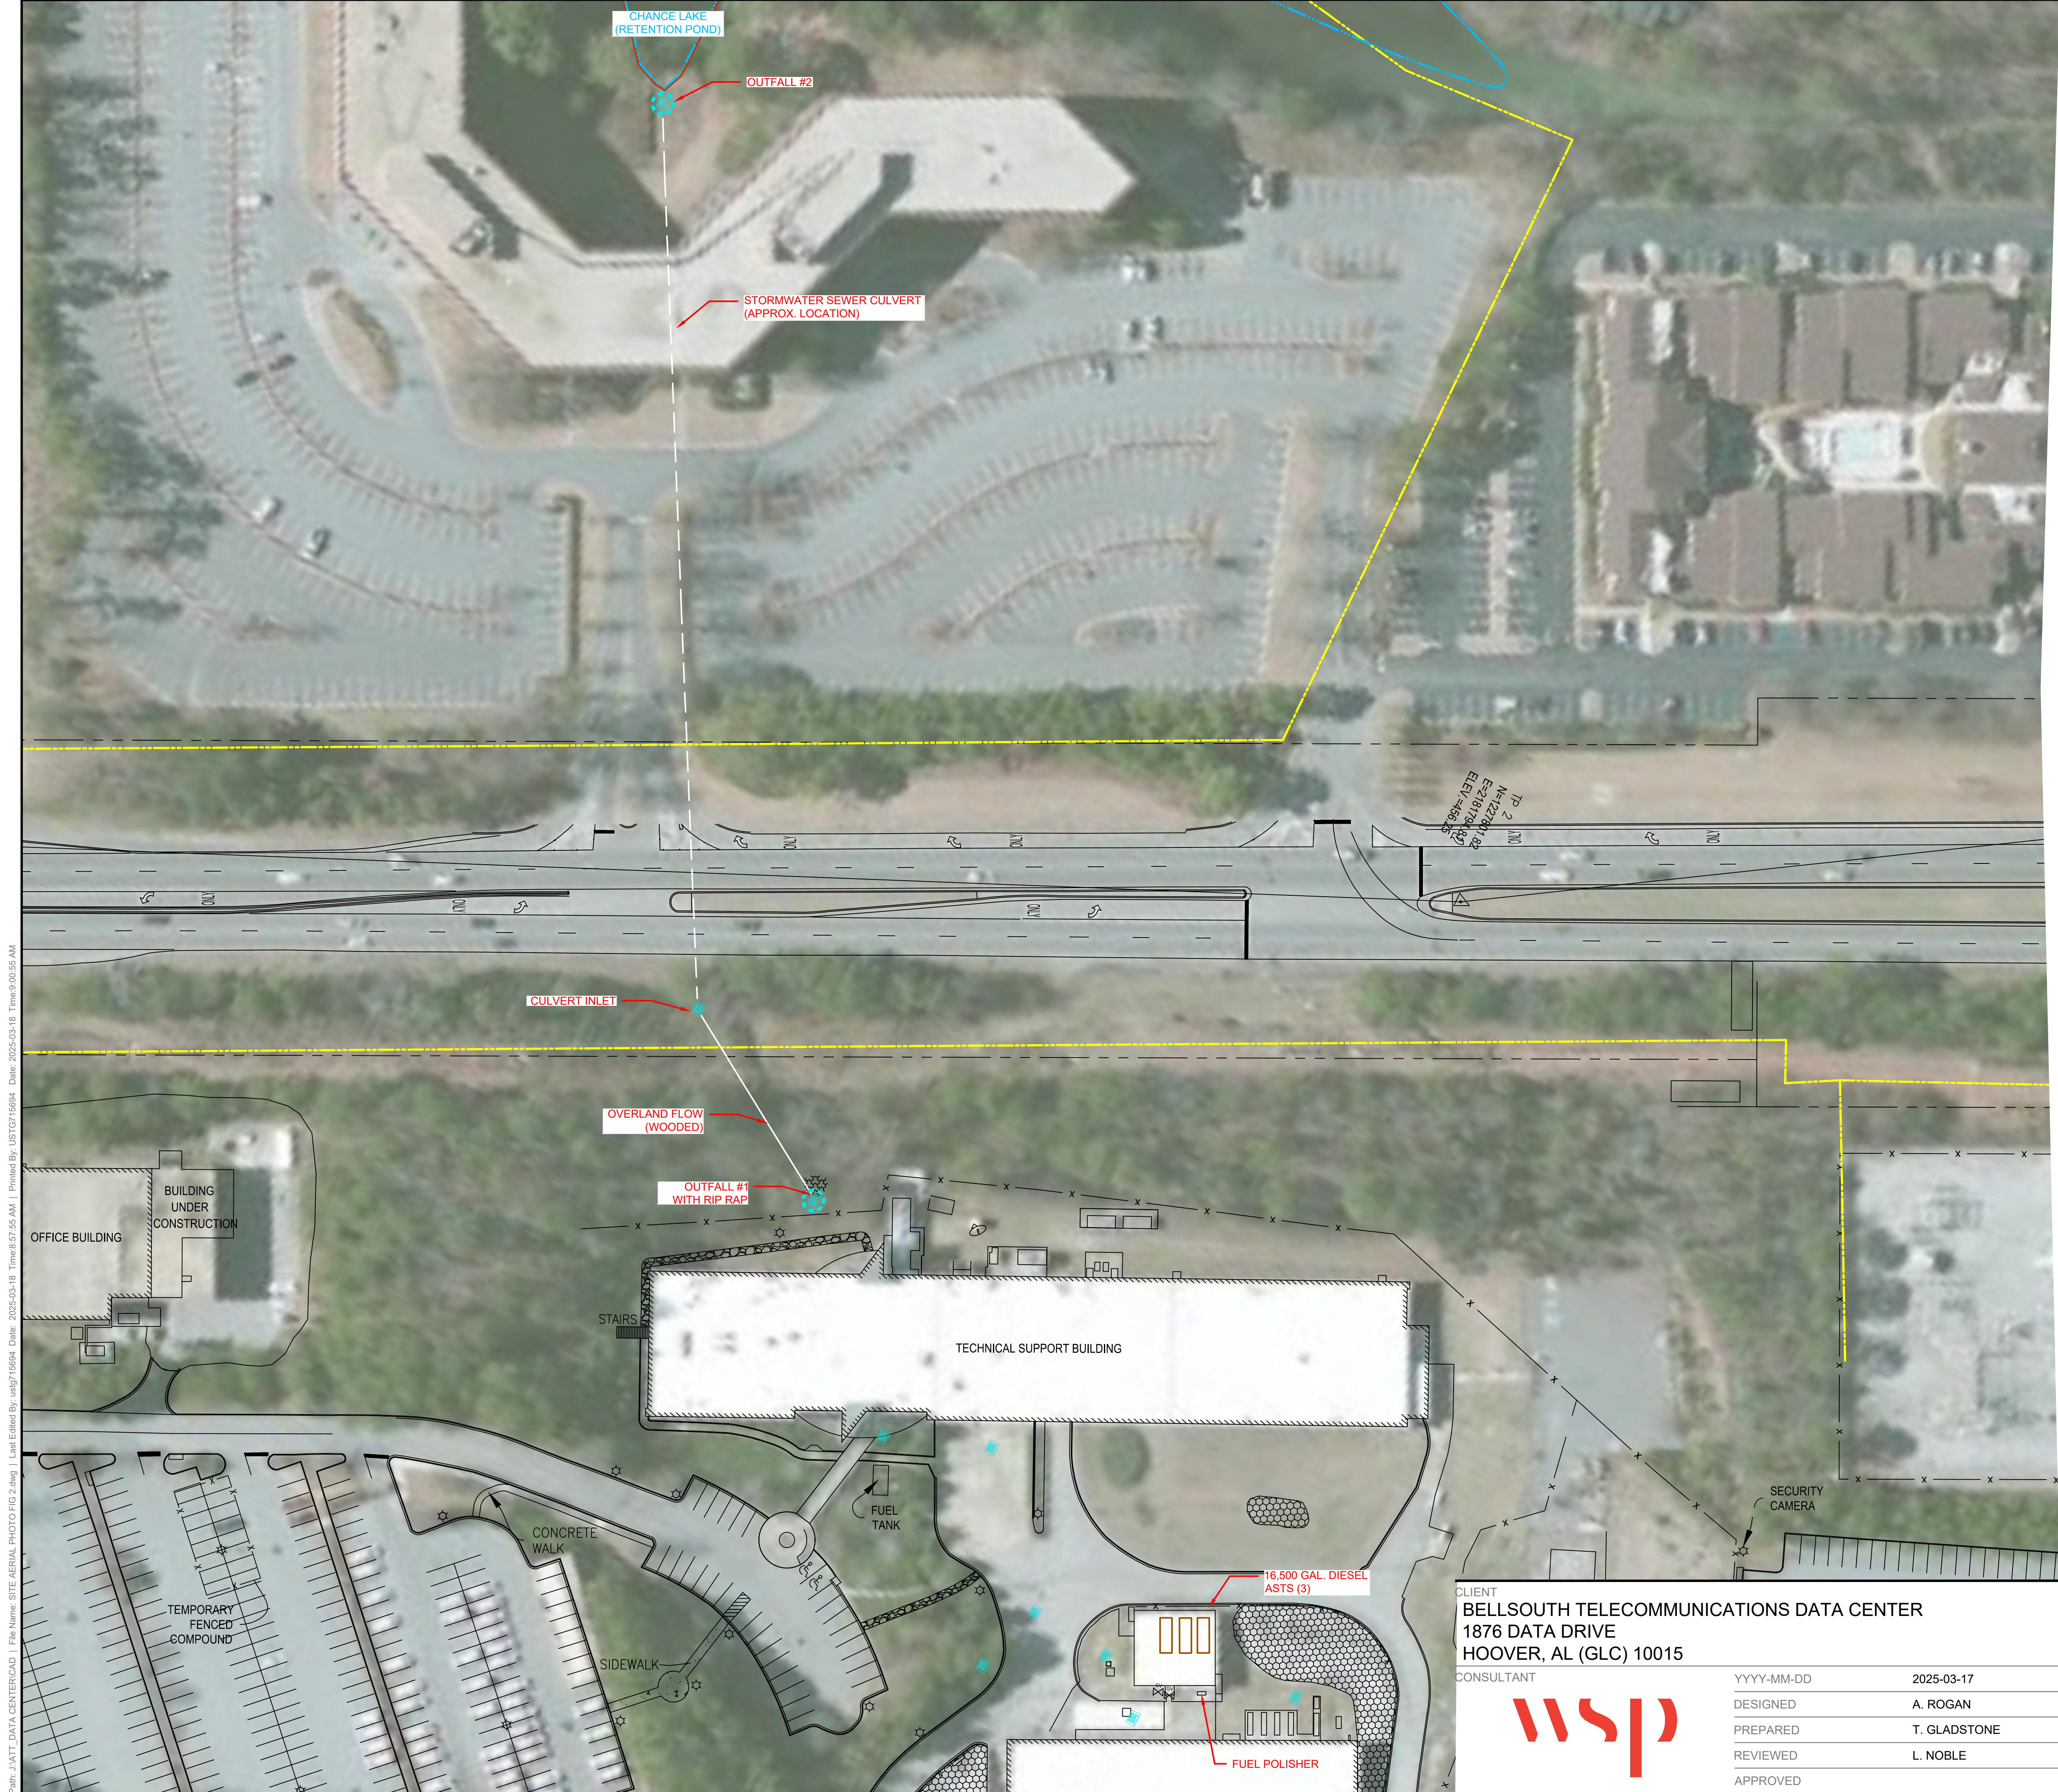
PROJECT NO. US0041468.2272	PHASE	REV. 0	FIGURE NO. 2
-------------------------------	-------	-----------	-----------------

SOIL IMPACTS WITH DIESEL

TITLE  
**SITE AERIAL PHOTOGRAPH**

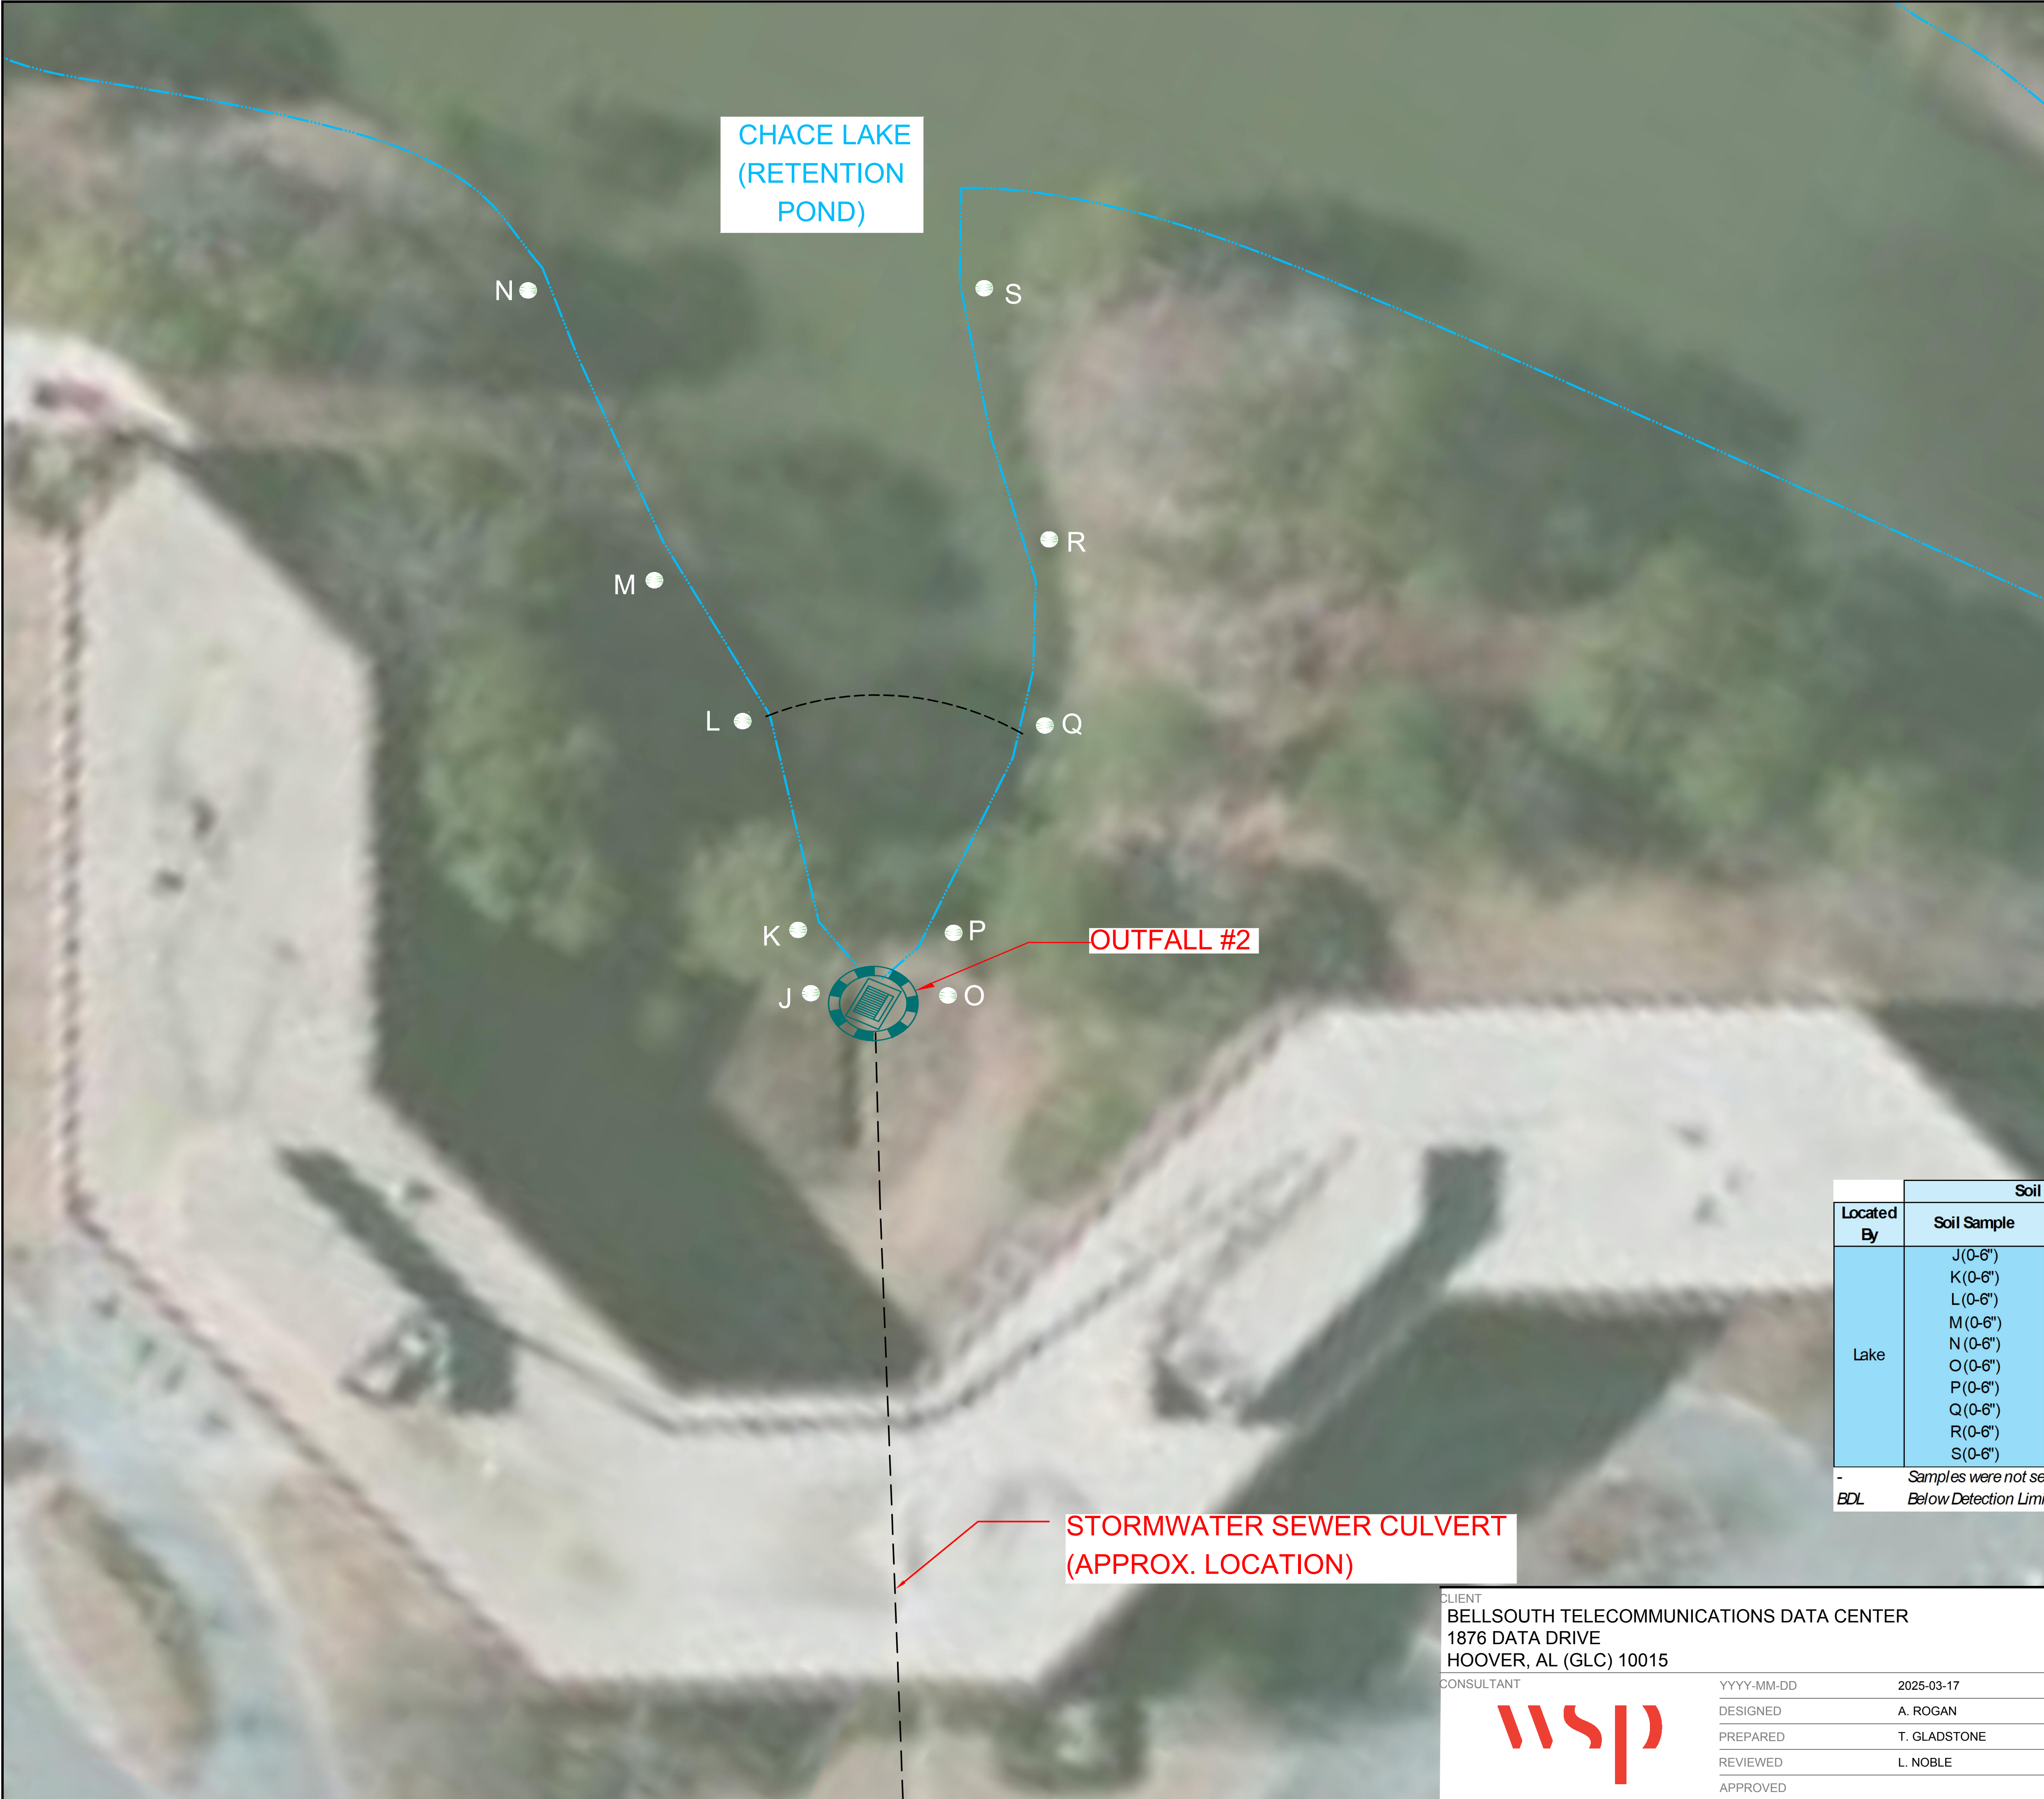
PROJECT NO. US0041468.2272	PHASE	REV. 0	FIGURE NO. 5
-------------------------------	-------	-----------	-----------------

Soil Screening Results and Laboratory Analytical Summary (ppm) - March 7, 2025								
Located By	Soil Sample	PID Screening Level (in the field)	TPH	Benzene	Toluene	Ethylbenzene	Xylenes	Naphthalene
Lake	J (0-6")	33.3	-	-	-	-	-	-
	K (0-6")	15.7	69	-	-	-	-	-
	L (0-6")	4.9	-	-	-	-	-	-
	M (0-6")	4.2	-	-	-	-	-	-
	N (0-6")	3.2	-	-	-	-	-	-
	O (0-6")	35.5	519	BDL	BDL	BDL	BDL	0.027
	P (0-6")	5.4	-	-	-	-	-	-
	Q (0-6")	8.9	-	-	-	-	-	-
	R (0-6")	3.4	30	-	-	-	-	-
	S (0-6")	2.5	-	-	-	-	-	-

Red results indicate a concentration above 100 ppm on the PID or above the TPH action level

TITLE  
SOIL SAMPLE LOCATION MAP  
LAKE OUTFALL AREA

Soil/sediment samples collected along a ditch at the outfall of the storm drain line, and along the edges of the inlet of Chace Lake where it was originally impacted by the release were also field screened, and analyzed for TPH DRO, with selected samples further analyzed for BETX and naphthalene.

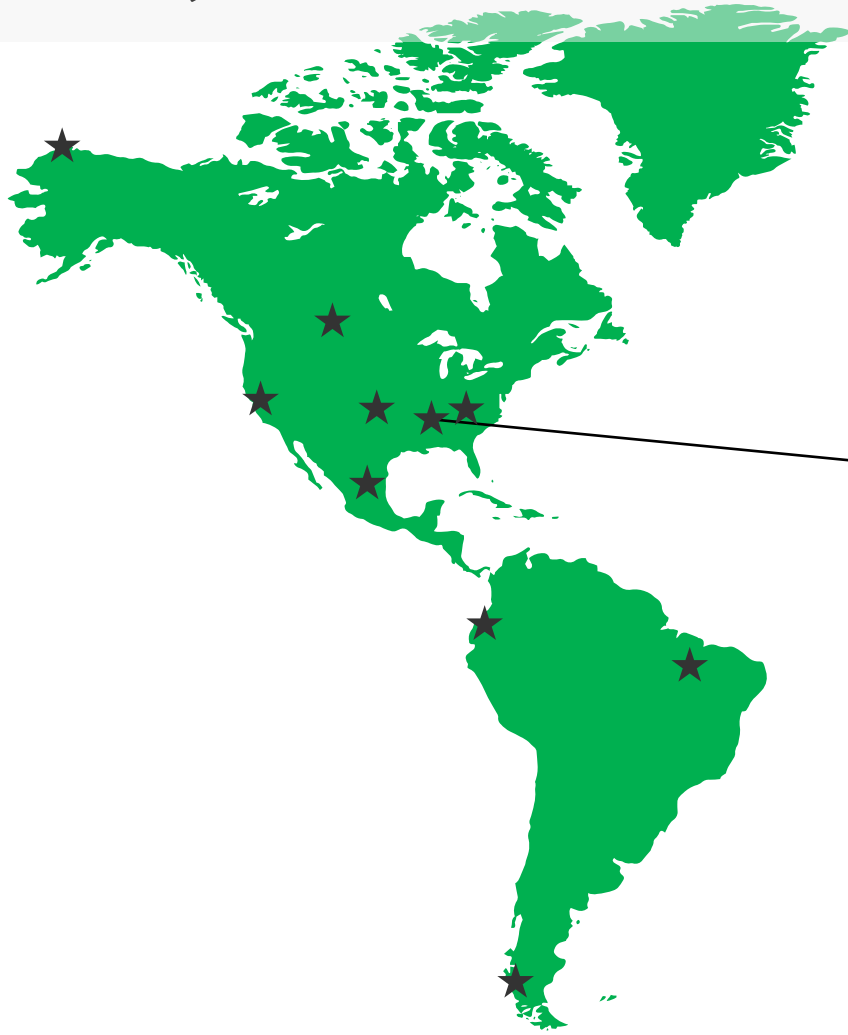
# Alabama, USA

## Project Background

Fuel Polisher Cabinet leaked and released into the local drains flowing under the roadway and out into a pond across the roadway.

## Scale & Scope

Bacteria treatments are recommended for the impacted areas and post excavation zone prior to backfill.

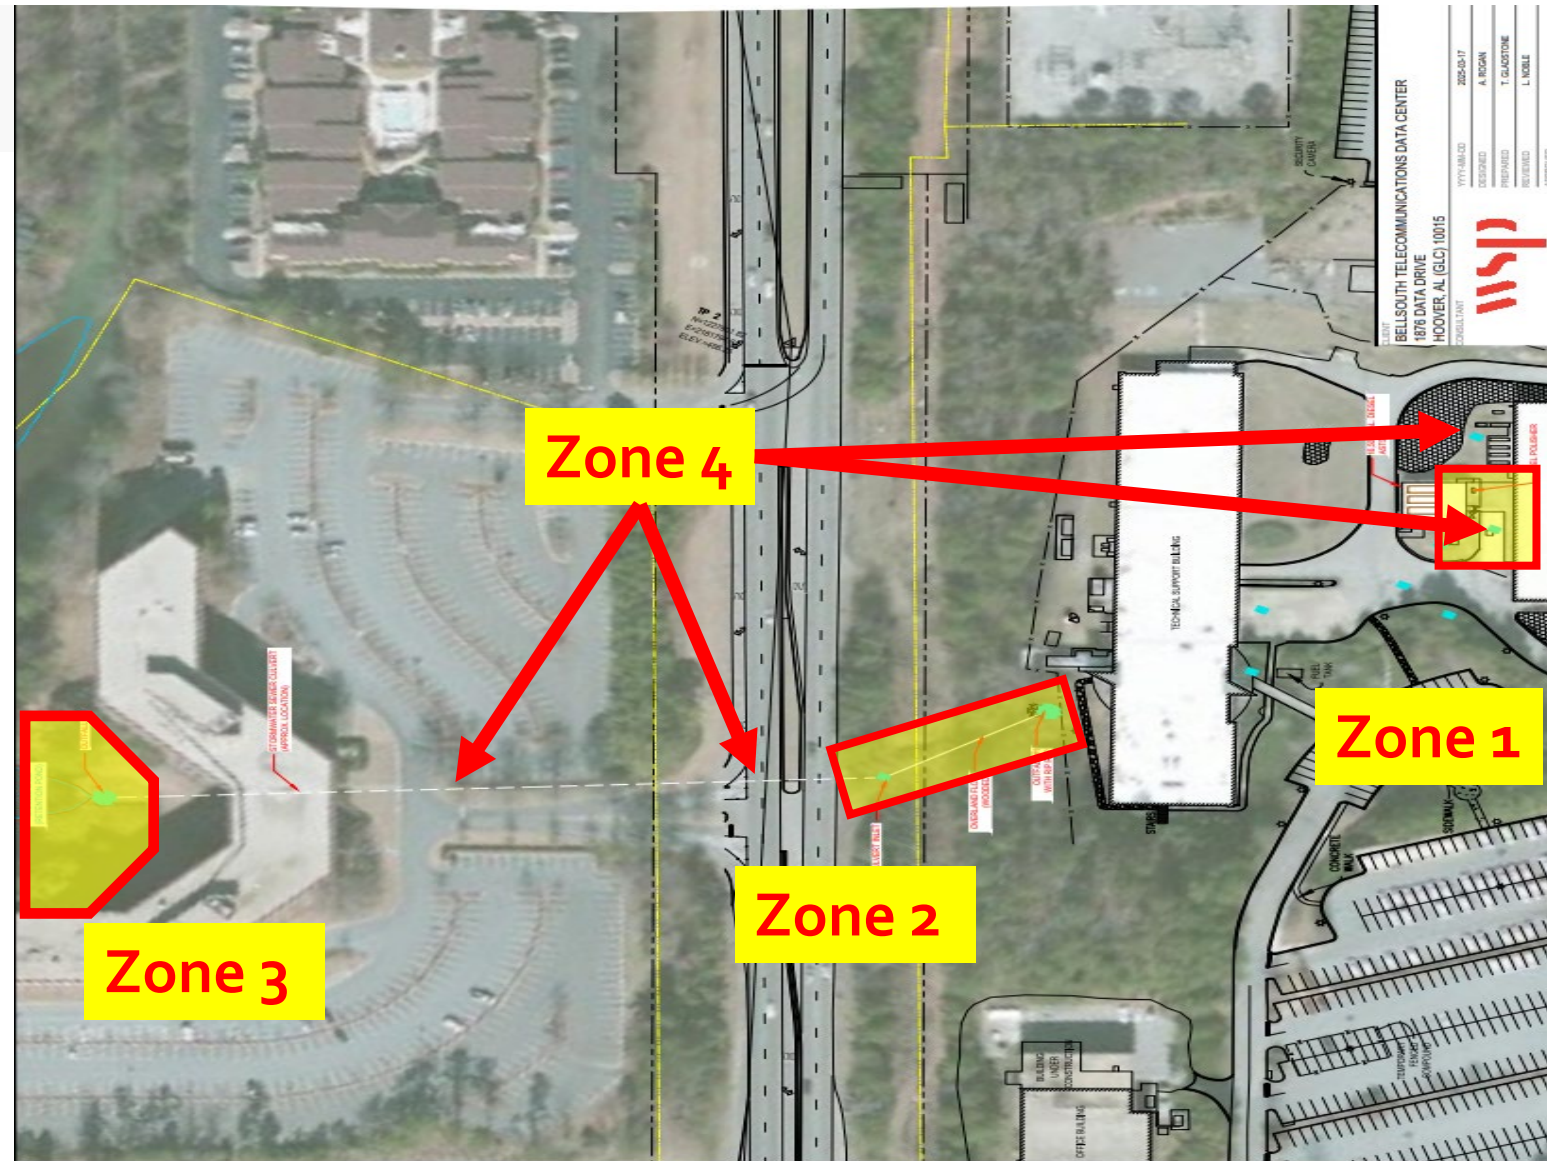
- » Our treatment recommendation consists of four zones.
- » Zone 1: Fuel Polisher Pad
- » Zone 2: 150' run between TSB & Hwy 31
- » Zone 3: 200'-400' Run along shoreline
- » Zone 4: Flush of drains with Bacteria

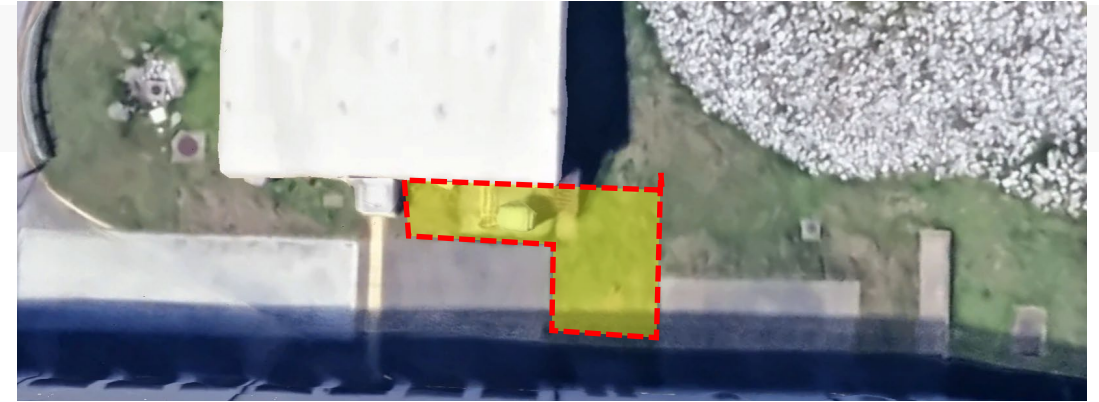
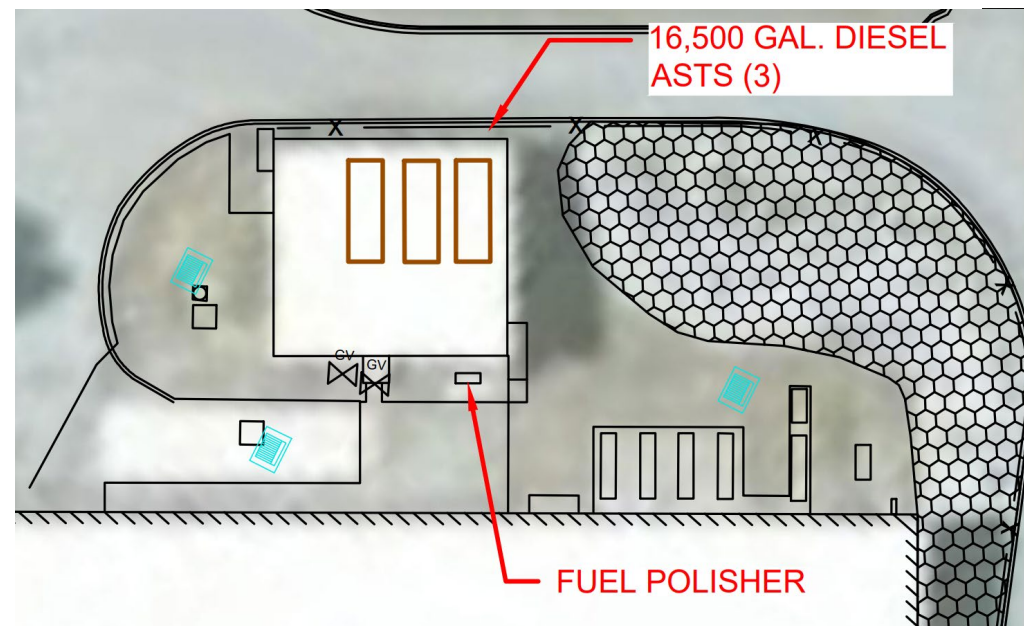
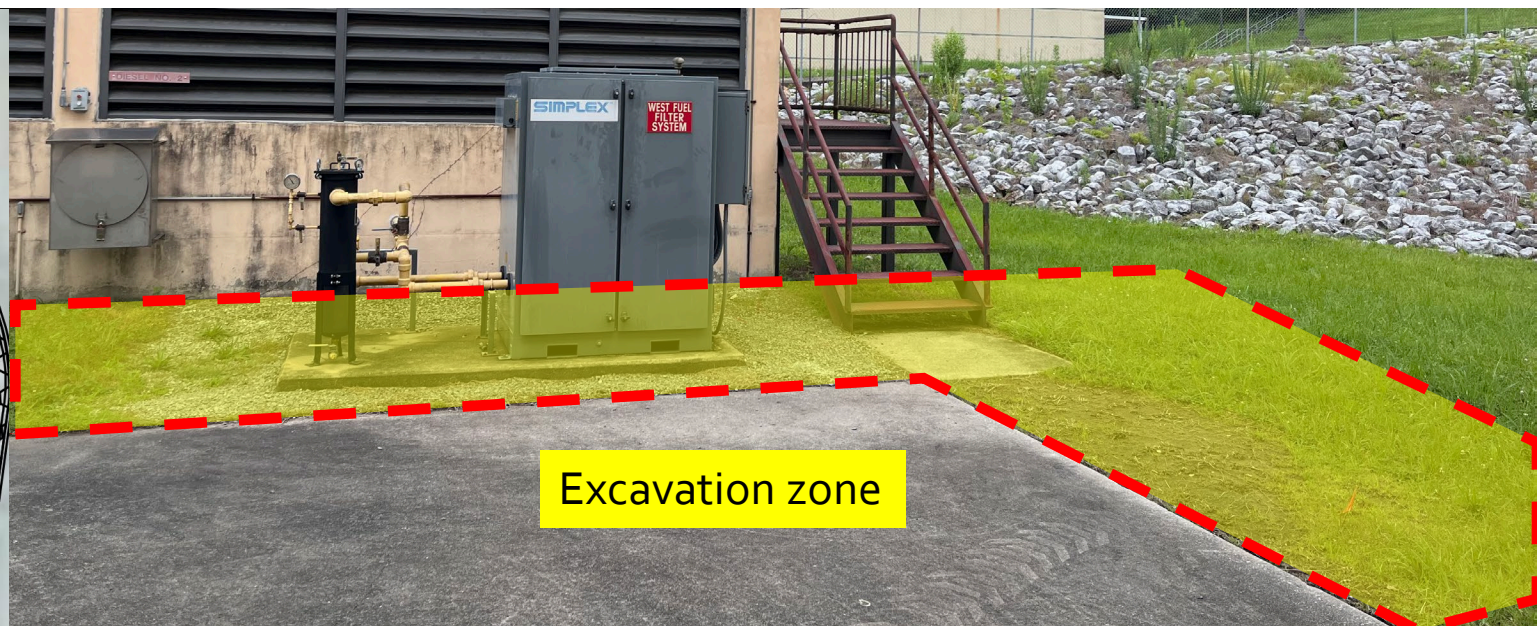
# Zone 1 – Treatment Recommendation

- » Bacteria: 20 Gallons      » Nutrient: 1.7 Gallons      » Water: 80 Gallons

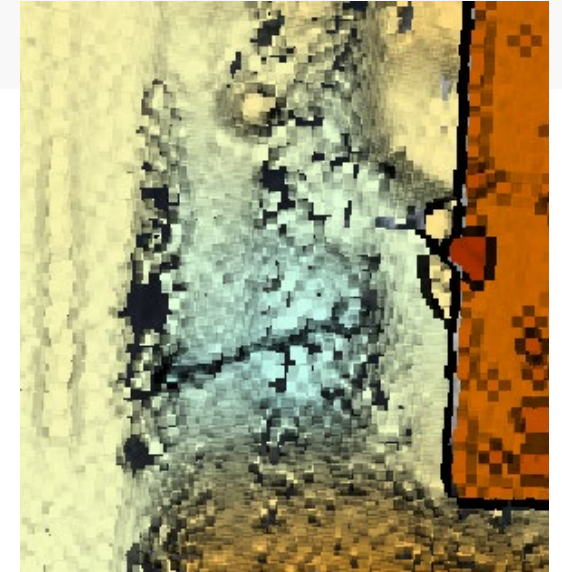
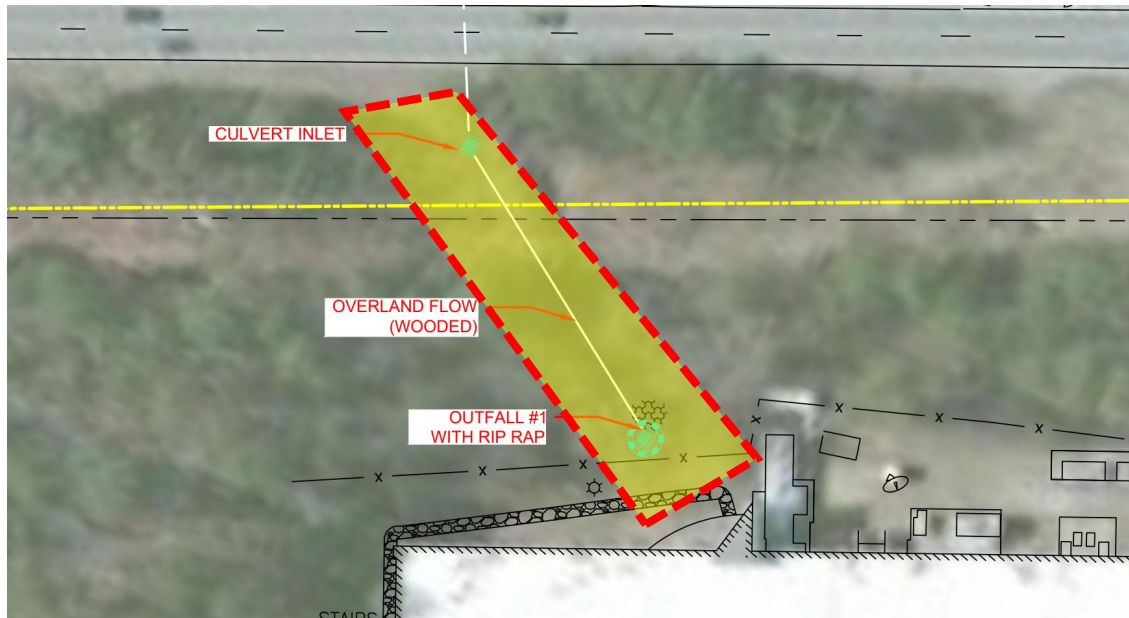
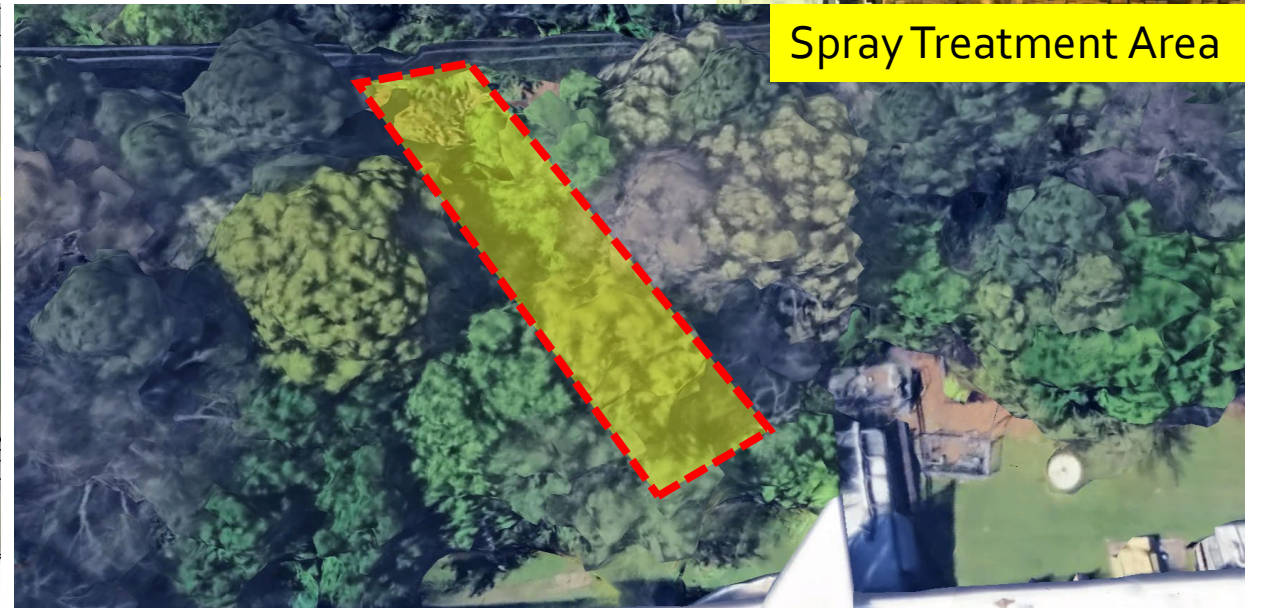
## Zone 2 – Treatment Recommendation

- » Bacteria: 31.25 Gallons      » Nutrient: 2.7 Gallons      » Water: 123 Gallons

Spray Treatment Area

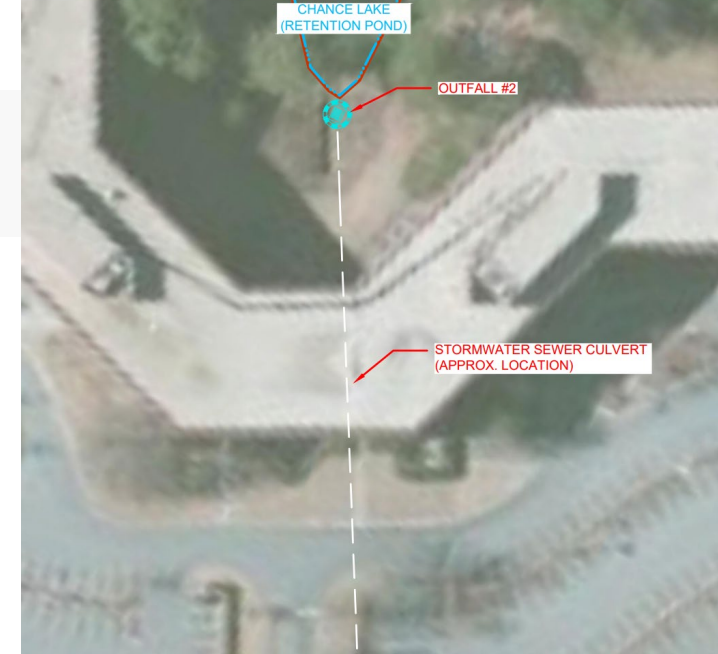
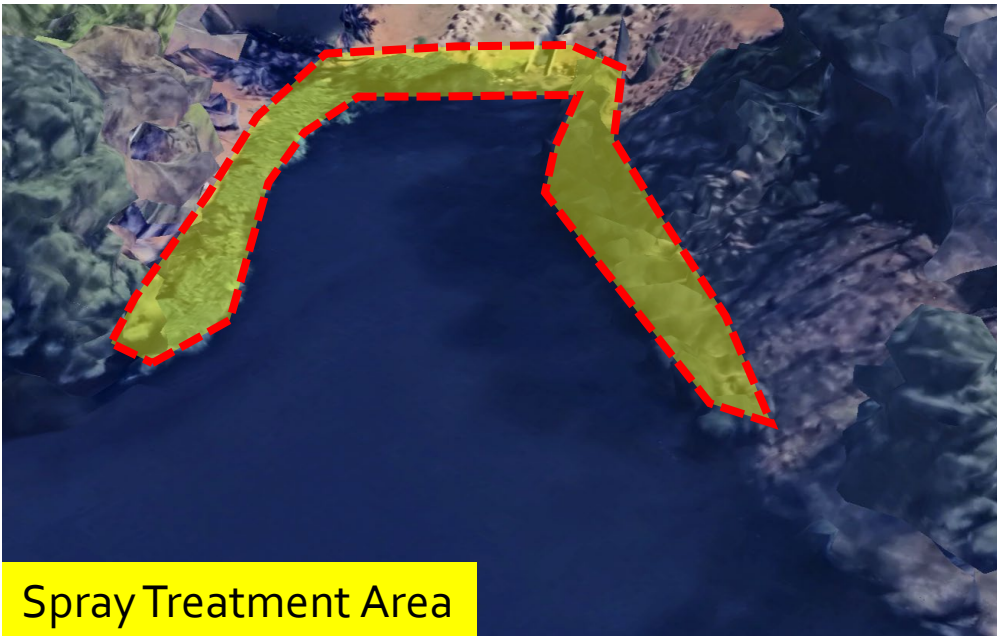
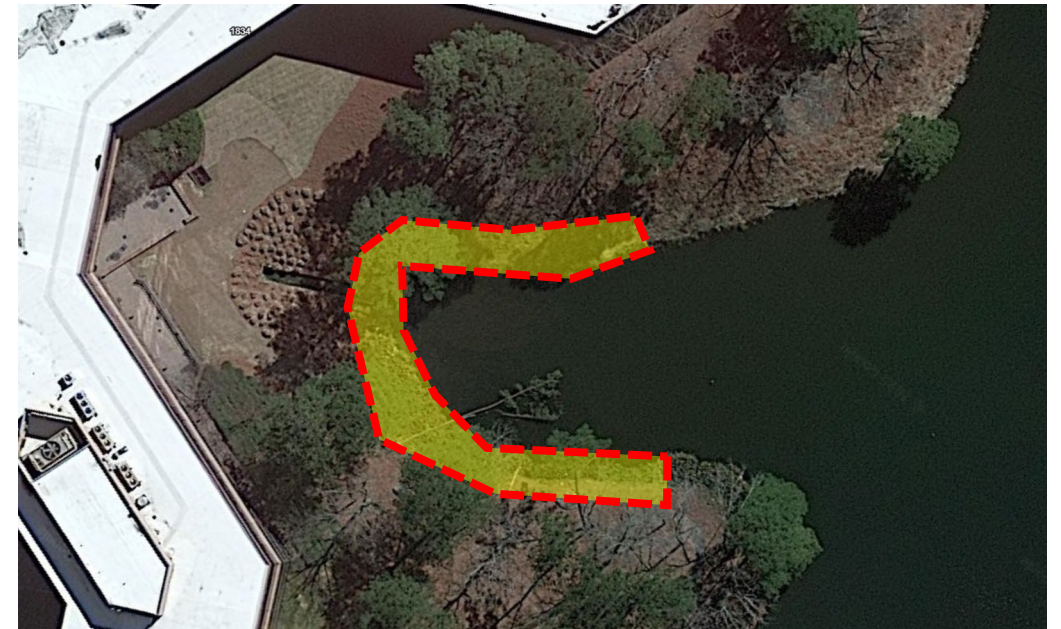
## Zone 3 – Treatment Recommendation

- » Bacteria: 41.563 Gallons    » Nutrient: 3.6 Gallons    » Water: 163 Gallons

Spray Treatment Area

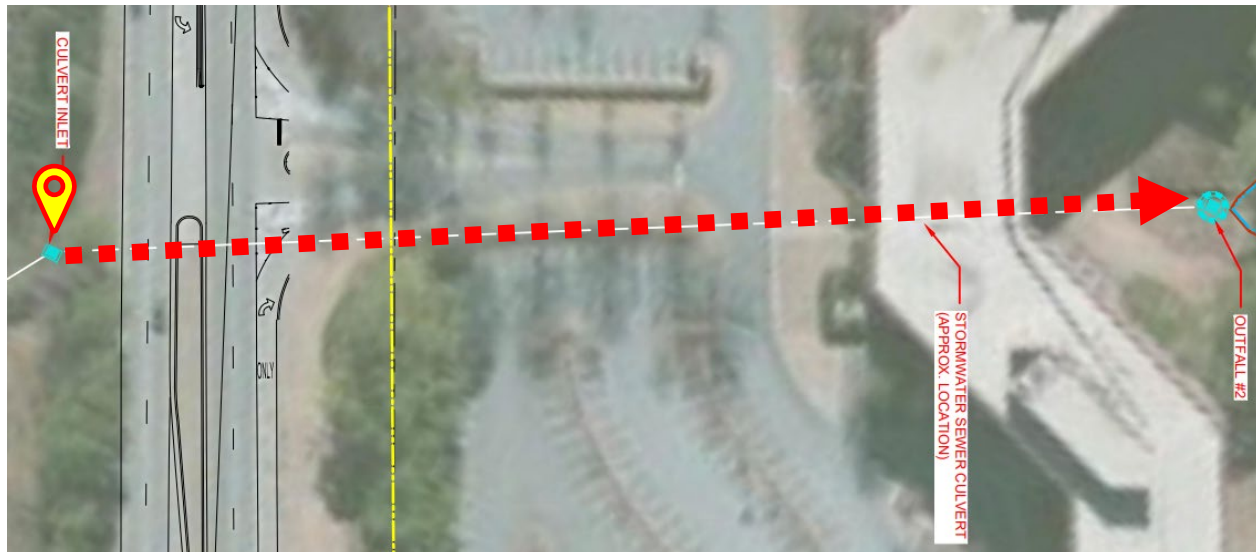
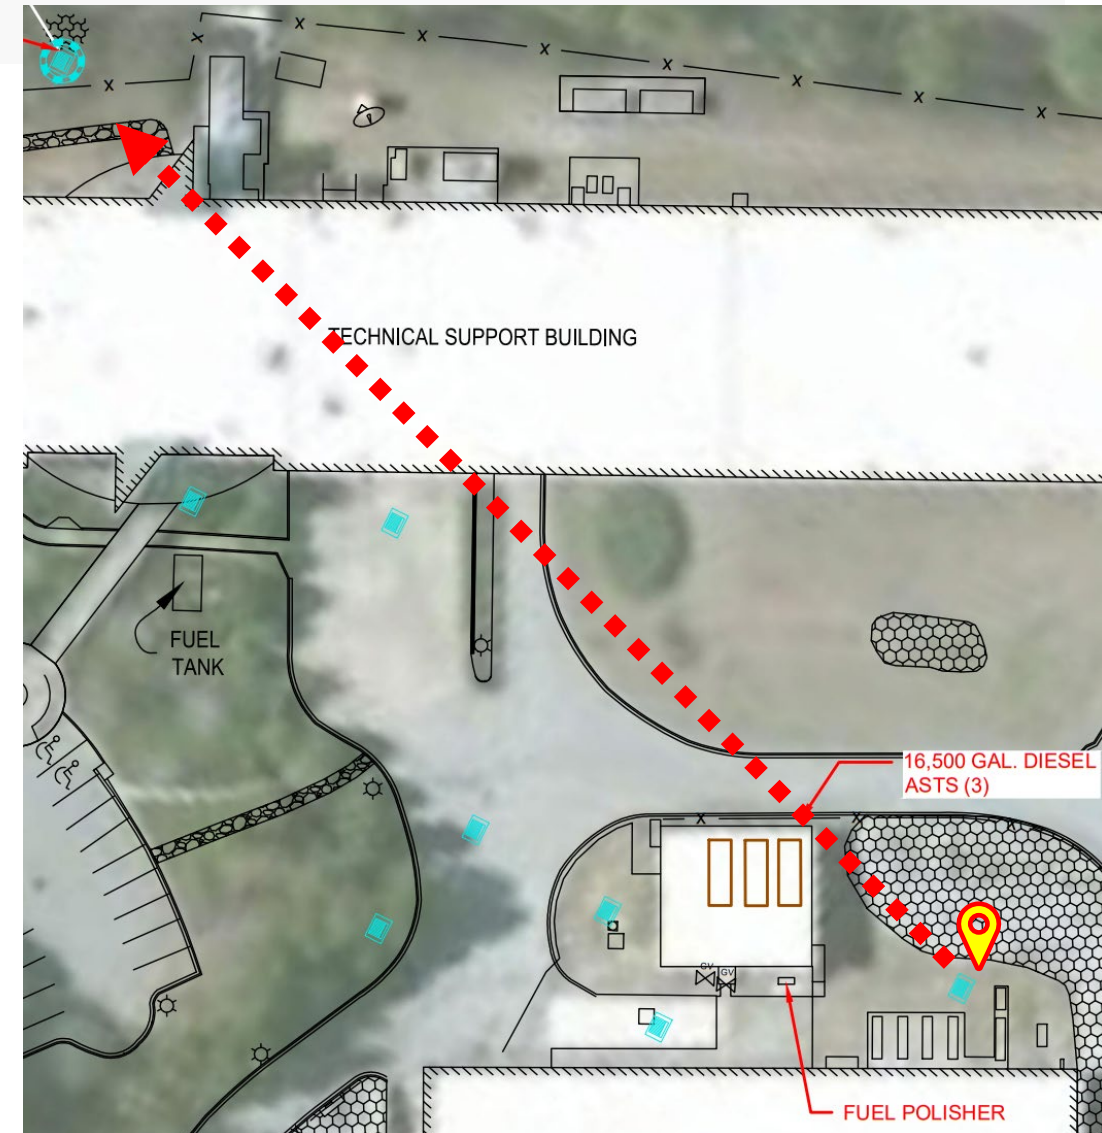
## Zone 4 – Treatment Recommendation

- » Bacteria: 17.19 Gallons
- » Water: 163 Gallons

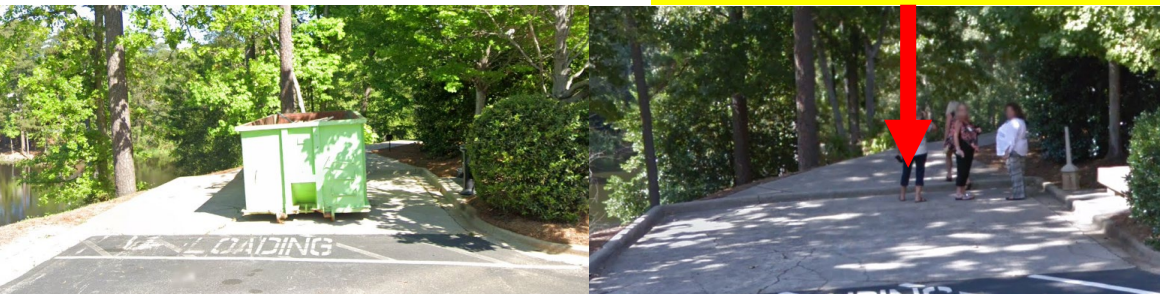
Potential Vehicle Access

- » Access to the back of the building may be limited due to the location of a temporary dumpster.
