## **Evaluation of a Rubber Modified Mixture Designed Using a Balanced Design in Lake Yahou Park**

### **Construction and Year 1 Field Evaluation**

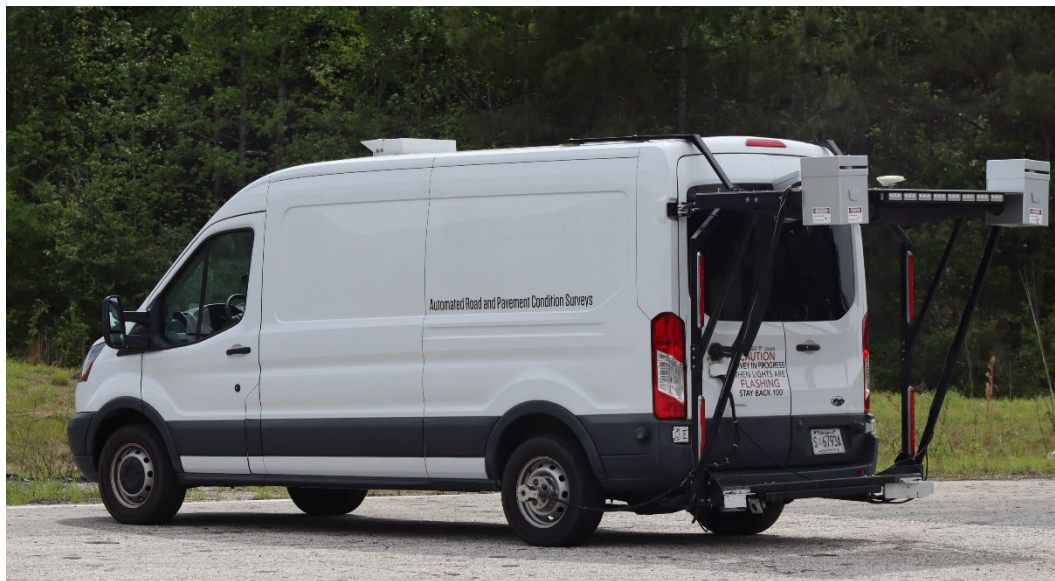
**Figure 2 NCAT's Automated Pavement Condition Survey Vehicle**

The first field performance evaluation was conducted in August of 2025. These sections were evaluated using NCAT's automated pavement condition survey vehicle, as shown in Figure 2. The purpose of this survey was to assess and compare the current pavement condition of the test

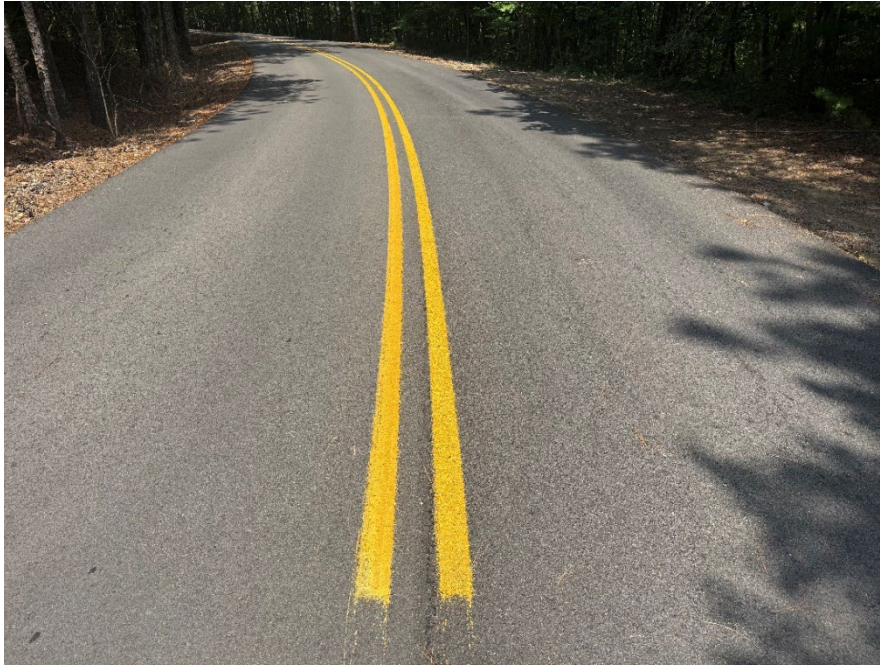
The average performance data for IRI and texture are shown in Figure 3. There was no measurable rutting in either section, and both mixes had similar IRI and macrotexture values.

**Figure 3 Example of Both Mixes at One-Year Inspection (GTR on Left, Control on Right)**

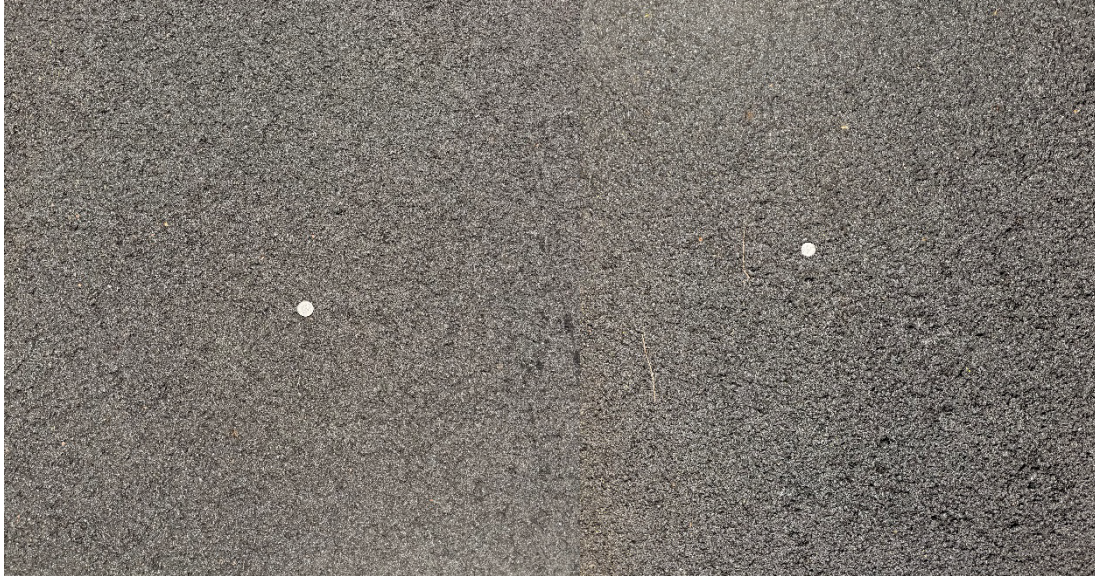
Potential cracking was detected and classified using Pathway Service's software AutoCrack and AutoClass, which classifies cracking by type. At the time of the one-year inspection, the Pathway system did not detect any discernible cracking in the mix sections. Figure 4 shows an example of the surface texture of the mixes. Both mixes were found to be performing well at the time of the one-year inspection.

**Figure 4 Example of Surface Texture at One-Year (GTR on left, Control on right)**
