November 2025

Evaluation of a Rubber Modified Mixture Designed Using a Balanced Design in Lake Guntersville State Park and De Soto State Park

Year 3 Field Evaluation

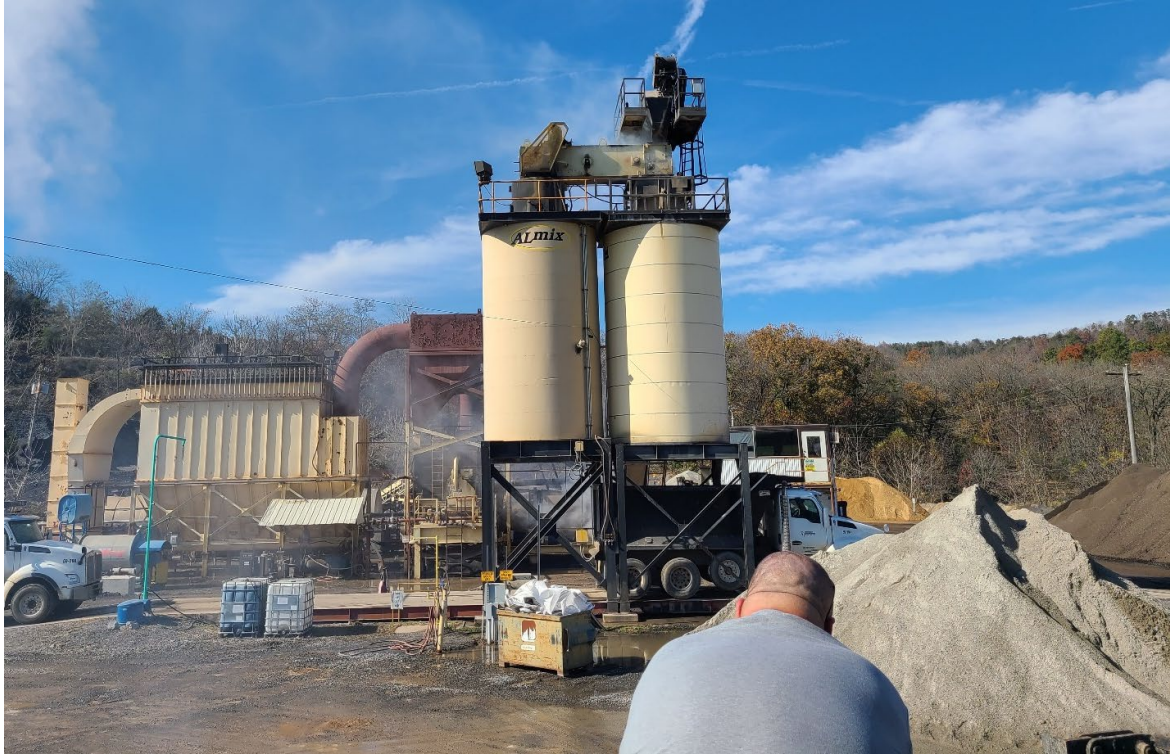
Figure 1. WCC Plant near Guntersville, AL

WCC placed this mix in Guntersville State Park in November 2021. An NCAT representative was onsite on November 11, 2021, to observe operations and to sample the mix for further testing at NCAT. Figures 1-2 contain pictures of the plant and the paving site. The existing surface mix was in poor condition and was milled. The existing surface in the lane adjacent to the paving lane in Figure 2.

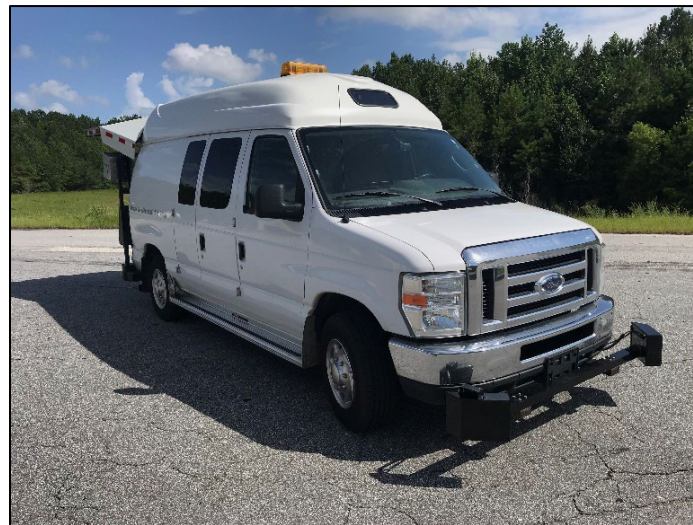
Figure 4. Data Collection Vehicle

This evaluation will be conducted using an automated pavement condition survey vehicle. The data collection vehicle used by NCAT is a fully automated PathRunner vehicle. The van is a class 1 inertial profiler with a 3D automated crack and rutting detection system. The van includes an on-board laser package that measures smoothness in terms of International Roughness Index (IRI), rutting, and macrotexture in terms of mean profile depth (MPD), in addition to front-facing super HD cameras, GPS, and 3D automated crack detection software providing a comprehensive pavement evaluation. The first and second field evaluations were conducted in February 2023 and February 2024. The results of the evaluations are summarized in the next section.

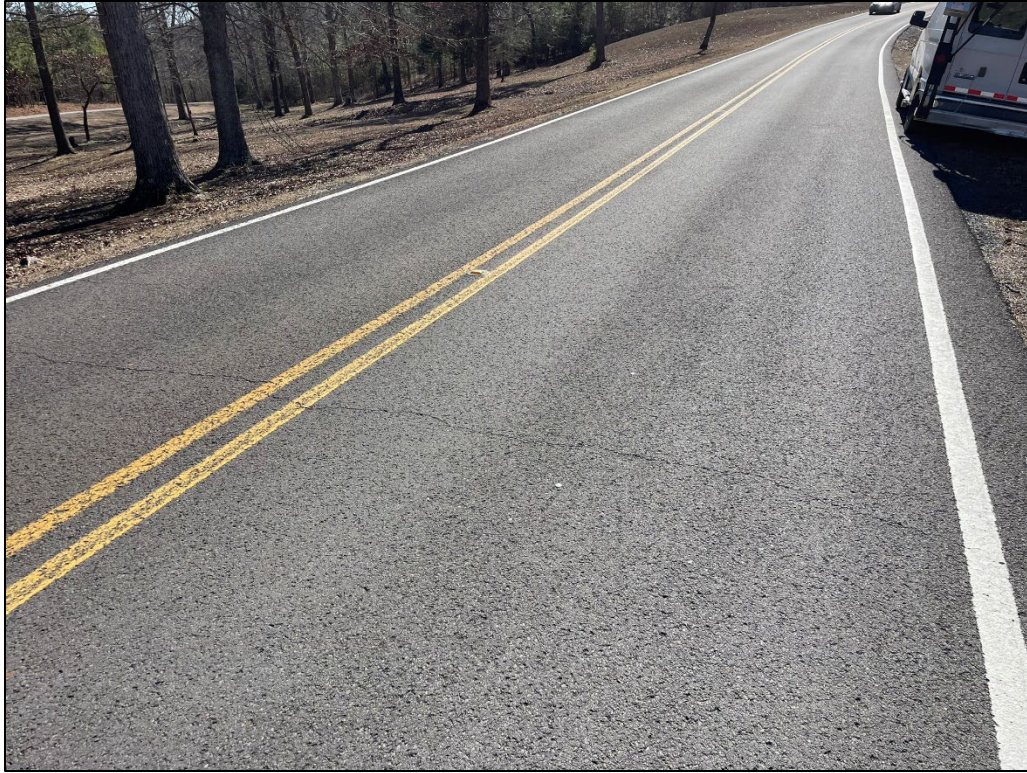
Figure 5. Example of Cracking Observed at the 2024 Survey

The pavement surface appeared to be performing well, with no distresses visible to the survey vehicle at the time of the 2023 survey. At the time of the 2024 survey, minimal cracking was detected, with a total cracking rate of less than 0.5% by lane area for all areas. At the 2025 survey, cracking had increased slightly to an average of 1% of the total lane area. Figure 5 shows an example of the transverse cracking observed at the time of the 2024 survey, and Figure 6 shows an example at the 2025 survey.

At this point, it is concluded that the sites are still performing well, but minimal cracking has been observed in both sites. The year 4 visit scheduled for February 2026 will closely monitor the status of these cracks.

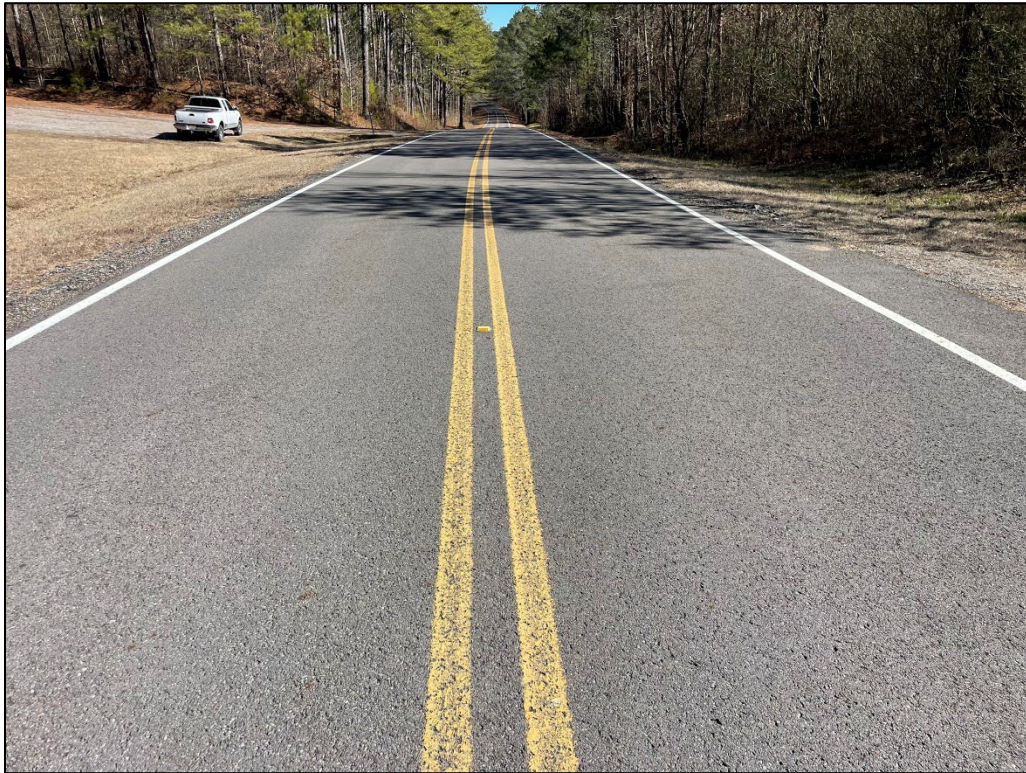
Figure 7. Pavement Overview during 2024 Survey of Guntersville Site

There was no measurable rutting at the time of any survey. The average performance data for IRI and texture are shown in Table 4. This data shows there is little change in terms of ride quality and texture as of 2025. Figure 7 shows an overview of the pavement in 2024, and Figure 8 shows an overview in 2025. Figure 9 shows an example of the pavement texture at the time of the 2024 visit, and Figure 10 shows the pavement texture in 2025.

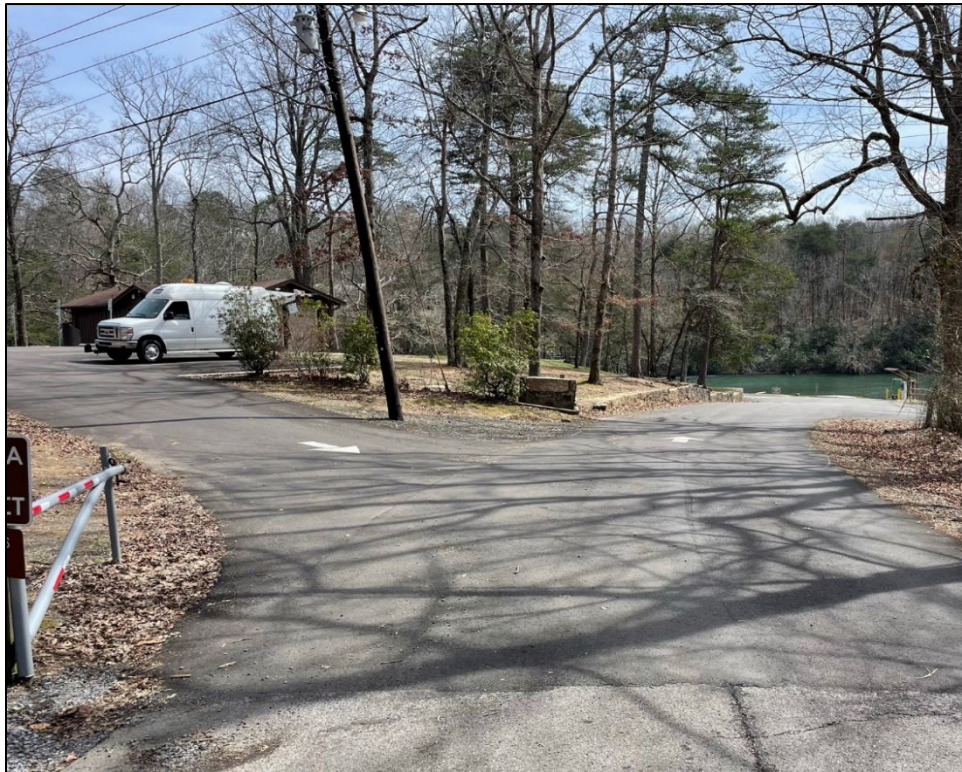
Figure 12. Site Overview at Desoto Falls Site

Another ground tire rubber (GTR) asphalt mix was placed in Desoto State Park in 2021. This site is a parking lot/circular drive for Desoto Falls, as shown in Figure 11 and Figure 12. Field surveys were conducted each year beginning in 2023. NCAT's high-speed data collection vehicle was unable to travel at speed due to the geometry of the parking lot. Therefore, IRI could not be accurately measured.

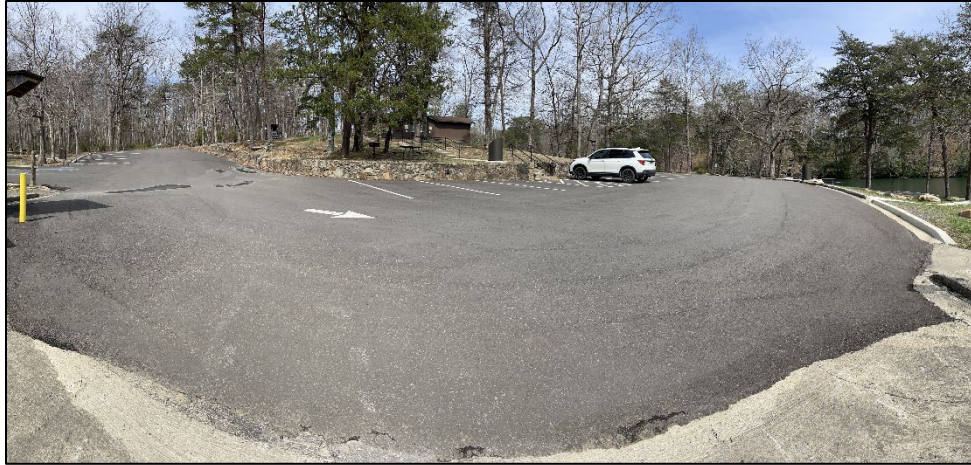
Figure 13. Pavement Example at Desoto Falls Site in 2023

A manual survey was conducted each year, and there was no cracking or rutting visible in 2023 or 2024. Figure 13, Figure 14, and Figure 15 show examples of the pavement at the time of the 2023, 2024, and 2025 visits, respectively. In 2025, there were two areas where cracking was observed, as shown in Figure 16 and Figure 17. There were some roller marks noted coming up the hill, as shown in Figure 18. The texture results shown in Table 5 are relatively stable and are still within normal ranges observed for dense-graded mixtures.
