# 2019 Monitoring Summary

## Ecological Reference Reach

Butler Creek at Lauderdale County Road 302 (34.97376/-87.61127)

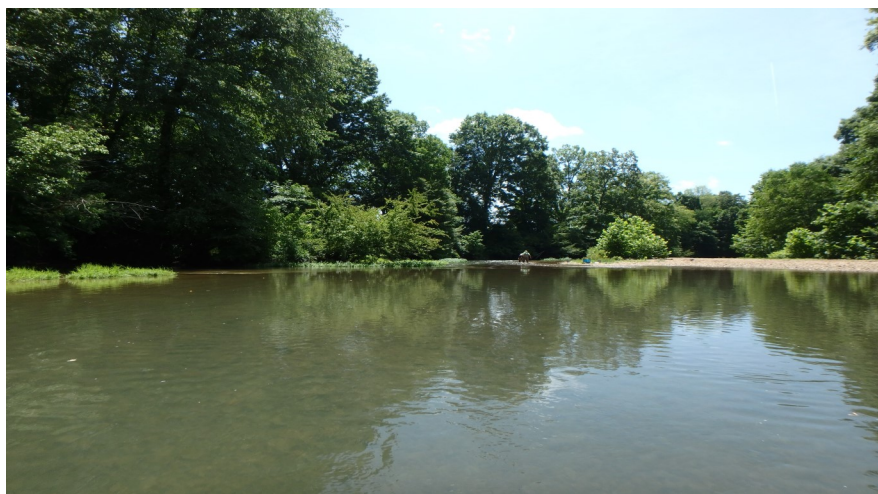
Figure 1. Butler Creek at BTLL-1, June 26, 2019.

General observations (Figure 1, Table 2) and a habitat survey (Table 3) were completed during the macroinvertebrate assessment. In comparison with reference reaches in the same ecoregion, they give an indication of the physical condition of the site and the quality and availability of habitat. Like other streams in ecoregion 71f, Butler Creek at BTLL-1 is a medium-high gradient stream characterized predominantly by a bedrock, cobble and gravel substrates. Overall habitat quality was categorized as *sub-optimal* for supporting the biological communities in this stream type.
