# 2019 Monitoring Summary

## Ecological Reference Reach

### Little Butler Creek at Lauderdale County Road 299 (34.98961/-87.64323)

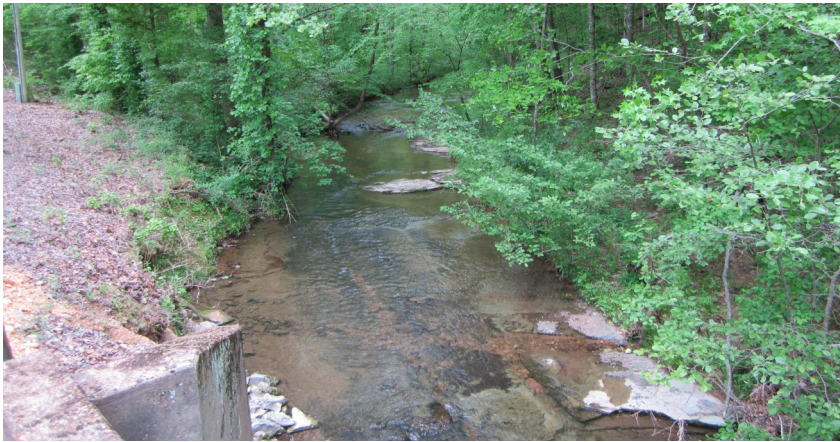
Figure 1. Little Butler Creek at LBTL-3, May 1, 2019.

General observations (Figure 1, Table 2) and a habitat survey (Table 3) were completed during the macroinvertebrate assessment. In comparison with reference reaches in the same ecoregion, they give an indication of the physical condition of the site and the quality and availability of habitat. Like other streams in ecoregion 71f, Little Butler Creek at LBTL-3 is a medium-high gradient stream characterized predominantly by a bedrock, boulder, cobble and gravel substrate. Overall habitat quality was categorized as *optimal* for supporting the biological communities in this stream type due to the availability and quality of habitat and minimal sediment deposition.
