# 2019 Monitoring Summary

## Ecological Reference Reach

### Unnamed tributary to Tallapoosa River at Punkin Hill Road (32.93171/-85.66638)

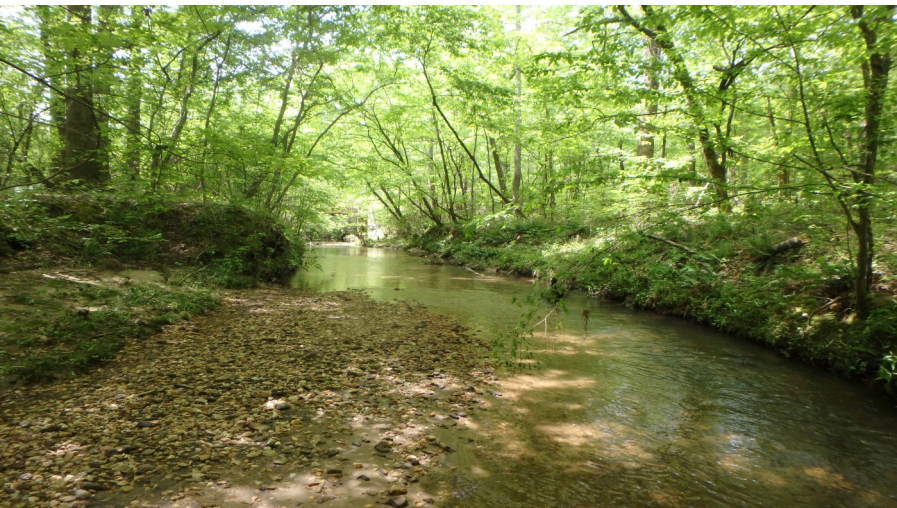
**Figure 1.** Unnamed tributary to Tallapoosa River at UCOT-2, April 23, 2019.

General observations (Figure 1, Table 2) and a habitat survey (Table 3) were completed during the macroinvertebrate assessment. In comparison with reference reaches in the same ecoregion, they give an indication of the physical condition of the site and the quality and availability of habitat. Like other streams in ecoregion 45b, The unnamed tributary to Tallapoosa River at UCOT-2 is a low to moderate gradient stream characterized predominantly by a gravel and sand substrate. Overall habitat quality and availability has been rated as *Sub-optimal* for supporting the macroinvertebrate communities due to a large riparian buffer and stable banks. However, there is a decrease in riffle frequency from slight sediment deposition.
