## **Evaluation of a Rubber Modified Mixture Designed Using a Balanced Design in Lake Yahou Park**

### **Year 2 Field Evaluation**

### **Project Objective**

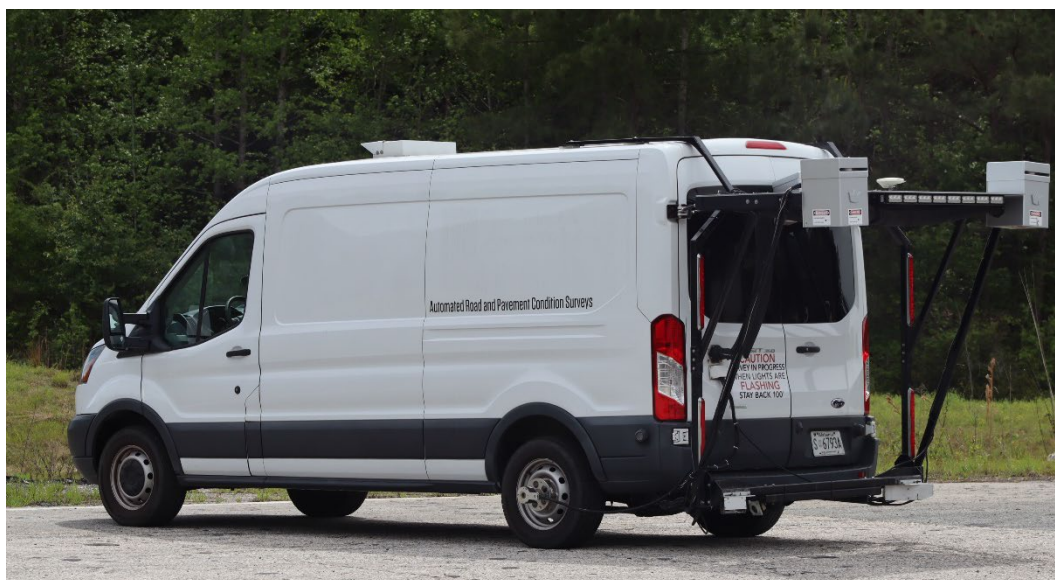
**Figure 2 NCAT’s Automated Pavement Condition Survey Vehicle**

The first field performance evaluation was conducted in August of 2025, and a second was conducted in August of 2026. These sections were evaluated using NCAT's automated pavement condition survey vehicle, as shown in Figure 2. The purpose of these surveys was to assess and compare the current pavement condition of the test sections in terms of IRI, rutting, texture, and cracking. Three data collection runs were made in each lane.

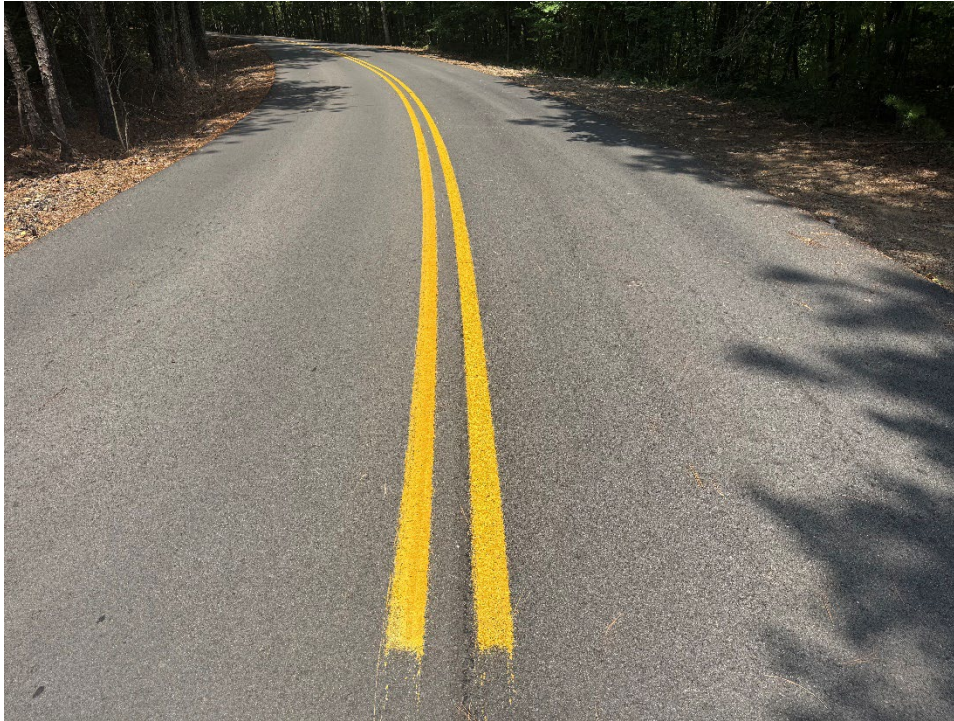
Potential cracking was detected and classified using Pathway Service’s software AutoCrack and AutoClass, which classifies cracking by type. At the two-year inspection, the Pathway system did not detect cracking in the mix sections. Figure 3 and Figure 4 show overviews of the two mixes at the time of each inspection. Figure 5 and Figure 6 show examples of the surface texture of the mixes at the time of each inspection. Both mixes were found to be performing well after two years in service.

**Figure 1 Example of Both Mixes at One-Year Inspection (Rubber on Left, Control on Right)**

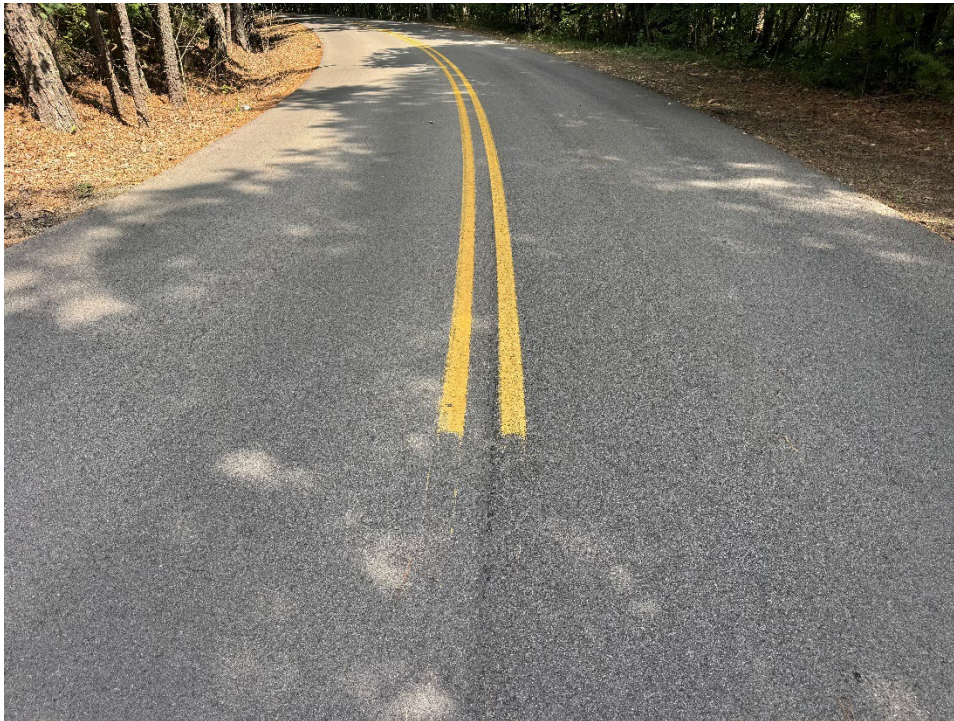
**Figure 2 Example of Both Mixes at Two-Year Inspection (Rubber on Left, Control on Right)**

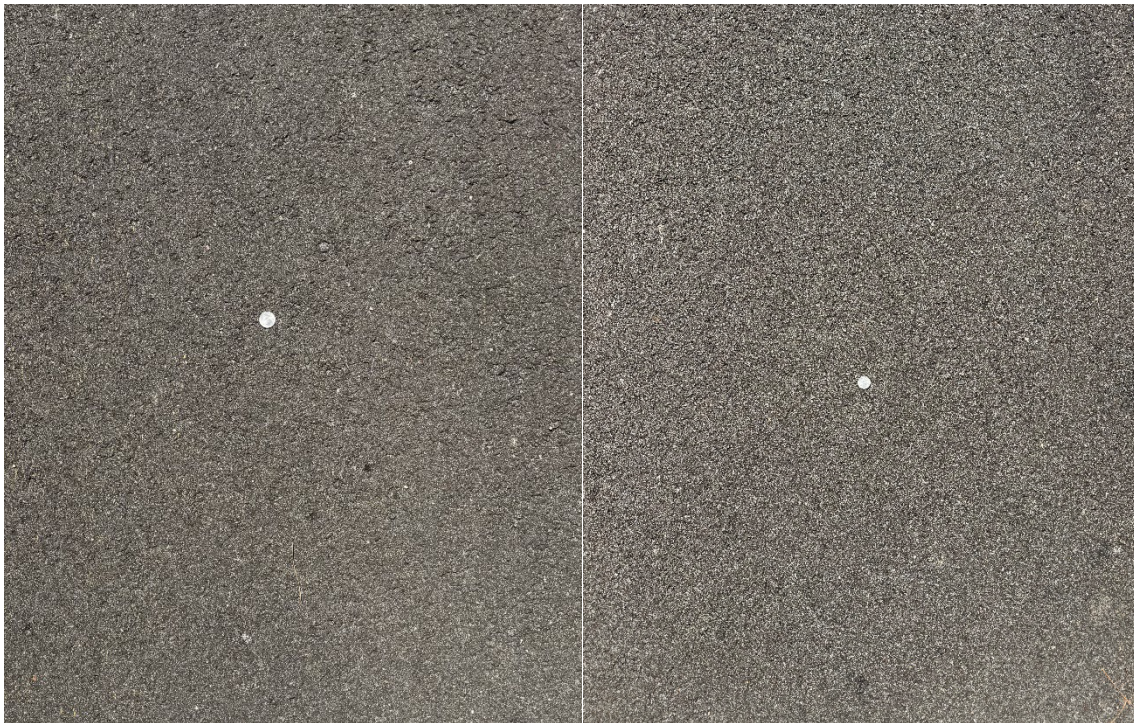
**Figure 4 Example of Surface Texture at Two-Years (Rubber on left, Control on right)**
