EVALUATION OF A RUBBER-MODIFIED MIXTURE DESIGNED USING A BALANCED DESIGN IN COFFEE COUNTY, ALABAMA

Year 3 Evaluation Report

Evaluation of a Rubber-Modified Mixture Designed Using a Balanced Design in Coffee County, Alabama

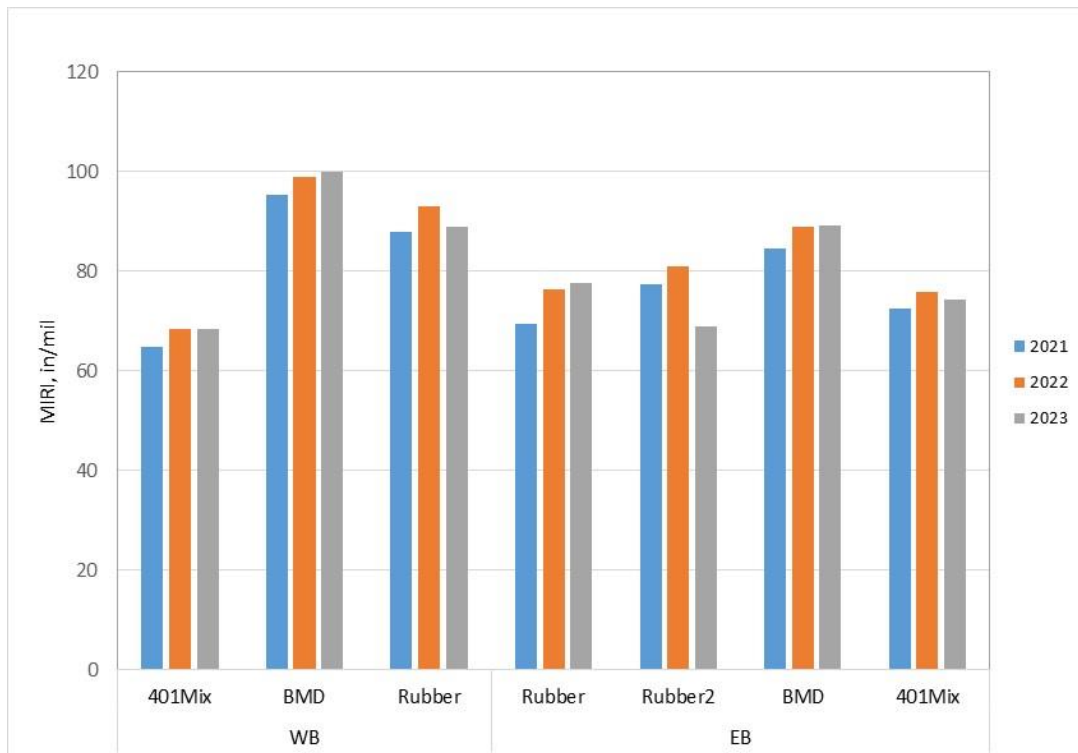
Figure 4 IRI Results

The average performance data for IRI, rutting, and texture measured after 1, 2, and 3 years of performance are shown in Figures 3-5. As presented in Figure 3, the rutting performance of all the sections after 3 years did not change significantly with rutting not exceeding 0.11 in. IRI of the sections was similar with the BMD-WB mix showing the highest value after 3 years of performance at 100 in/mi. The macrotexture increased for year 3, with the highest value reported for the control Superpave mix (401 mix).
