Turkey Creek at County Road 48 in Chilton County (32.94441/-86.66283)

BACKGROUND

The Alabama Department of Environmental Management (ADEM) selected the Turkey Creek watershed for biological and water quality monitoring as part of the 2005 Assessment of the Alabama, Coosa, and Tallapoosa (ACT) River Basins. The objectives of the ACT Basin Assessments were to assess the biological integrity of each monitoring site and to estimate overall water quality within the ACT basin group.

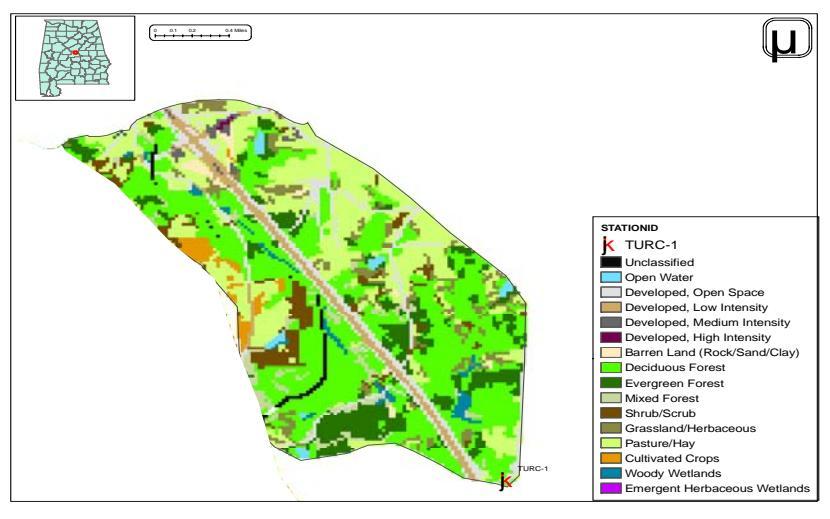
Figure 1. Sampling location and landuse within the Turkey Creek watershed at TURC-1

Watershed characteristics are summarized in Table 1. Turkey Creek at TURC-1 is a *Fish & Wildlife (F&W)* stream located in Chilton County (Fig. 1). It is located in the Coosa River Basin within the Southern Inner Piedmont ecoregion (45a) (Table1). Landuse in the watershed is primarily forest (49%) and pasture (23%).
