Estill Fork at Jackson County Road 140 (34.96529/-86.15370)

The Alabama Department of Environmental Management (ADEM) selected the Estill Fork watershed for biological and water quality monitoring as part of the 2009 Assessment of the Tennessee (TN) River Basin. The objectives of the Tennessee and to Tennessee the biological integrity of each monitoring site and to Tennessee functional constraints are to assess the biological integrity of each monitoring site and to Tennessee (Tennessee).

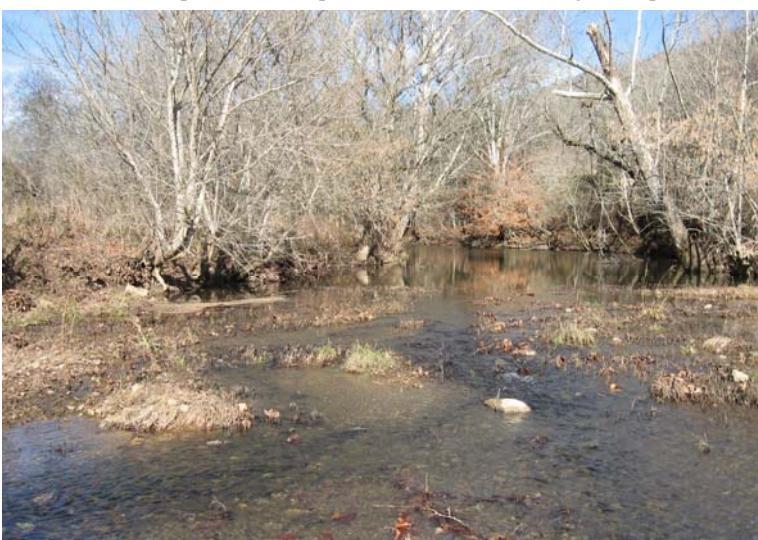
Figure 1. Estill Fork at ESTL-1 on December 3, 2008, facing upstream.

General observations (Table 2) and a habitat assessment (Table 3) were completed during the macroinvertebrate assessment. In comparison with reference reaches in the same ecoregion, they give an indication of the physical condition of the site and the quality and availability of habitat. Estill Fork at ESTL-1 is characterized by sand and gravel substrates (Figure 1). Overall habitat quality was categorized as *sub-optimal*. The low bridge crossing and culverts at County Road 140 currently impede flow and have widened the stream above and below the bridge.

Bioassessment results indicated the macroinvertebrate community to be in *good* condition. Results of a fish community assessment conducted by the Geological Survey of Alabama indicated fish community to be in *good* condition. However, stream flows and fish migration are affected by the low bridge crossing and culverts at County Road 140. The TNC plans to remove this bridge in fall, 2013.
