# 2013 Monitoring Summary

### Brier Fork at Meridianville Bottom Road in Madison County (34.85329/-86.54330)

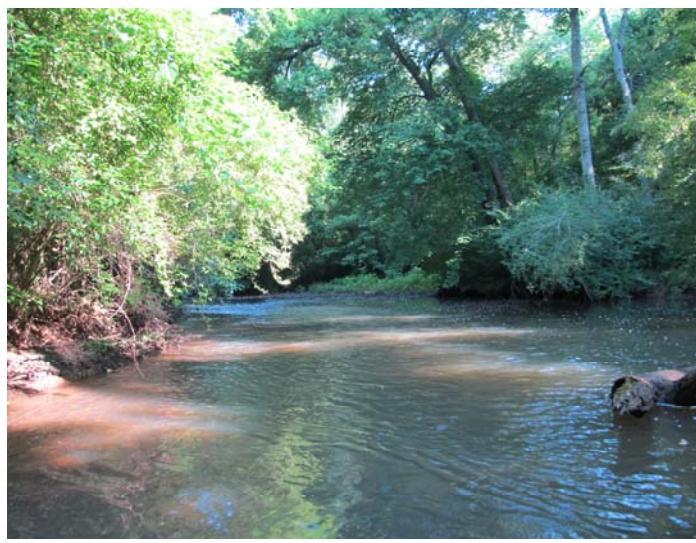
Figure 1. Brier Fork Creek at BFFM-3A, June 20, 2013.

General observations (Table 2) and a habitat assessment (Table 3) were completed during the macroinvertebrate assessment. In comparison with reference reaches in the same ecoregion, they give an indication of the physical condition of the site and the quality and availability of habitat. Brier Fork at BFFM-3A (Figure 1) is characterized mostly as having gravel substrate with frequent pool and run habitats. BFFM-3A is located in the Eastern Highland Rim ecoregion (Table 1). Overall habitat quality was categorized as *optimal* due to favorable instream habitat conditions with low amounts of sedimentation found within the reach. Gravel, which is considered a stable and suitable habitat that was scored at the reach.
