# 2015 Monitoring Summary

## Negro Creek at Baldwin County Road 87 (30.50008/-87.58168)

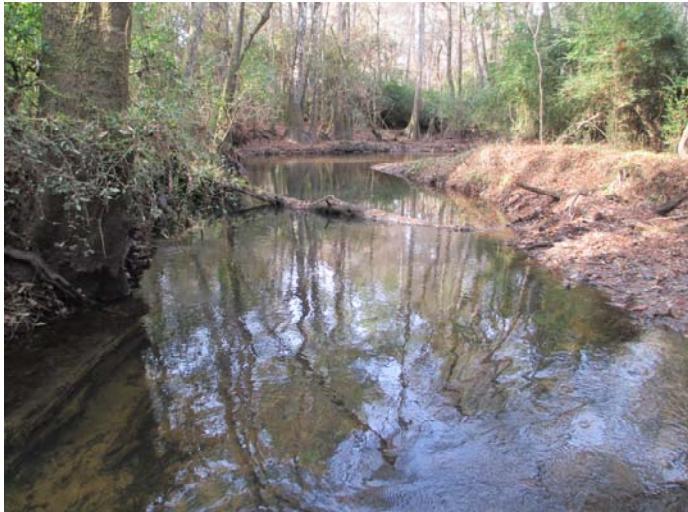
Figure 1. Negro Creek at NGOB-1, August 4, 2015.

General observations (Table 2) and a habitat assessment (Table 3) were completed during the fish community assessment. In comparison with reference reaches in the same ecoregion, they give an indication of the physical condition of the site and the quality and availability of habitat. Negro Creek is a low-gradient, slow moving stream. The plentiful streams bends, snags and woody debris, and relatively deep pools provided optimal habitat and cover for aquatic organisms (Figure 1).
