2006 Monitoring Summary

Ulcanush Creek at Clark County Road 31 north of Coffeerville (31.78408/-88.10808)

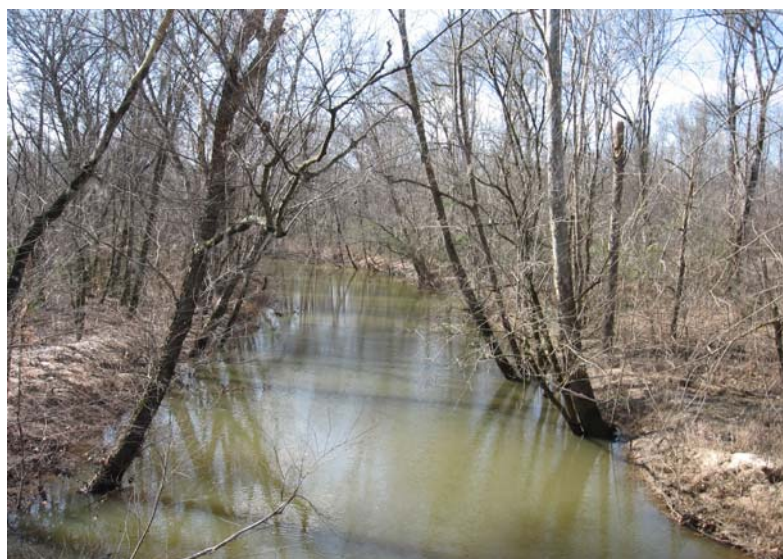
Figure 1. Ulcanush Creek at ULCC-1, January 2010.

General observations (Table 2) and a habitat assesment (Table 3) were completed during the macroinvertebrate assessment. In comparison with reference reaches in the same ecoregion, they give an indication of the physical condition of the site and the quality and availability of habitat. Ulcanush Creek at ULCC-1 is a low-gradient, glide-pool stream located in the Burhstone/Lime Hills ecoregion (Figure 1). Overall habitat quality was categorized as *marginal* due to a relatively straight stream channel, limited instream habitat, and eroding banks.
