2006 Monitoring Summary

White House Creek at White House Fork Road (Mobile County) (30.77626/-87.87133)

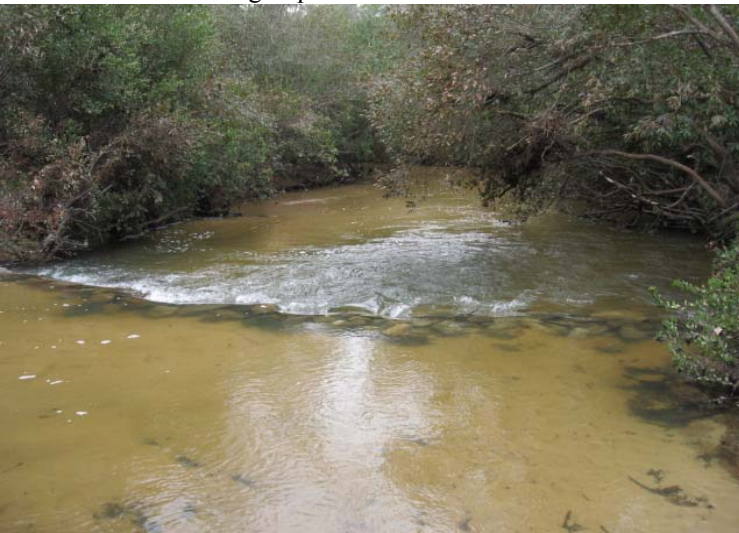
Figure 1. White House Creek at WHSB-1, January 2010.

General observations (Table 2) and a habitat assessment (Table 3) were completed during the macroinvertebrate assessment. In comparison with reference reaches in the same ecoregion, they give an indication of the physical condition of the site and the quality and availability of habitat. White House Creek at WHSB-1 is a low gradient stream characterized by a sandy substrate (Figure 1). Habitat quality was rated as *optimal*.
