# 2007 Monitoring Summary

## Fivemile Creek at Lawson Road in Jefferson County (33.60707/-86.74214)

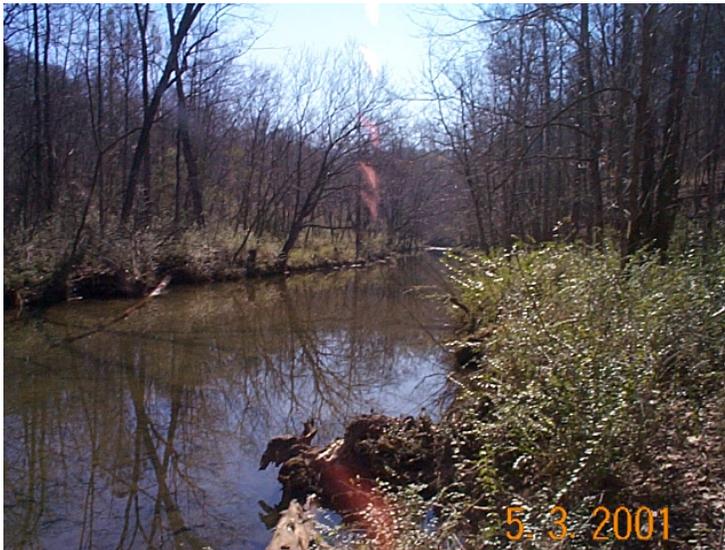
Figure 1. Fivemile Creek at FMCJ-1, May 3, 2001.

General observations (Table 2) and a habitat assessment (Table 3) were completed during the macroinvertebrate assessment. In comparison with reference reaches in the same ecoregion, they give an indication of the physical condition of the site and the quality and availability of habitat. Fivemile Creek at FMCJ-1 is a high-gradient stream with a gravel, sand, and bedrock substrate (Figure 1). Overall habitat quality was categorized as *optimal* for supporting macroinvertebrate communities.
