2008 Monitoring Summary

Beaver Creek at Houston County Road 59 (31.21647/-85.48691)

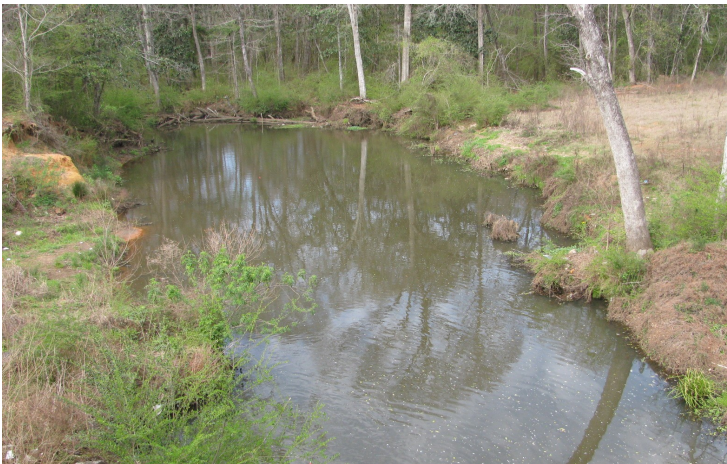
Figure 1. Beaver Creek at BVC-2, March 3, 2011.

General observations (Table 2) and a habitat assessment (Table 3) were completed during the macroinvertebrate assessment. In comparison with reference reaches in the same ecoregion, they give an indication of the physical condition of the site and the quality and availability of habitat. Beaver Creek is characterized by a sandy substrate typical of the Dougherty Plain ecoregion (Figure 1). Overall habitat quality was rated as *marginal* for supporting macroinvertebrate communities due to poor in-stream habitat, weak bank and vegetative stability, channelization, and minimal riparian buffer.
