2008 Monitoring Summary

Bennett Mill Creek at Henry Co Rd 47 (31.52586/-85.07152)

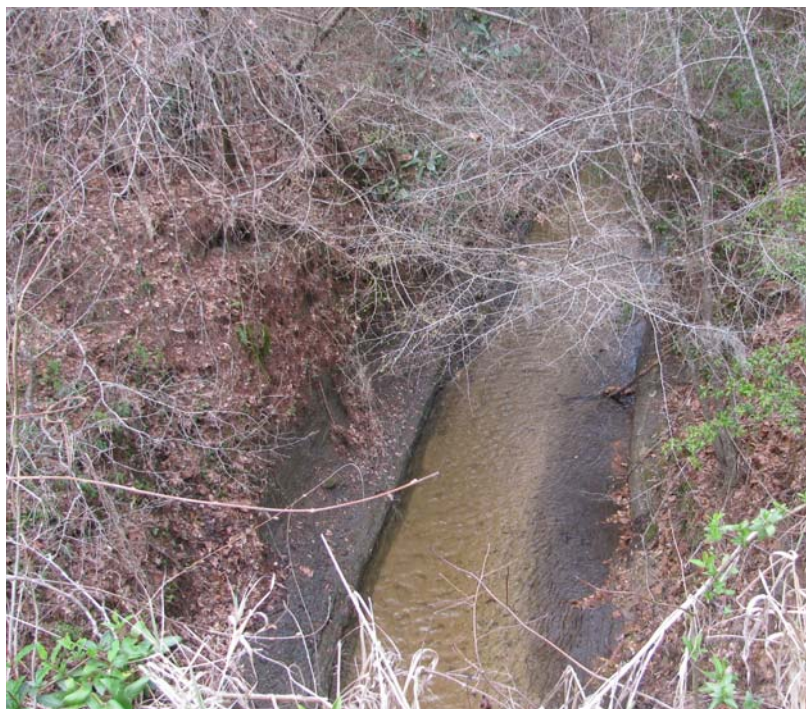
Figure 1. Reach Characteristics of Bennett Mill Creek at BMCH-1.

[General observations](#) (Table 2) and a [habitat assessment](#) (Table 3) were completed during the macroinvertebrate assessment. In comparison with reference reaches in the same ecoregion, they give an indication of the physical condition of the site and the quality and availability of habitat. Bennett Mill Creek at BMCH-1 is a medium gradient, sand bottomed stream typical of ecoregion 65d (Figure 1). Overall habitat quality was categorized as *sub-optimal*, but a lack of stream sinuosity and instream habitat were noted.
